Submersible Pump Repair Report
Georges Inc
1810 S. St. Louis Street
Batesville, AR 72501

Submersible Pump Repair Report
Location: Shop
Serial Number: 39264
Description:7.5HP ZOELLER PUMP

HP:	7.5 (HP)
Model:	G7112-A
Serial:	39264
V:	460 (V)
A:	11 (A)
RPM:	3450 (RPM)
Hz:	60 (Hz)
Phase:	3

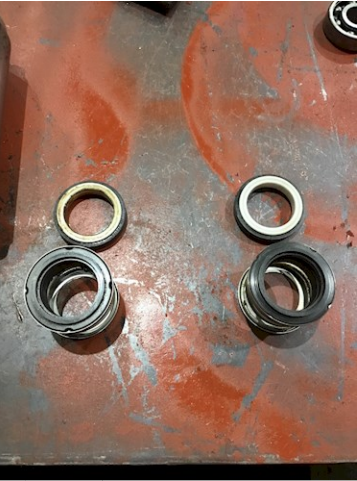
4.	Power Cord Wire Size	12 AWG	
5.	Power Cord # of Conductors	4	
6.	Power Cord Length	25 ft	
7.	Power Cord Condition	(P) Pass	
8.	Sensor Cord Wire Size	18 AWG	
9.	Sensor Cord # of Conductors	5	
10.	Sensor Cord Length	25 ft	
11.	Sensor Cord Condition	(P) Pass	
12.	Sensor Cord for Thermal Protection?	(Y) Yes	
13.	Sensor Cord for Water Protection	(Y) Yes	
14.	Bowl Condition	(P) Pass	
15.	Impeller Condition	(P) Pass	
16.	Number of Wear Rings	1	
17.	Wear Ring Condition	(P) Pass	
18.	Wear Ring Size	in	
19.	Wear Ring Clearance to Impeller	in	
20.	Wear Ring Material		
21.	Seal Surfaces Condition	(F) Fail	P98

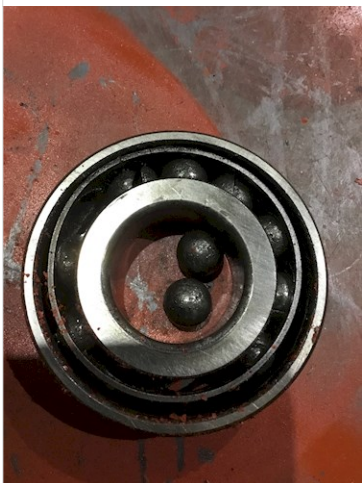
P65

60. Stator Condition

rewind

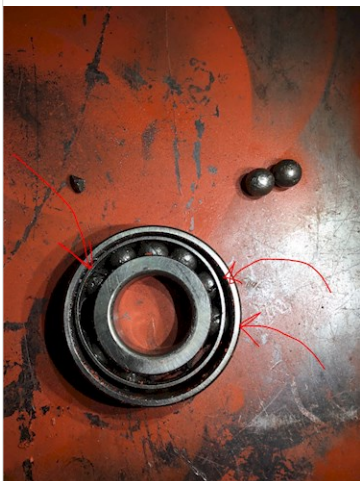
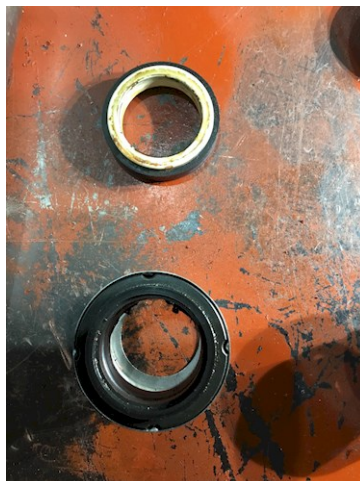
84. Component Failure	DE and ODE Brearing and seal failure

DE seal failed allowing water to penetrate the housing. This caused the bearing lubrication to fail resulting in multiple cracked balls in the DE thrust bearing and the ODE bearing to lock up. Bearing fragments imbedded themselves into the windings resulting in a short circuit.

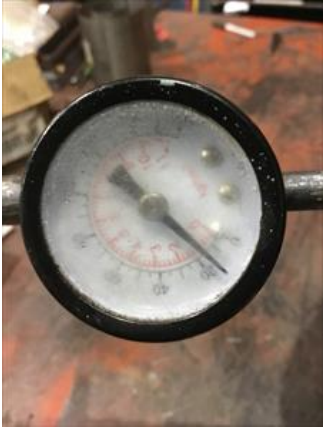
</div> <div> <i>Bottom</i> </div> </div> <div> <div>

125. Rotor and Impeller Balanced	(NA) Not Applicable	
<div> <div></div> 126. Stator Housing Refilled with Oil (if required) </div> <div> <div></div> <i>Witness:</i> </div>	(Y) Yes	
<div> <div></div> 127. Stator Pressure Test </div> <div> <div></div> <i>See below</i> </div>	(P) Pass	
<div> <div></div> 128. Seal Cavity Pressure Test </div> <div> <div> <div> <div>

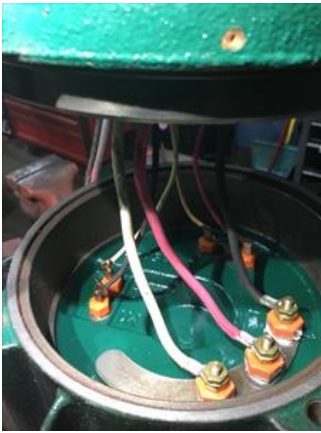
</div> <div> <i>Top</i> </div> </div> </div> </div>	(P) Pass	P35
129. Time Under Pressure	15 min	
<div> <div></div> 130. Overload Continuity </div>	(P) Pass	
131. Water Sensor Open?	(NA) Not Applicable	
132. Meggar Testing Reading	498 Mohm	P61
<div> <div>   </div> </div>		
133. Surge Test		P67

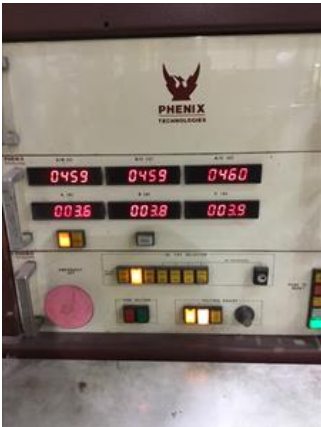
134. Hi-Pot	Ua		
135. Winding Resistance			
1-2	2-3	3-1	
136. Test Run	(P) Pass		
Witness: CW			
137. Test Run Voltage			P95
Phase A	Phase B	Phase C	
459	459	460	
138. Test Run Current			
Phase A	Phase B	Phase C	
3.6	3.8	3.9	
139. DE Vibration Reading			
Horizontal	Vertical	Axial	
140. ODE Vibration Reading			
Horizontal	Vertical	Axial	
141. Ambient Temp at start of Test Run	Degrees F.		
142. Temp at 5 minutes	Degrees F.		
143. Temp at 10 minutes	Degrees F.		
144. Temp at 15 minutes	Degrees F.		
145. Temp at 20 minutes	Degrees F.

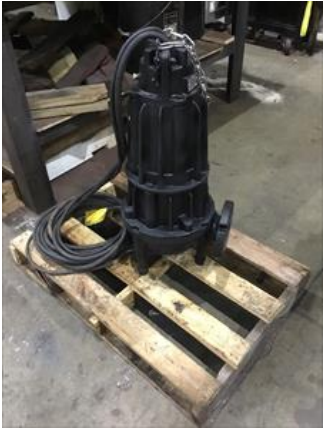
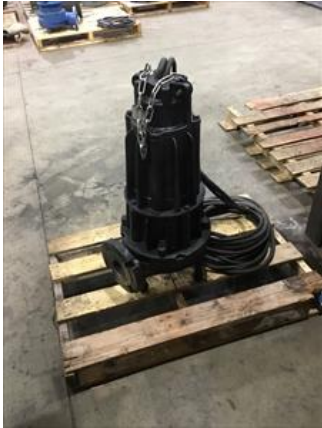
146. Temp at 25 minutes	Degrees F.	
147. Temp at 30 minutes	Degrees F.	
148. Temp at 35 minutes	Degrees F.	
149. Temp at 40 minutes	Degrees F.	
150. Temp at 45 minutes	Degrees F.	
151. Temp at 50 minutes	Degrees F.	
152. Temp at 55 minutes	Degrees F.	
153. Temp at 60 minutes	Degrees F.	
154. Motor Paint		P141
<div>
