## Submersible Pump Repair Report

Tyson Foods (10914)

Location: MOTOR SHOP LR

Description: 5HP GOULD PUMP

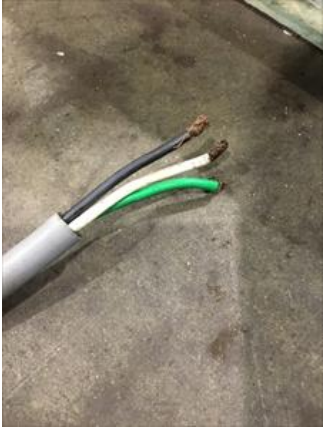
5.	Power Cord # of Conductors	3	P19

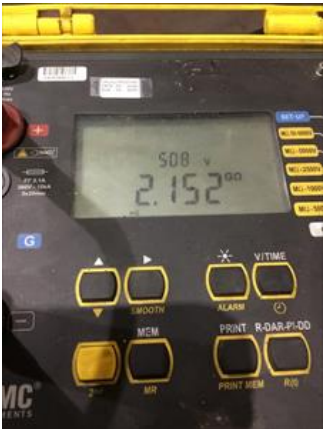
6.	Power Cord Length	20 ft	
<input checked="" type="radio"/>	7. Power Cord Condition	(P) Pass	P37

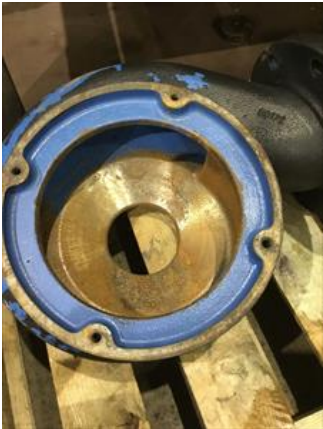
8.	Sensor Cord Wire Size	AWG	
9.	Sensor Cord # of Conductors		
10.	Sensor Cord Length	ft	
11.	Sensor Cord Condition		
<input checked="" type="radio"/>	12. Sensor Cord for Thermal Protection?	(N) No	
13.	Sensor Cord for Water Protection	(NA) Not Applicable	
<input checked="" type="radio"/>	14. Bowl Condition	(P) Pass	P74

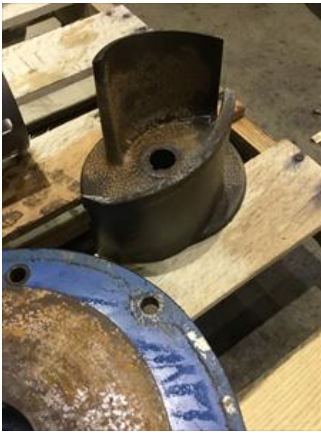
<input checked="" type="radio"/>	15. Impeller Condition	(P) Pass	P80

84. Component Failure	impeller
85. Cause of Failure	<i>Excessive amounts of rag like material entangled around the impeller</i>
86. Comments	<i>Motor test ran good.</i>
87. Service Technician	Terrence Holland

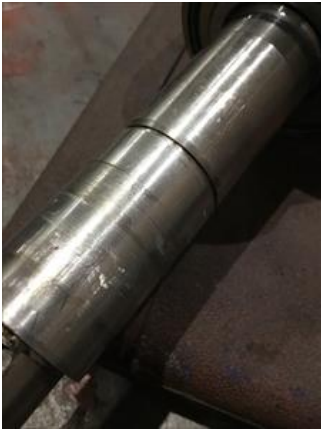
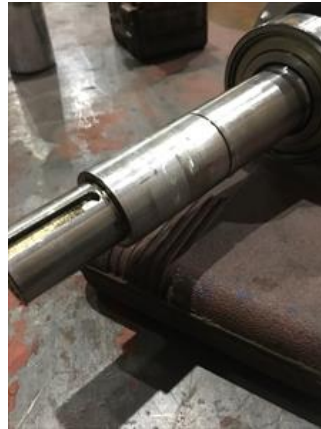
P98

16.	Number of Wear Rings	1
17.	Wear Ring Condition	
18.	Wear Ring Size	in
19.	Wear Ring Clearance to Impeller	in
20.	Wear Ring Material	
21.	Seal Surfaces Condition	(F) Fail

yes, seal surface worn

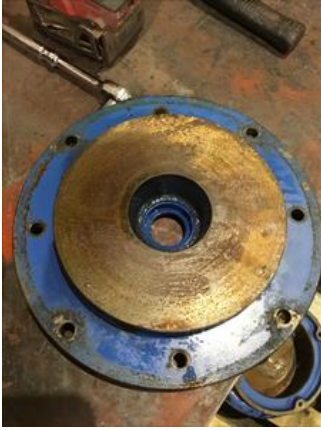
22.	Seal Type	Mechanical
23.	Number of Seals	2
24.	Seal Material on Rotary Face	tungsten carbon
25.	Seal Material on Stationary Seat	tungsten ceramic
26.	Elastic Component Material	Viton
27.	Seal OD	1.7525 in
28.	Seal ID	1.1498 in
29.	Seal Sleeve Material

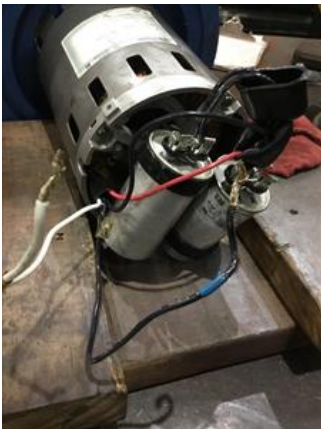
P16

34. Number of Leads

4

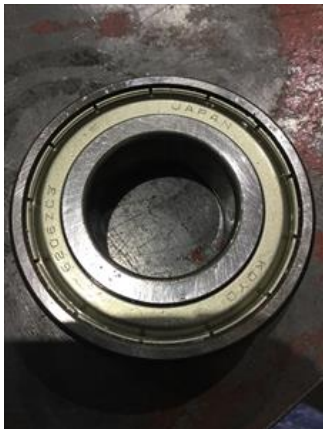
51.	Fan Condition		
52.	Broken or missing components		
	None		
Initial Electric Test			
53.	Resistance to Ground	2,000 Mohm	
54.	Winding Resistance 1-2	Ohm	
55.	Winding Resistance 2-3	Ohm's	
56.	Winding Resistance 1-3	Ohm's	
57.	Resistive Imbalance	%	
58.	Hi-Pot	Ua	
59.	Surge Test		
60.	Stator Condition	pass	
61.	Failure Location		
	Impeller was entangled with rag like materials.		
Initial Rotor Inspection			
62.	Rotor Type	squirrel cage	
63.	Air Gap <10% Variation	(P) Pass	
64.	Number of Rotor Bars	48	
65.	Number of Broken Rotor Bars	0	
66.	Growler Test	(P) Pass	
67.	Rotor Condition	(P) Pass	
Mechanical Inspection			
68.	Bearing Manufacturer	koyo	
69.	Bearing DE Size	6206	P18

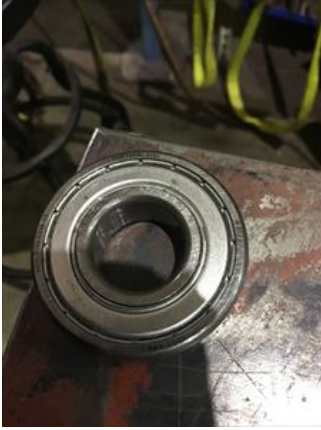
70.	Bearing DE Type	ball bearing.	
71.	DE Bearing Qty.	1	
72.	Bearing ODE Size	6204
