## AC Inspection as Found

Reynolds Metals company

### AC Inspection - Rev. 2

Description: 40HP BALDOR RELIANCE EVAL

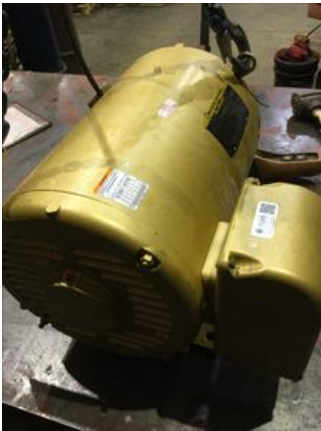
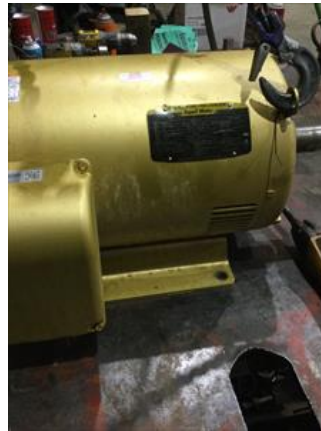
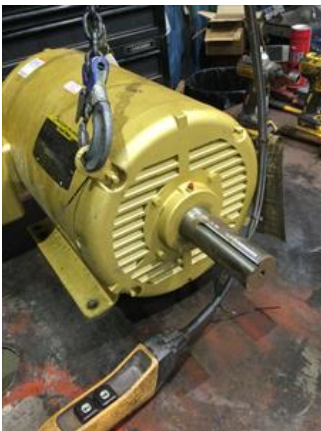
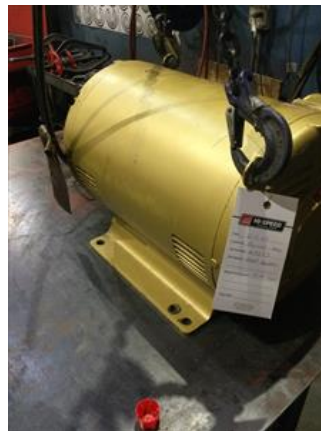
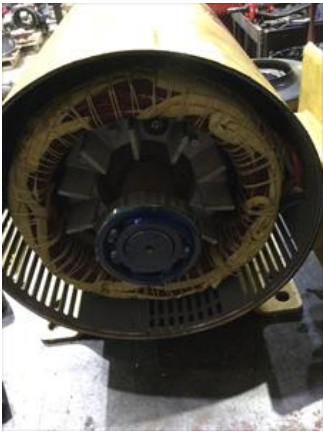
3. Photos of all six sides of the machine.

4. Describe the Overall Condition of the Equipment as Received  
*Serviceable*

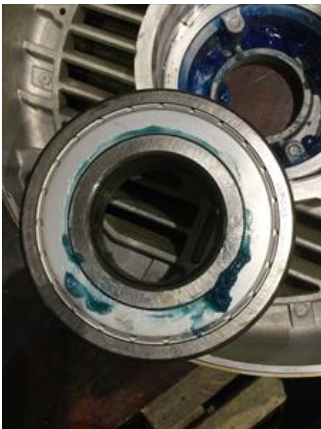
26. Drive End Bearing Brand

SKF

27. Drive End Bearing Number-

6312

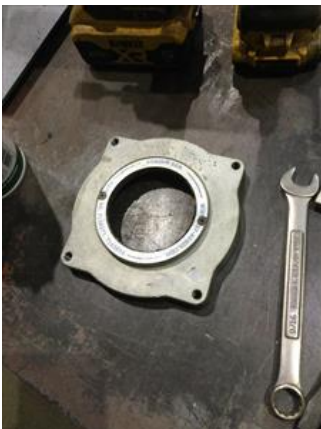
31. Drive End Bearing Insulation or Grounding Device?

Aegis Ring

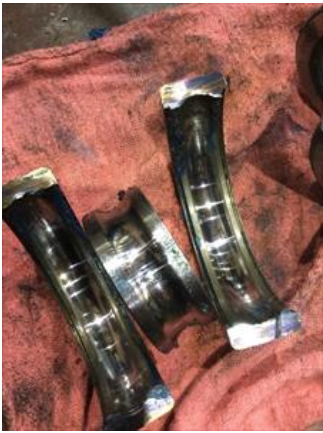
34.	Opposite Drive End Bearing Brand	FAG	
35.	Opposite Drive End Bearing Number-	6309	P100

36.	Opposite Drive End Bearing Qty.	1	
37.	Opposite Drive End Bearing Type	(Ball) Ball Bearing	
38.	Opposite Drive End Lubrication Type	(Grease) Grease Lubricated	
39.	Opposite Drive End Bearing Insulation or Grounding Device?		
	Na		
40.	Opposite Drive End Wavy Washer/Snap-Ring Other Retention Device?	Wavy washer	
41.	Opposite Drive End Bearing Condition	normal wear	P119

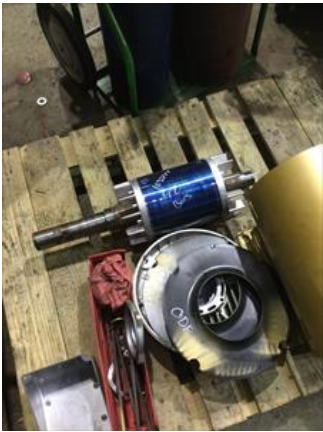
44. Rotor Type/Material

(Squirrel Aluminum) Squirrel  
Cage Aluminum Die Cast

45. Growler Test

(Pass) Pass

47. Rotor Condition

pass

1-6312 Bearing 1-6309 Bearing

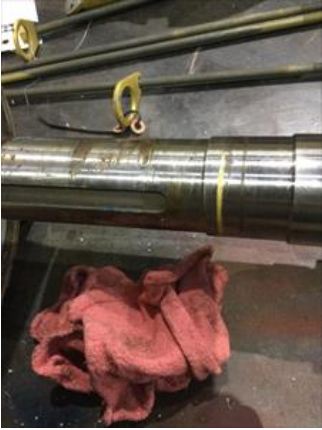
51.	Rotor Runout		
	Drive End Bearing Fit	Rotor Body	Opposite Drive End Bearing
	Na		
52.	Coupling Fit Closest to Bearing Housing		P33
	0 Degrees	90 Degrees	120 Degrees
	2.125	2.125	2.125

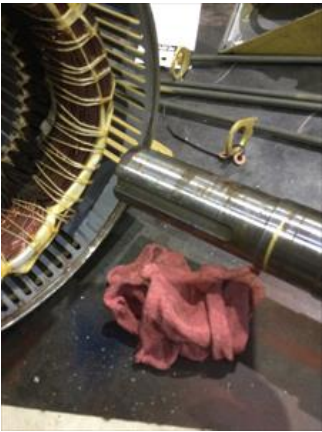
53.	Coupling Fit Closest to the end of the Shaft		P46
	0 Degrees	60 Degrees	120 Degrees
	2.125	2.125	2.125

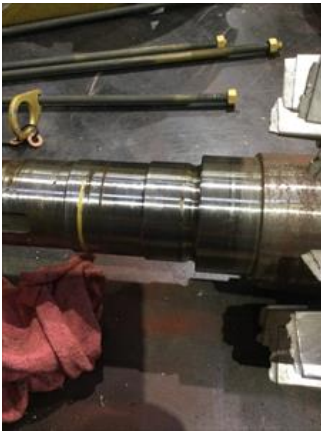
54.	Drive End Bearing Shaft Fit		
	0 Degrees	60 Degrees	120 Degrees
	2.3621	2.3621	2.3621
55.	Drive End Bearing Shaft Fit Condition	(P) Pass	P81

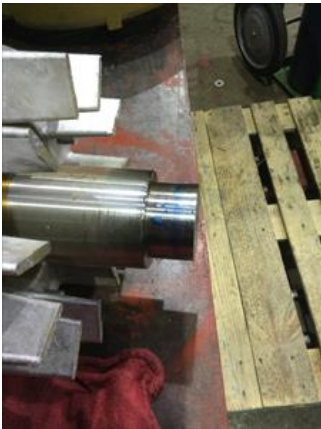
0 Degrees	60 Degrees	120 Degrees
1.7718	1.7718	1.7718

57. Opposite Drive End Bearing Shaft Fit Condition (P) Pass P96

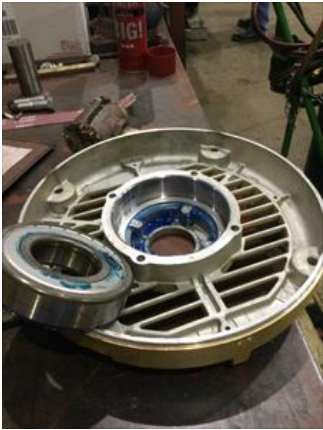
#### 59. Drive End - Endbell Bearing Fit

0 Degrees	60 Degrees	120 Degrees
5.1183	5.1183	5.183

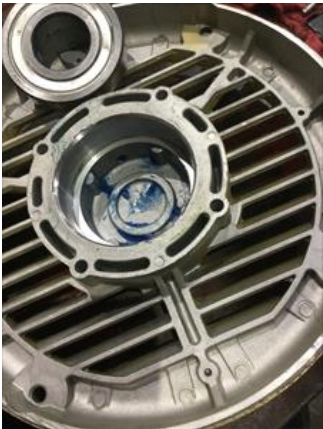
61. Opposite Drive End - Endbell Bearing Fit			
0 Degrees		60 Degrees	120 Degrees
3.9379		3.9379	3.9379

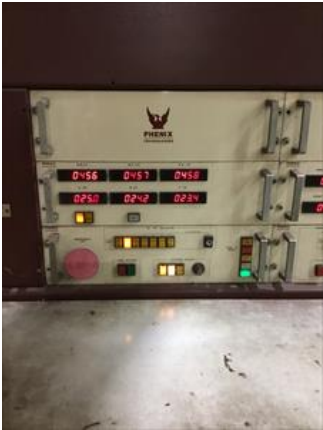
75. Final Insulation Resistance Test			Megohms
Pass			
76. Assembled Shaft Endplay			
77. Assembled Shaft Runout			
78. Test Run Voltage			P56
Volts	Volts	Volts

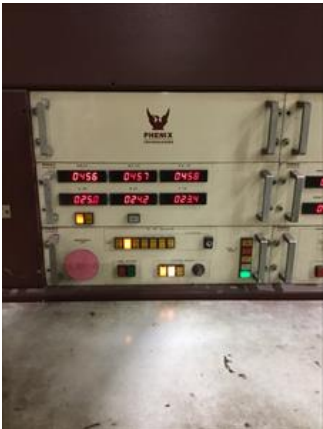
79. Test Run Amperage			P65
Amps	Amps	Amps
