AC Inspection as Found

Sage V Foods

AC Inspection - Rev. 2

Description: 0.5HO SWECO MOTOR EVAL

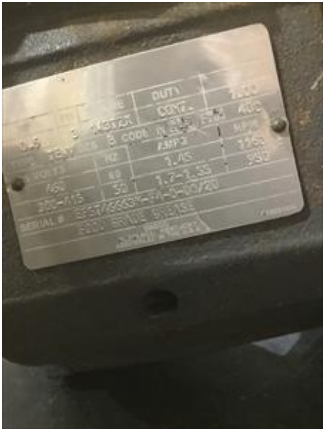
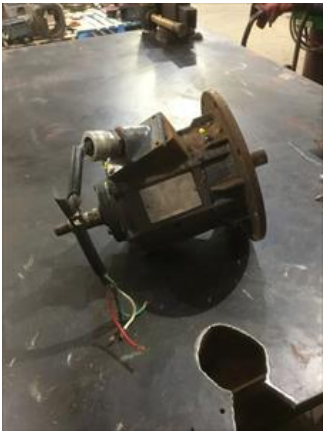
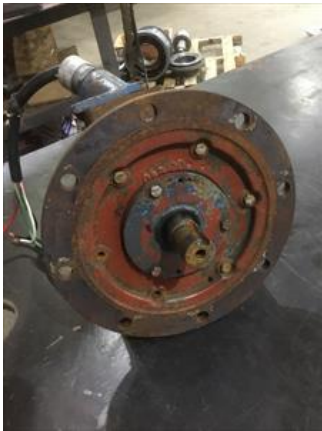
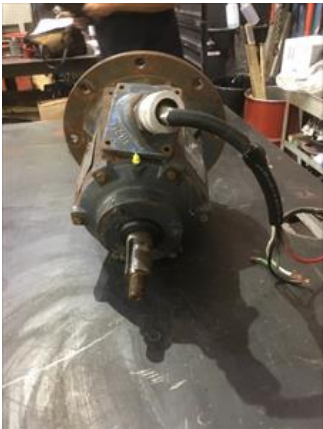
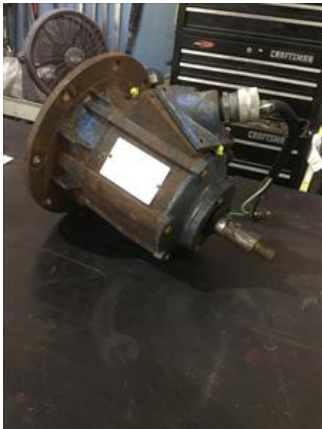
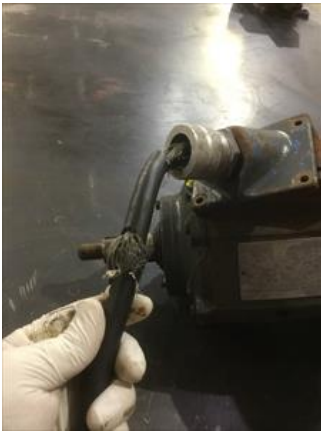
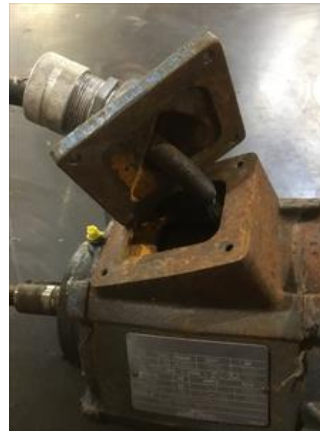
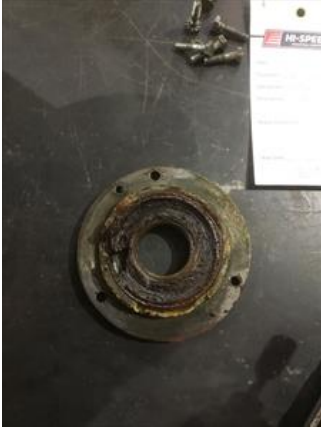
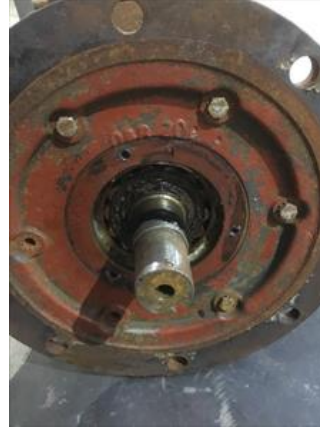
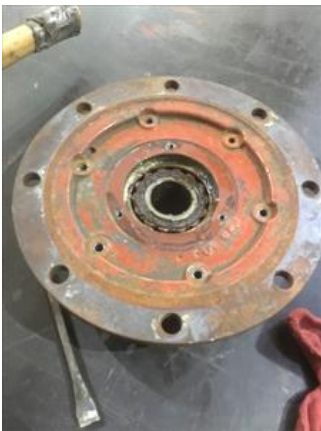
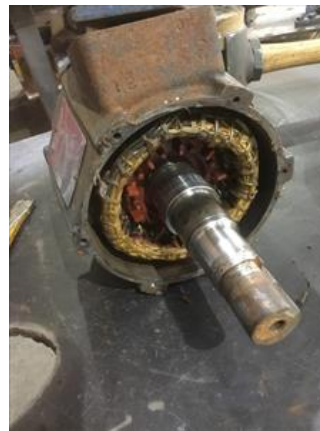
4. Describe the Overall Condition of the Equipment as Received
Dirty and locked up

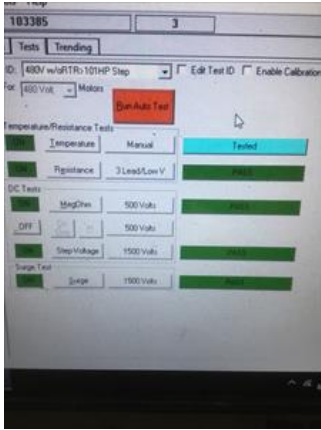
22. Number of Stator Slots	36
23. Stator Condition	pass
24. Stator Thermistors/Ohms	
25. Stator Overloads/Ohms

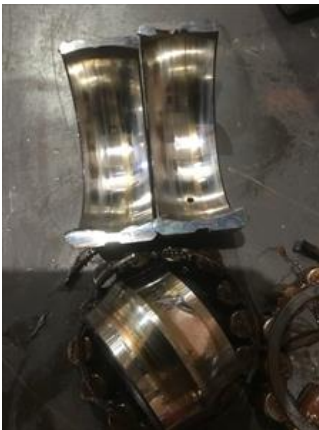
P83

26. Drive End Bearing Brand	FAG
27. Drive End Bearing Number-	22308
28. Drive End Bearing Qty.	1
29. Drive End Bearing Type	(Tapered) Tapered Roller Bearing
30. Drive End Lubrication Type	(Grease) Grease Lubricated
31. Drive End Bearing Insulation or Grounding Device?	
32. Drive End Wavy Washer/Snap-Ring Other Retention Device?	snap ring
33. Drive End Bearing Condition

Contamination and wear

44. Rotor Type/Material (Squirrel Aluminum) Squirrel
Cage Aluminum Die Cast
45. Growler Test (Pass) Pass
46. Number of Rotor Bars
47. Rotor Condition pass
48. List the Parts needed for the Repair Below
22308-E1-XL-T41A
NU307
SEAL- National 340853x2
New cord 4/c 12awg
New snap rings
49. Signature of Technician that Disassembled Motor Cw
- [Handwritten Signature]*

67.	Failure locations		
	<i>Bearings and cord</i>		
68.	Root cause of failure		
	<i>Cord was cut and bearings have contaminants</i>		
Dynamic Balance Report

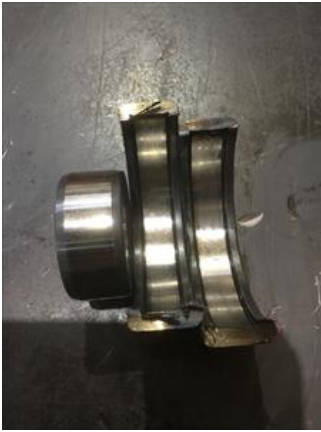
34. Opposite Drive End Bearing Brand	FAG
35. Opposite Drive End Bearing Number-	NU307
36. Opposite Drive End Bearing Qty.	1
37. Opposite Drive End Bearing Type	(Roller) Roller Bearing
38. Opposite Drive End Lubrication Type	(Grease) Grease Lubricated
39. Opposite Drive End Bearing Insulation or Grounding Device?	
40. Opposite Drive End Wavy Washer/Snap-Ring Other Retention Device?	snap ring

Contamination

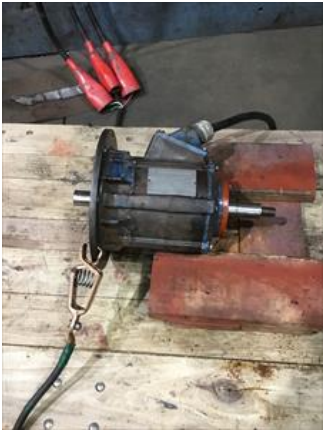
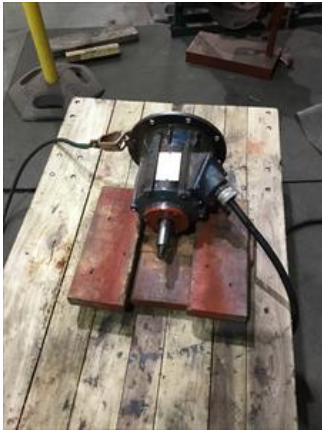
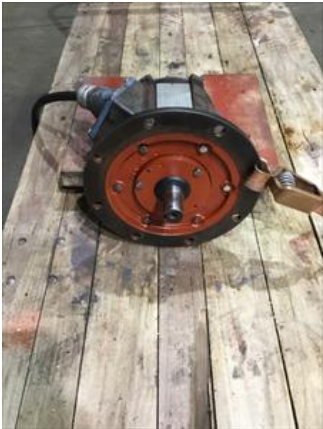
71. Final Balance Readings	
Drive End	Opposite Drive End
72. Technician	
Assembly <div></div>	
73. QC Check All Parts for Cleanliness Prior to Assembly	
74. Photograph All Major Components prior to assembly	P17
<div>

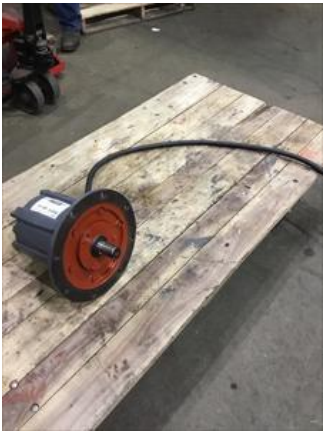
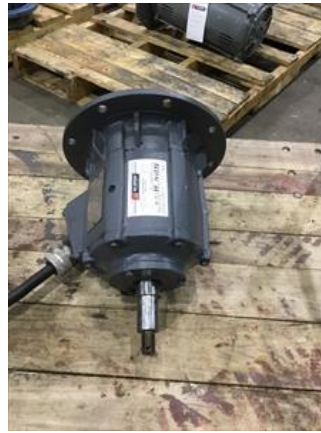
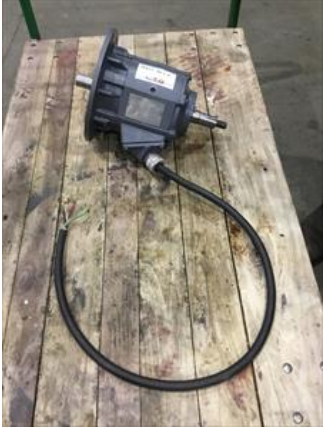
P132

85. Document Final Condition with Pictures after paint

86. Final Pics and QC Review
