Submersible Pump Repair Report
MOUNTAIN VIEW WASTE WATER
340 WESTWOOD
MOUNTAIN VIEW, AR 72560

Submersible Pump Repair Report

Description: YEOMENS PUMP EVAL

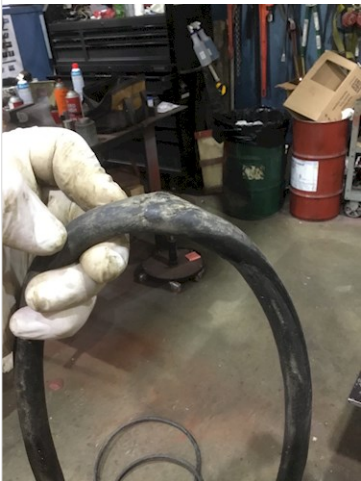
11. Sensor Cord Condition	(F) Fail	P60

Has a <i>smashed area</i>

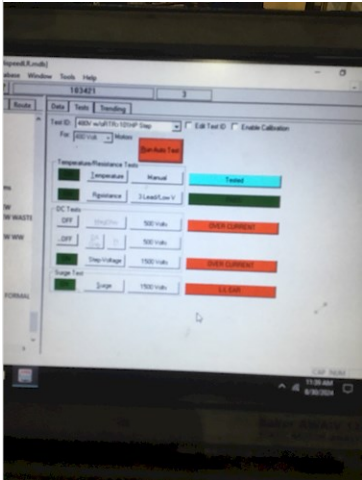
53.	Resistance to Ground	Mohm	
54.	Winding Resistance 1-2	Ohm	
55.	Winding Resistance 2-3	Ohm's	
56.	Winding Resistance 1-3	Ohm's	
57.	Resistive Imbalance	%	
58.	Hi-Pot	Ua	
● 59.	Surge Test	(F) Fail	P56

60.	Stator Condition	rewind	
61.	Failure Location		
Initial Rotor Inspection			
62.	Rotor Type	squirrel cage aluminum	
● 63.	Air Gap <10% Variation	(NA) Not Applicable	
64.	Number of Rotor Bars		
65.	Number of Broken Rotor Bars		
● 66.	Growler Test	(P) Pass	
● 67.	Rotor Condition	(P) Pass	
Mechanical Inspection

86.	Comments	Recommend new o'rings, new seals, new bearings, and rewind	
87.	Service Technician	Cw

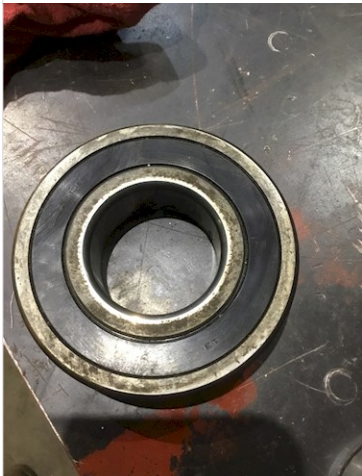
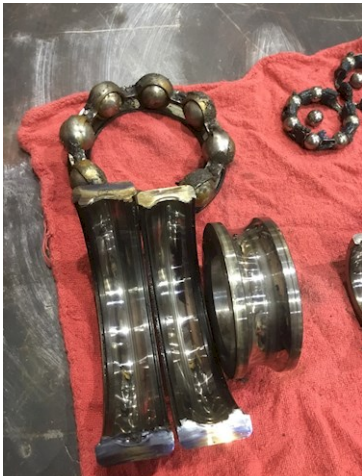
68.	Bearing Manufacturer	na	
69.	Bearing DE Size	6311-2RS	P18

Contamination and frosting

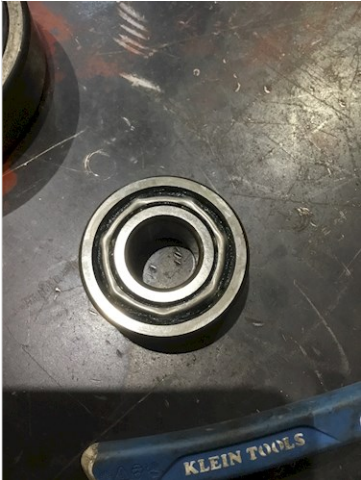
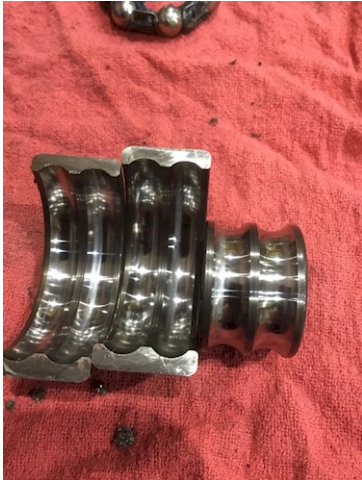
70.	Bearing DE Type	sealed bearing	
71.	DE Bearing Qty.	1	
72.	Bearing ODE Size	5305	P42
<div> <div></div> Contamination and frosting </div>

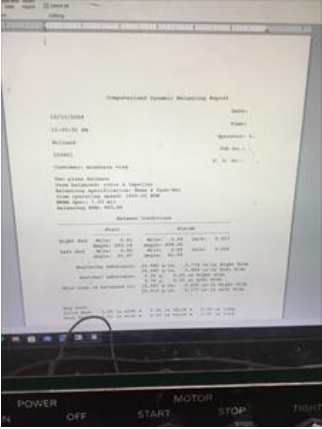
125. Rotor and Impeller Balanced	(Y) Yes	P3

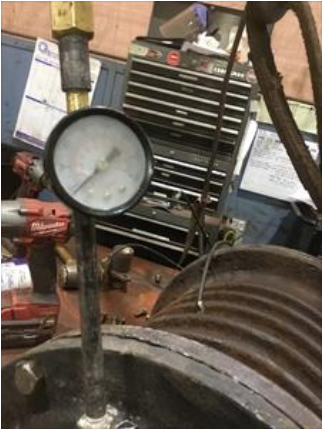
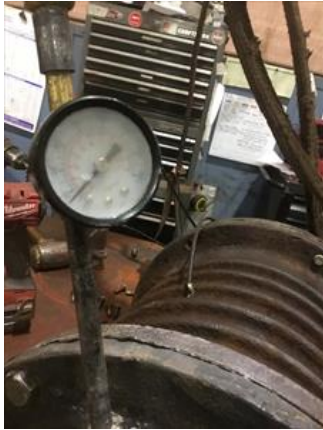
126. Stator Housing Refilled with Oil (if required)	(NA) Not Applicable	
127. Stator Pressure Test	(P) Pass	P29
<div style="display: flex; justify-content: space-around;">

</div>		
128. Seal Cavity Pressure Test	(P) Pass	
129. Time Under Pressure	30 min	
130. Overload Continuity	(P) Pass	
131. Water Sensor Open?	(Y) Yes	
132. Meggar Testing Reading	Mohm	P61

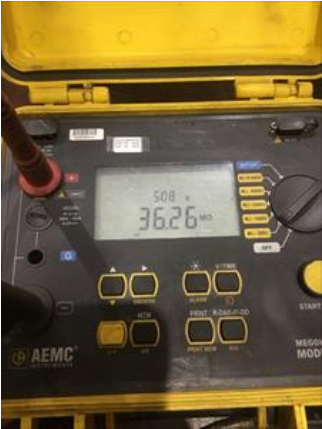
133. Surge Test		
134. Hi-Pot	Ua	
Pass

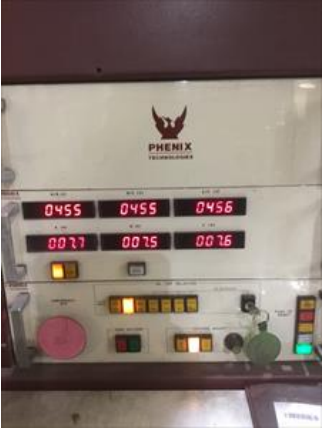
135. Winding Resistance			
1-2	2-3	3-1	
136. Test Run	(P) Pass		
137. Test Run Voltage			P95
Phase A	Phase B	Phase C

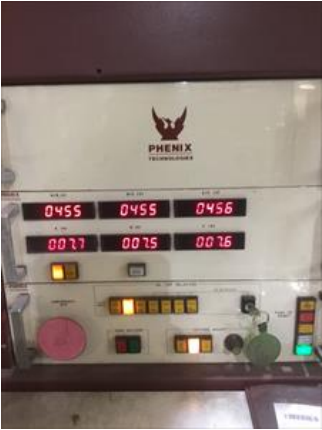
138. Test Run Current			P99
Phase A	Phase B	Phase C	
7.7	7.5	7.6
