## AC Inspection as Found

### Mondi

#### AC Inspection - Rev. 2

Location: LITTLE ROCK MOTOR SHOP  
Serial Number: 8566150229  
Description: 15KW INGERSOLL-RAND

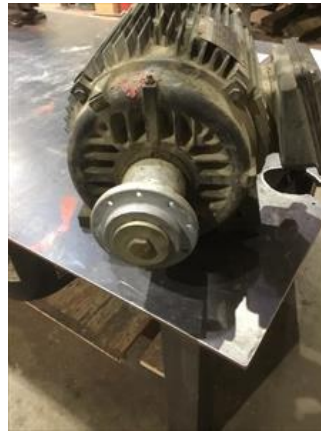
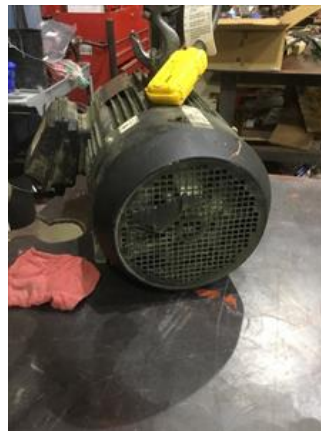
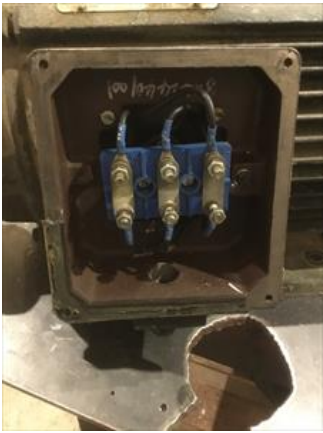
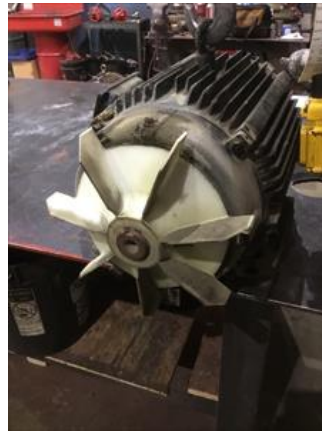
3. Photos of all six sides of the machine.

| 4. | Describe the Overall Condition of the Equipment as Received | |
| | <i>Dirty</i> | |

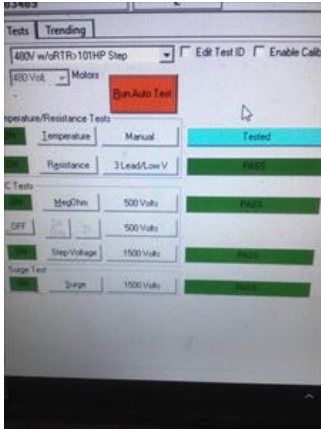
| 21. | Winding Resistance | | P20 |

| L1-L2 (Ohms) | 0.403 | Corr: 0.4... |
| L2-L3 (Ohms) | 0.403 | Corr: 0.4... |
| L3-L1 (Ohms) | 0.403 | Corr: 0.4... |
| Max Delta R % | 0.206 | |

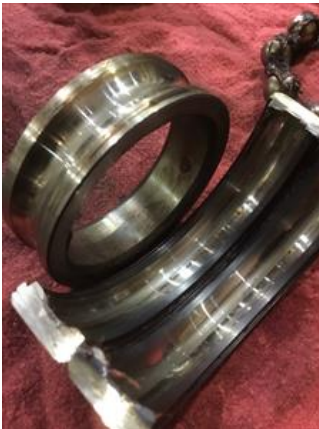
| 34. Drive End Bearing Condition | |

**Signs of fluting**

| | <i>Bearings</i> | | |
| | <i>Contamination and fluting</i> | | |

45. Rotor Type/Material **(Squirrel Aluminum) Squirrel Cage Aluminum Die Cast**
46. Growler Test **(Pass) Pass**
47. Number of Rotor Bars **33**
48. Rotor Condition **pass**
49. List the Parts needed for the Repair Below  
 6211  
 6309  
 Seal/ 55-70-8  
 Seal/ 45-68-8
