## AC Inspection as Found

### Mondi

#### AC Inspection - Rev. 2

Description: 15KW INGERSOLL-RAND

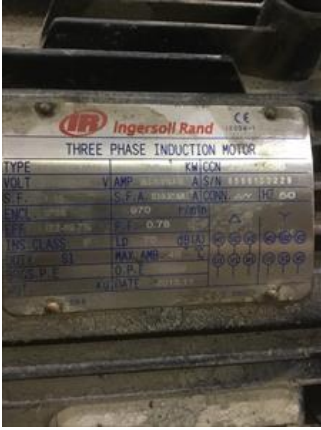
P37

## 2. Nameplate Picture

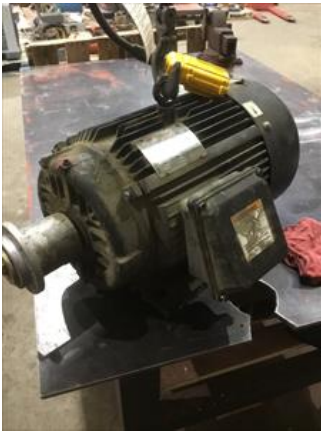
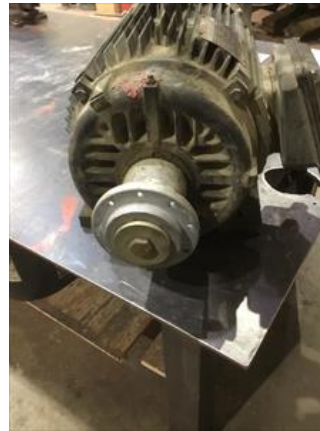
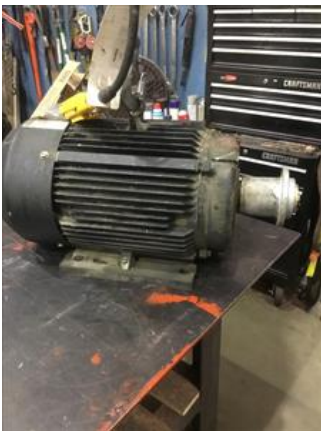
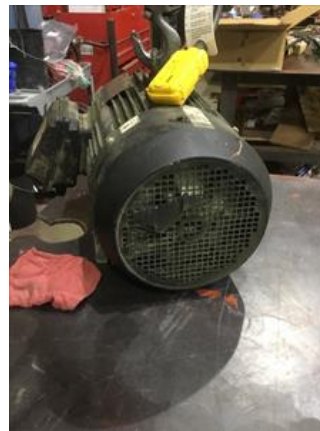
P45

3. Photos of all six sides of the machine.

4.	Describe the Overall Condition of the Equipment as Received	
	<i>Dirty</i>	
5.	Distance from the end of the shaft to the Coupling/Sheave	inches
	<i>Flush</i>	
6.	Report Date [COPY]	
<b>Initial Mechanical/Electrical</b>		
7.	Does Shaft Turn Freely?	(Y) Yes
8.	Does the shaft require T.I.R in Lathe to identify additional repairs?	(No) No
9.	Does Shaft Have Visible Damage?	(No) No
10.	Assembled Shaft Runout	Inches
11.	Assembled Shaft End Play	inches

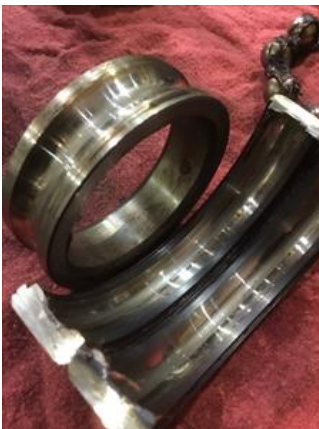
P83

27. Drive End Bearing Brand	SKF
28. Drive End Bearing Number-	6211
29. Drive End Bearing Qty.	1
30. Drive End Bearing Type	(Ball) Ball Bearing
31. Drive End Lubrication Type	(Grease) Grease Lubricated
32. Drive End Bearing Insulation or Grounding Device?	
33. Drive End Wavy Washer/Snap-Ring Other Retention Device?	2 snap rings
34. Drive End Bearing Condition

**Signs of fluting**

68.	Failure locations		
	<i>Bearings</i>		
69.	Root cause of failure		
	<i>Contamination and fluting</i>		
<b>Dynamic Balance Report</b>

45. Rotor Type/Material **(Squirrel Aluminum) Squirrel Cage Aluminum Die Cast**
46. Growler Test **(Pass) Pass**
47. Number of Rotor Bars **33**
48. Rotor Condition **pass**
49. List the Parts needed for the Repair Below  
 6211  
 6309  
 Seal/ 55-70-8  
 Seal/ 45-68-8

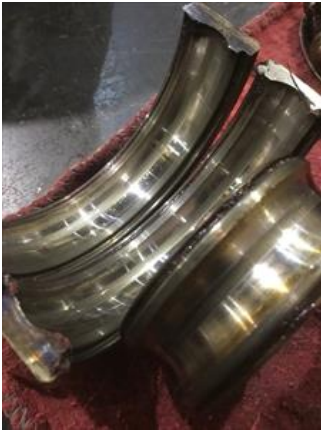
35. Opposite Drive End Bearing Brand	NSK
36. Opposite Drive End Bearing Number-	6309
37. Opposite Drive End Bearing Qty.	1
38. Opposite Drive End Bearing Type	(Ball) Ball Bearing
39. Opposite Drive End Lubrication Type	(Grease) Grease Lubricated
40. Opposite Drive End Bearing Insulation or Grounding Device?	
41. Opposite Drive End Wavy Washer/Snap-Ring Other Retention Device?	wavy washer

**Signs of fluting**

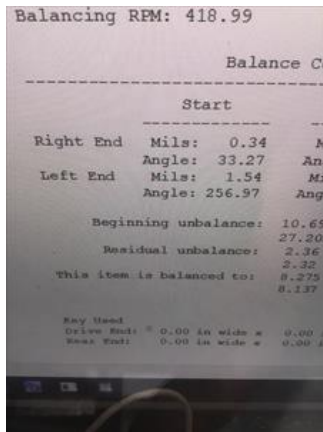
P11

## 71. Initial Balance Readings

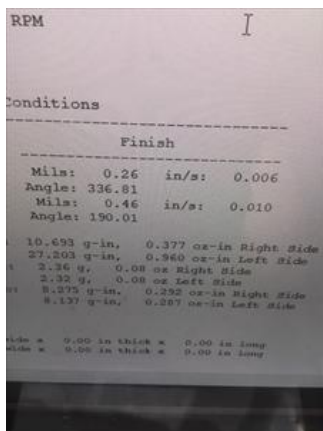
P27

## 72. Final Balance Readings

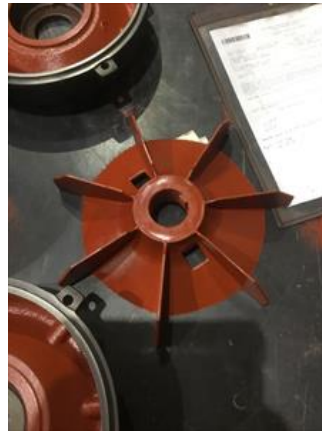
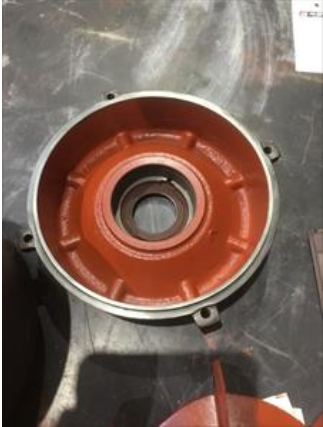
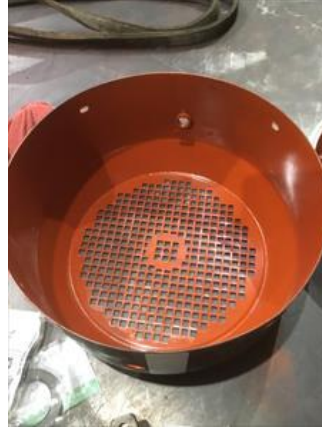
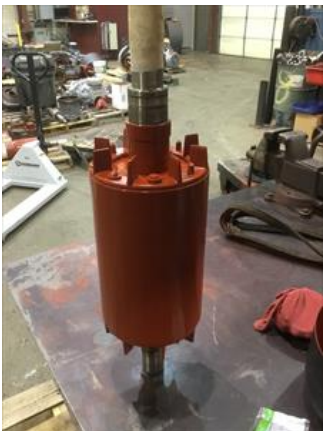
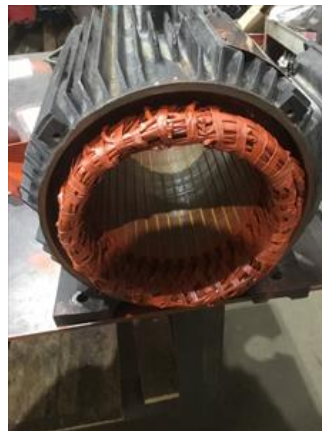
P17

## 75. Photograph All Major Components prior to assembly

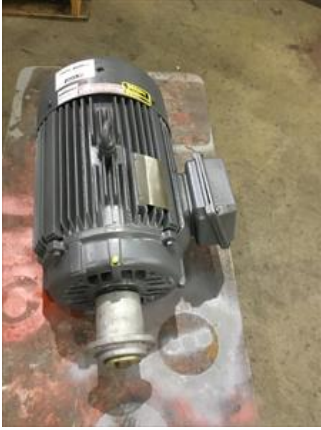
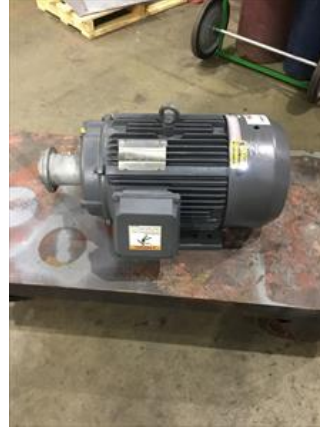
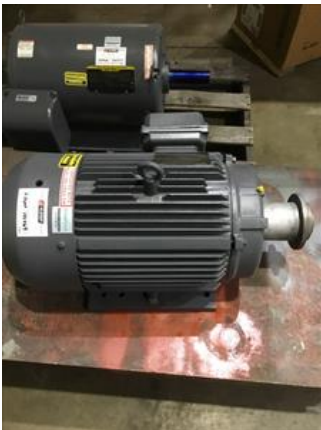
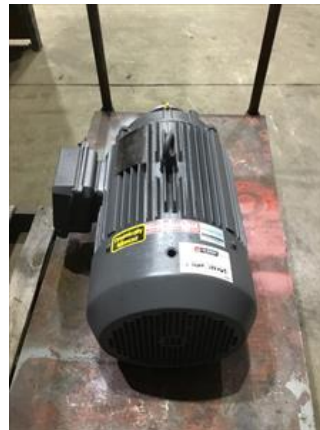
P132

86. Document Final Condition with Pictures after paint

87. Final Pics and QC Review
