AC Inspection as Found
Community Water System (12207)
299 Lakeshore Drive
Greers Ferry, AR 72067

AC Inspection - Rev. 2

Location: LR MOTORSHOP
Serial Number: C1112131247
Description: 150HP BALDOR 3560RPM

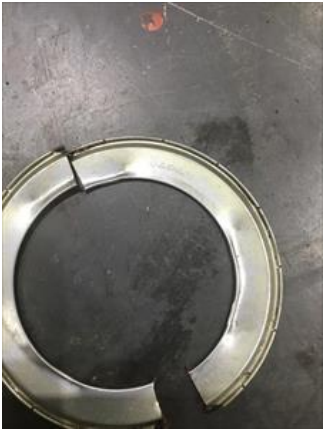
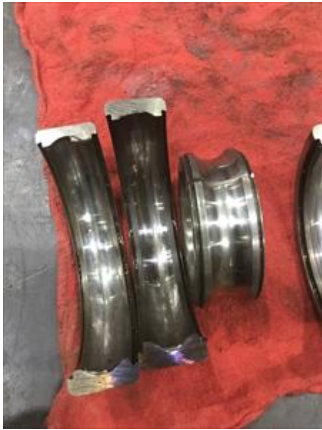
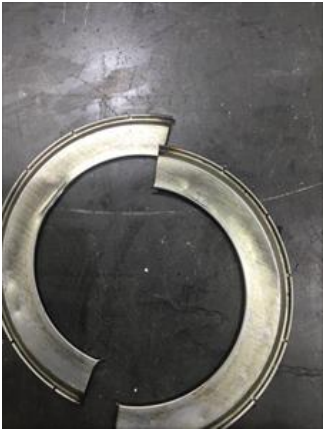
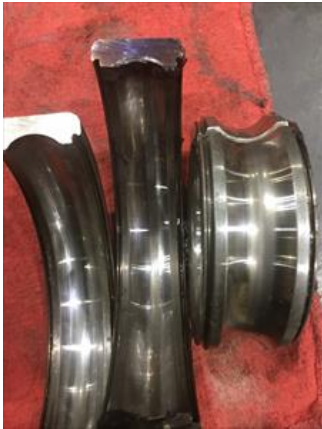
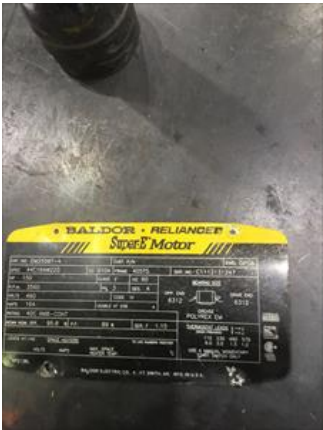
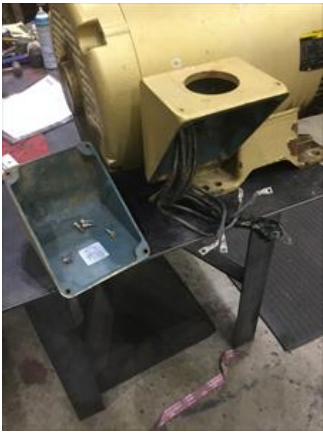
4. Describe the Overall Condition of the Equipment as Received
5. Report Date [COPY]

59.	Drive End - Endbell Bearing Fit		
	0 Degrees	60 Degrees	120 Degrees
	5.1186	5.1188	5.1189
60.	Drive End - Endbell Bearing Fit Condition (P) Pass		
61.	Opposite Drive End - Endbell Bearing Fit		
	0 Degrees	60 Degrees	120 Degrees
	5.12	5.13	5.133
	Pitted needs sleeved		
62.	Opposite Drive End - Endbell Bearing Fit Condition (F) Fail		
63.	Bearing Cap Condition		
	Drive End Bearing Cap	Opposite Drive End Bearing Cap	
64.	End Bell Air Seal Fits		
	Drive End Air Seal	Opposite Drive End Air Seal	
65.	List Machine Work Needed Below Both end bell need sleeved		
66.	Technician RHR

Root Cause of Failure			
67.	Failure locations Housing fits		
68.	Root cause of failure Unknown		
Dynamic Balance Report			
69.	Rotor Weight and Balance Grade		
	Rotor Weight	Balance Grade	
70.	Initial Balance Readings		
	Drive End	Opposite Drive End	
	.92	...97

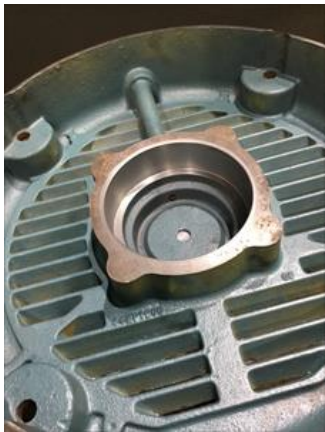
82. Opposite Drive End - Endbell Bearing Fit Post Repair

5.1186

5.1185

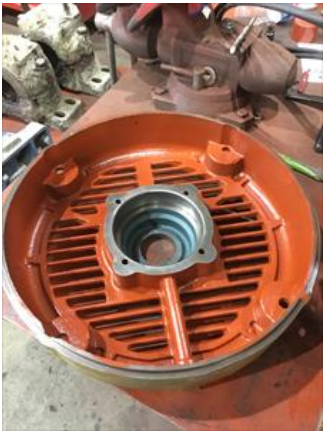
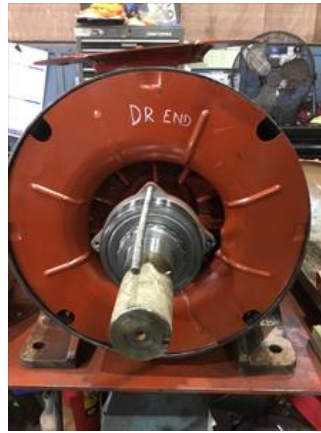
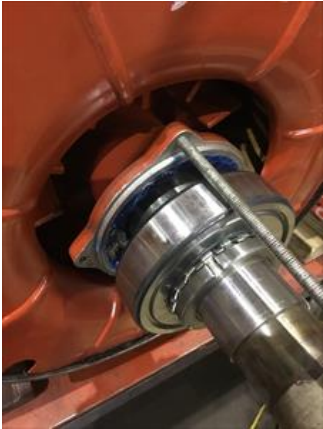
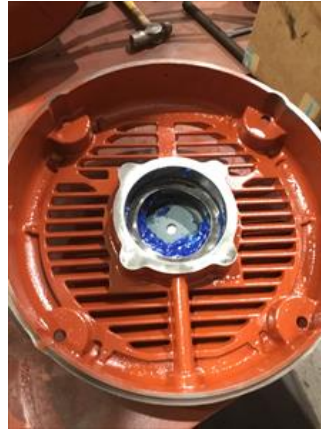
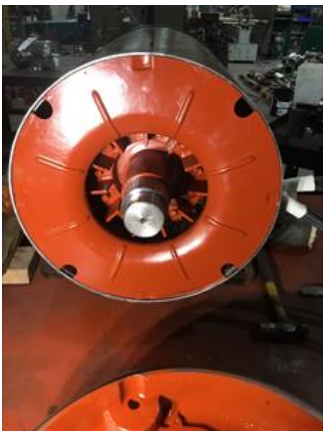
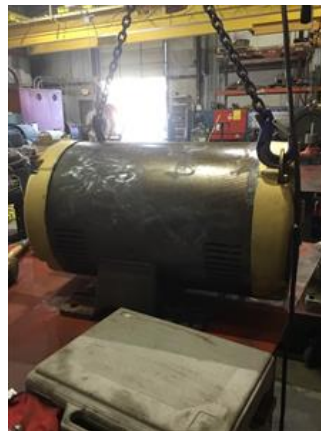
87. Photograph All Major Components prior to assembly

(Complete) Complete

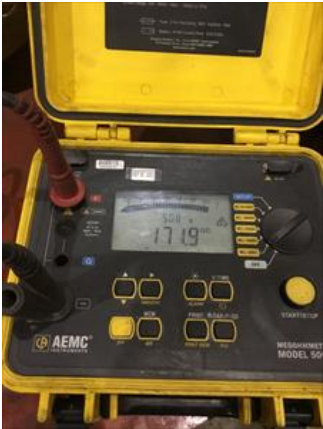
P31

88. Final Insulation Resistance Test

171.9 Gigohms

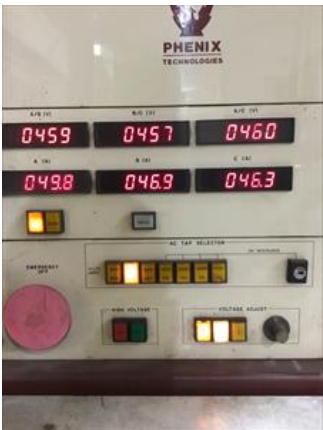
P56

90. Assembled Shaft Runout

459

457

460

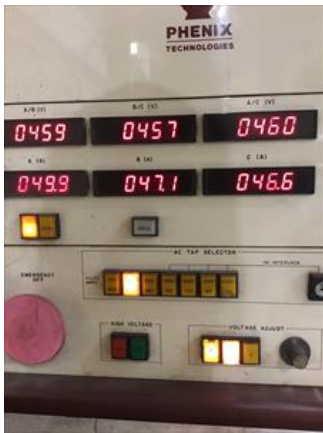
P65

92. Test Run Amperage

49.9

47.1

46.6
