DC Repair Report
Reynolds Metals company
1333 highway 270
Malvern, AR 72104

DC Repair Report Rev. 2

Location: LITTLE ROCK MOTOR SHOP
Job Number: 103617
Serial Number: CR-1-473CR
Description: 100HP GENERAL ELECTRIC

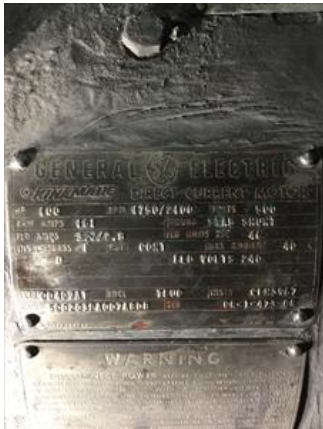
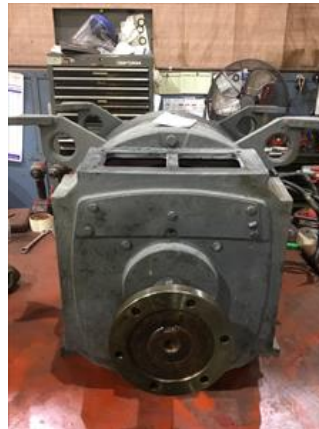
P17

1. Describe the Overall Condition of the Equipment as Received
Serviceable
2. Nameplate Picture

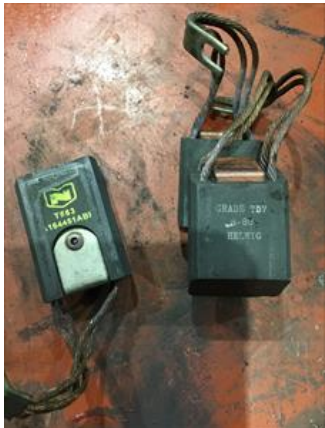
8.	Air Gap Variation <10%		
9.	Lead Condition		(P) Pass
10.	Lead Length		
11.	Frame Condition		(P) Pass
12.	Fan Condition		
13.	Brush Information		P87
	Brush Number	Quantity	Condition
	T563A164451ABP	8	some wear
	Two different kinds of brushes in motor

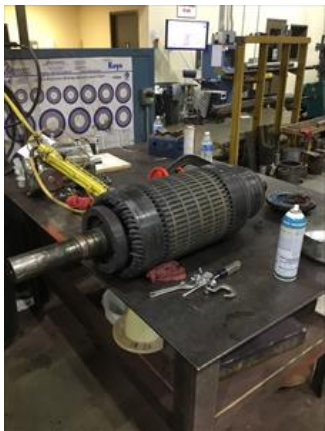
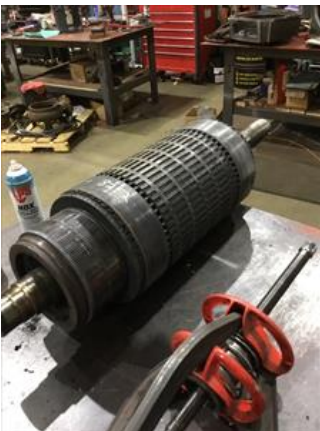
15.	General Condition of the Armature/Commutator		P6
	Dirty. Comm has some wear.

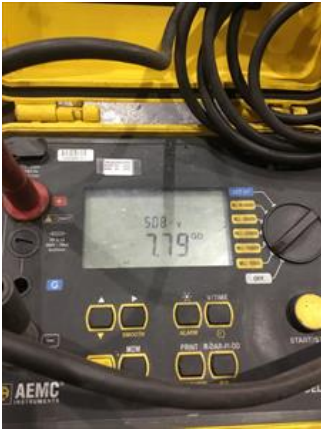
P19

16. Armature Insulation Resistance to Ground

7.79 Gigohms

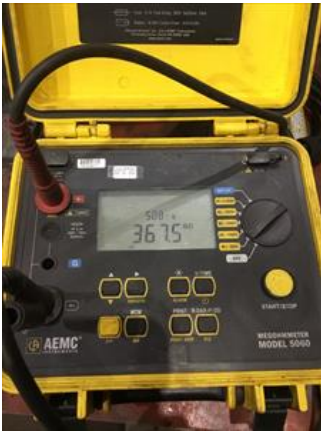
P30

17. Field Circuit Insulation Resistance to Ground

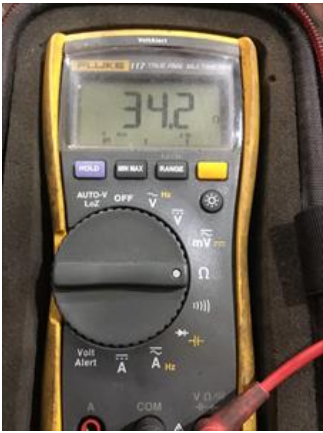
P60

19. Total Field Ohms

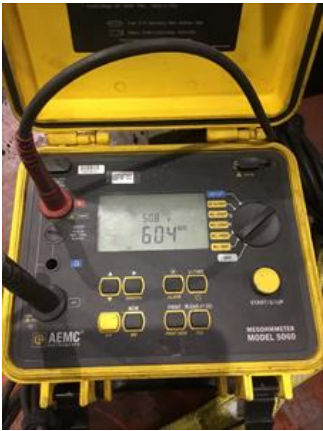
P83

21. MegOhms between Fields and Series

22. Series Drop Test 1&2		
Series 1	Series 2	
17	17	
23. Series Drop Test 3&4		
Series 3	Series 4	
17	18	
24. Field Drop Test Fields 1&2		
Total AC Voltage	Field #1	Field #2
120	0.702	0.782
25. Field Drop Test Fields 3&4		
Field #3	Field #4	
0.286	0.783	
26. Field Drop Test Fields 5&6		
Field #5	Field #6	
27. Field Drop Test Fields 7&8		
Field #7	Field #8

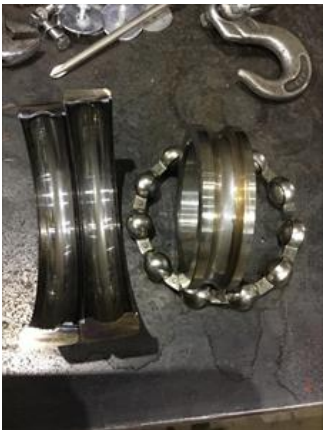
40.	Drive End Wavy Washer/Snap-Ring Other Retention Device?		snap ring
41.	Drive End Bearing Condition		
	Contaminated grease and frosting

</div>			
Root Cause of Failure			
66.	Failure Locations		
	<i>Motor fields show disproportionate ohm readings during drop test.</i> <i>DE shaft bearing journal is too small.</i> <i>Both bearings show signs of electrical discharge damage.</i>

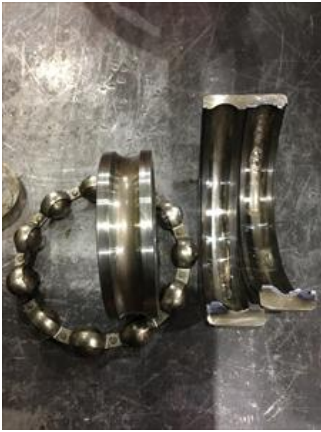
P114

48. Opposite Drive End Bearing Condition

*Aegis ring, insulated 6212 bearing, 8 sets of brushes.***Mechanical Fits - Armature**

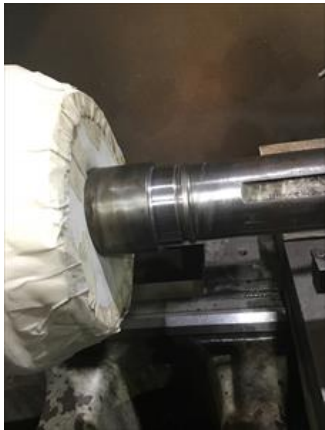
96.	Post Repair Drive End Bearing Shaft Fit		
	0 Degrees	60 Degrees	120 Degrees
	2.7566	2.7565	2.7565
97.	Post Repair Drive End Bearing Shaft Fit Condition		(P) Pass P38

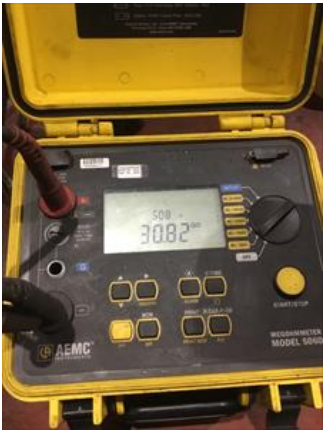
Meg armature and inter poles

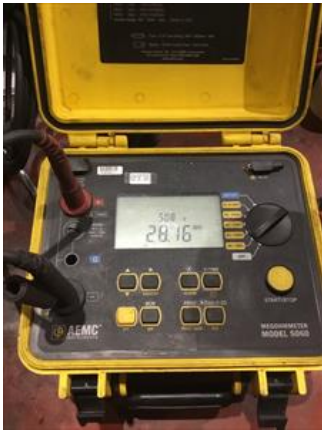
Series

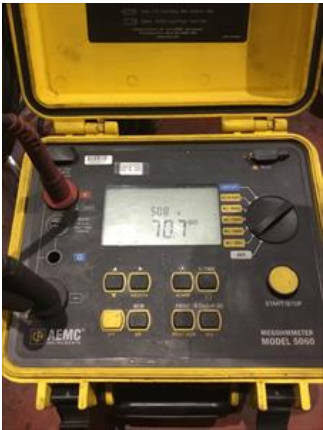
Fields

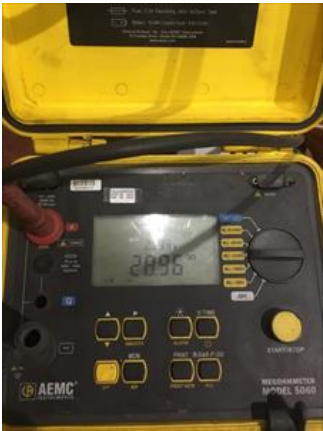
Arm & Inter poles @ 2500

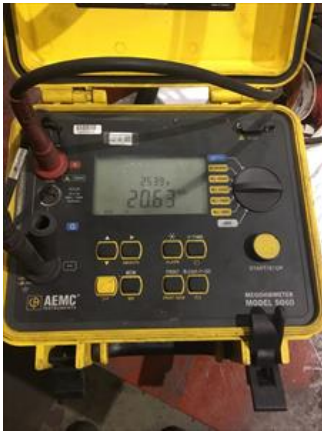
Series @ 2500

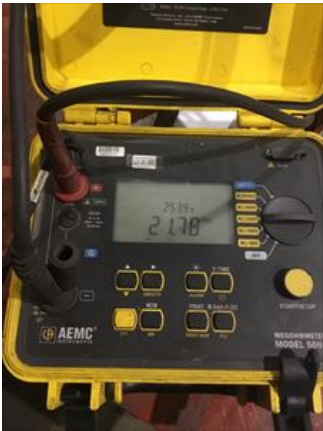
Fields @ 2500
