AC Inspection as Found

FUTURE FUEL CHEMICAL

AC Inspection - Rev. 2

Description: 75HP EXP RELIANCE

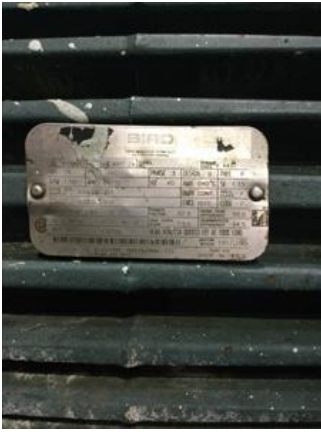
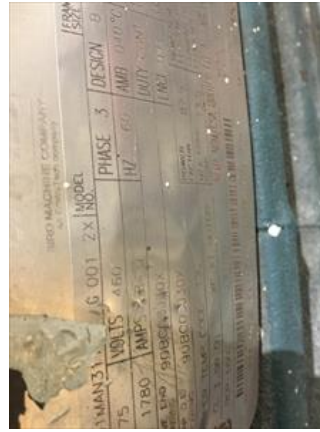
P37

2. Nameplate Picture

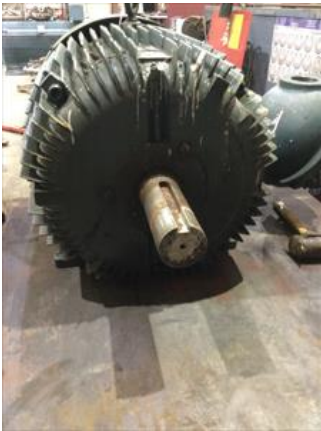
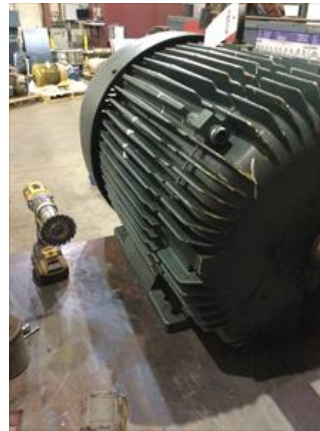
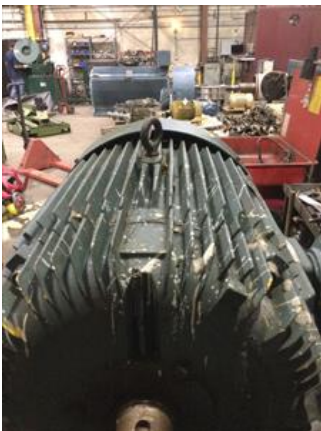
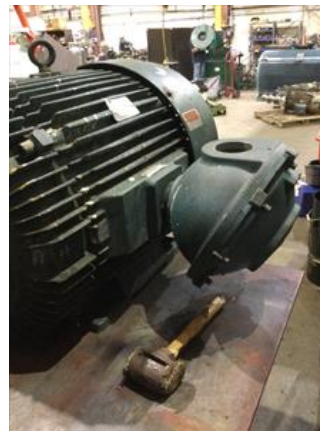
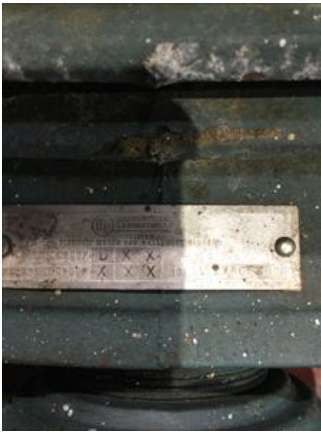
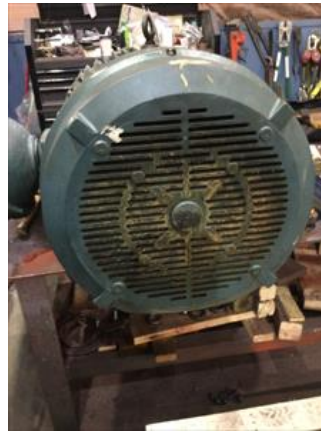
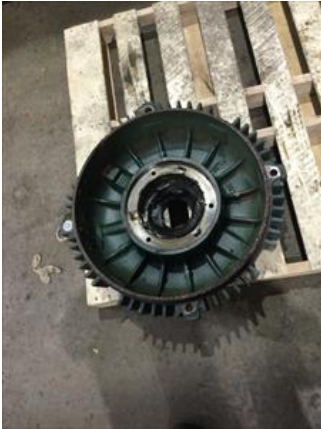
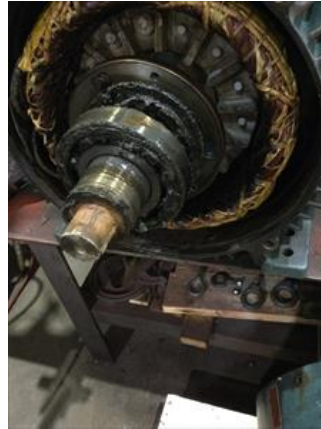
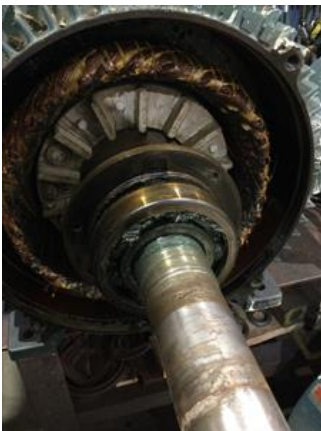
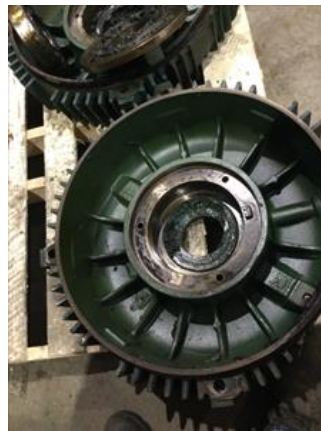
P45

3. Photos of all six sides of the machine.

4.	Describe the Overall Condition of the Equipment as Received	
	<i>Serviceable</i>	
5.	Report Date [COPY]	10/28/2024
Initial Mechanical/Electrical

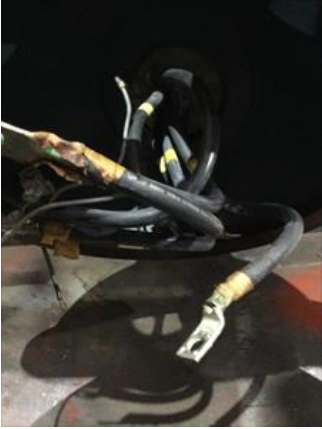
12. Lead Condition	(P) Pass	P69

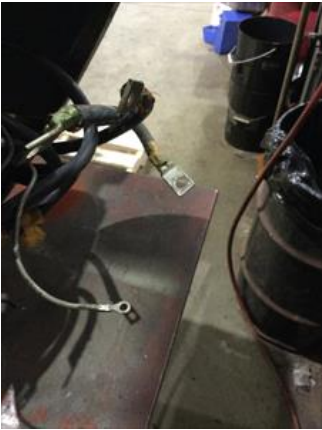
13. Lead Length	14 Inches	
14. Does it have Lugs?, If so what is the Stud Size?	(Yes) Yes	P94
<div>3/8</div>

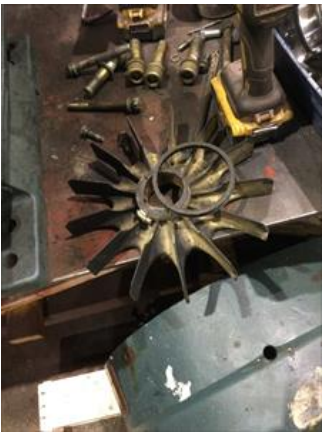
15. Lead Numbers	1-6	
16. Frame Condition	pass	
17. Fan Condition	(P) Pass	P116

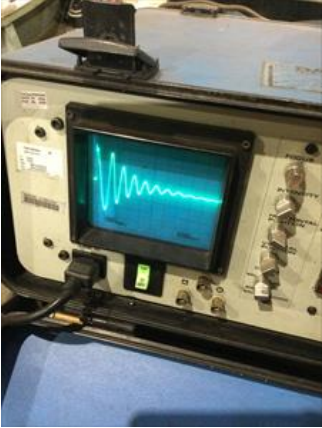
20. Winding Resistance		
1-2	1-3	2-3
Na		
21. Perform Surge Test	(P) Pass	P57

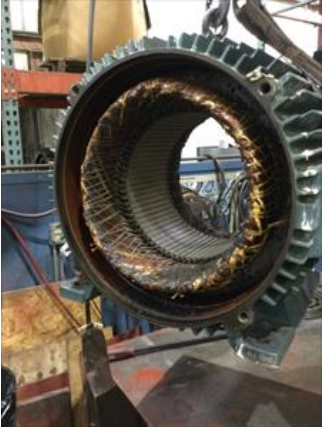
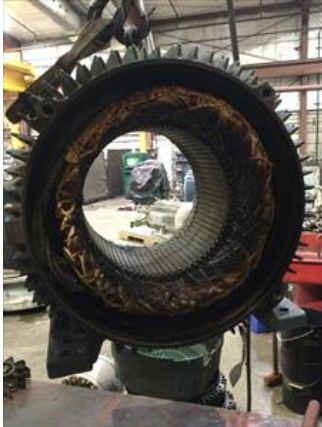
22. Number of Stator Slots	72	
23. Stator Condition	wash and bake	P85
<div>

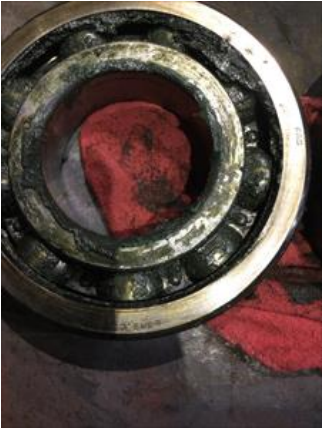
26. Drive End Bearing Brand	FAG	P12

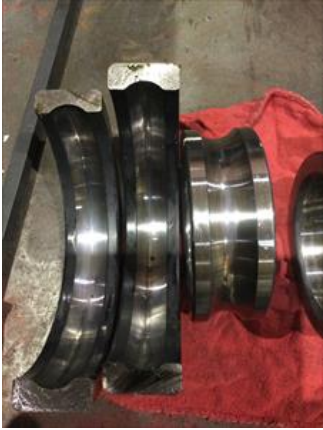
27.	Drive End Bearing Number-	6318ZZ	
28.	Drive End Bearing Qty.	1	
29.	Drive End Bearing Type	(Ball) Ball Bearing	
30.	Drive End Lubrication Type	(Grease) Grease Lubricated	
31.	Drive End Bearing Insulation or Grounding Device?	na	
32.	Drive End Wavy Washer/Snap-Ring Other Retention Device?	na	
33.	Drive End Bearing Condition	axial load	P83

67. Failure locations
Bearings and grease contamination. Bearings were over greased.
68. Root cause of failure
Axial load on bearings

<i>2-6318 bearings</i> |

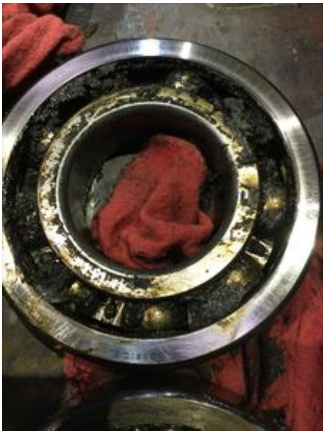
34.	Opposite Drive End Bearing Brand	FAG	P93
-----	----------------------------------	------------	------------

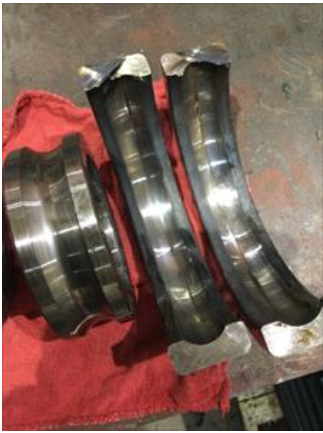
35.	Opposite Drive End Bearing Number-	6318ZZ	
36.	Opposite Drive End Bearing Qty.	1	
37.	Opposite Drive End Bearing Type	(Ball) Ball Bearing	
38.	Opposite Drive End Lubrication Type	(Grease) Grease Lubricated	
39.	Opposite Drive End Bearing Insulation or Grounding Device?	na	
40.	Opposite Drive End Wavy Washer/Snap-Ring Other Retention Device?	Wavy washer	
41.	Opposite Drive End Bearing Condition	axial load	P119

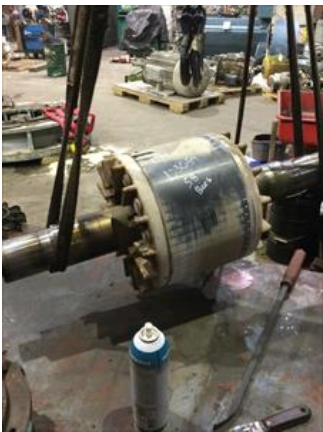
P41

| 44. | Rotor Type/Material | (Squirrel Aluminum) Squirrel
| 45. | Growler Test | (Pass) Pass |
| 47. | Rotor Condition | pass |

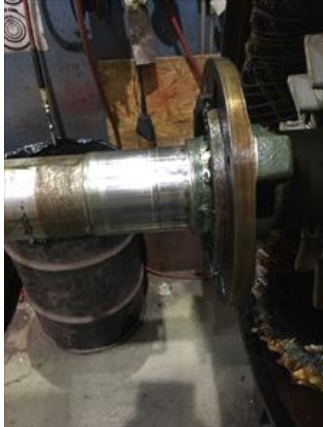
52.	Coupling Fit Closest to Bearing Housing		
	0 Degrees	90 Degrees	120 Degrees
53.	Coupling Fit Closest to the end of the Shaft		
	0 Degrees	60 Degrees	120 Degrees
54.	Drive End Bearing Shaft Fit		
	0 Degrees	60 Degrees	120 Degrees
	3.5436	3.5436	3.5436
55.	Drive End Bearing Shaft Fit Condition		(P) Pass P81

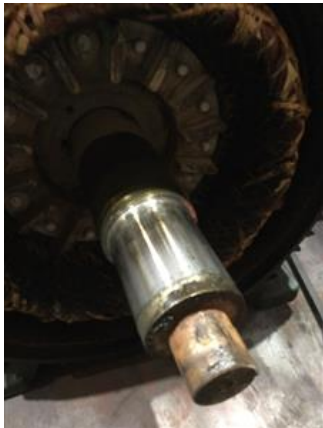
56.	Opposite Drive End Bearing Shaft Fit		
	0 Degrees	60 Degrees	120 Degrees
	3.5434	3.5434	3.5434
57.	Opposite Drive End Bearing Shaft Fit Condition		(P) Pass P96

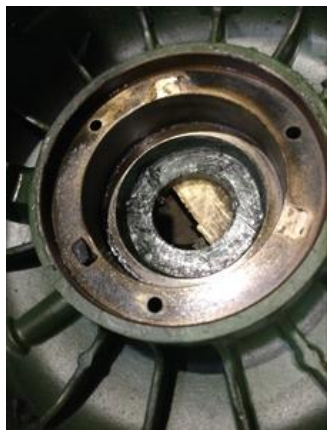
59. Drive End - Endbell Bearing Fit

60. Drive End - Endbell Bearing Fit Condition

(P) Pass

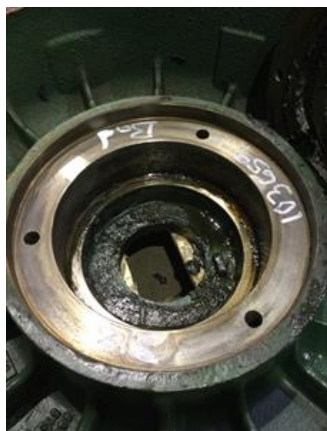
P30

61. Opposite Drive End - Endbell Bearing Fit

62. Opposite Drive End - Endbell Bearing Fit Condition

(F) Fail

Resleeve

Ode end bell bearing fit

73. Drive End - Endbell Bearing Fit Post Repair		
0 Degrees	60 Degrees	120 Degrees
74. Opposite Drive End - Endbell Bearing Fit Post Repair		
0 Degrees	60 Degrees	120 Degrees
7.4812	7.4812	7.4811

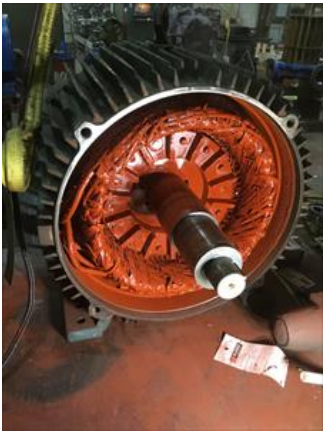
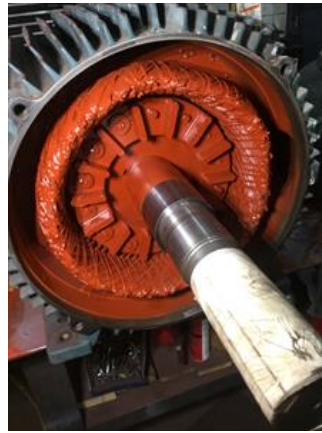
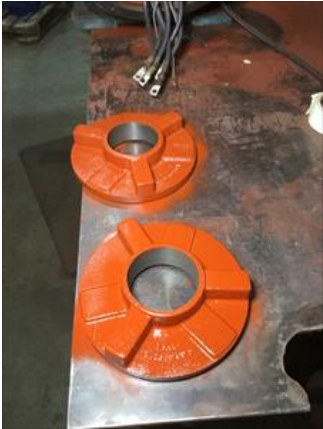
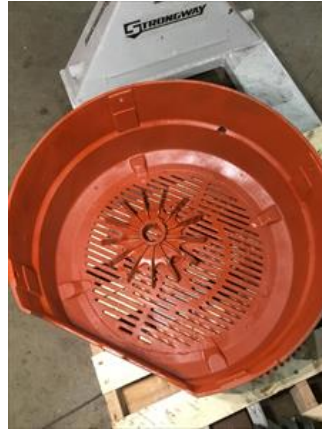
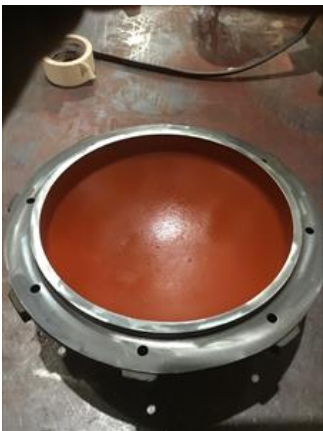
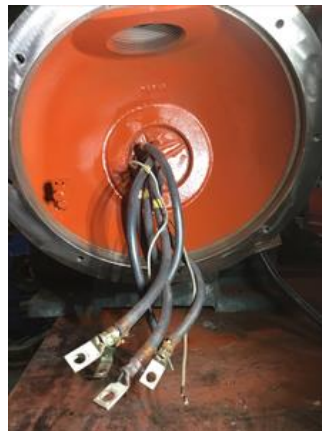
79. Photograph All Major Components prior to assembly		P17

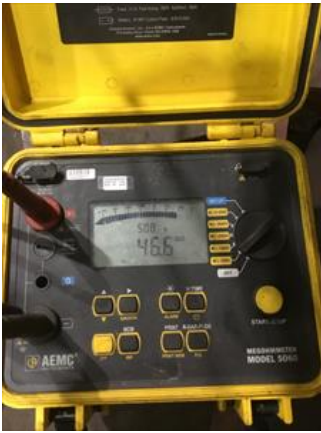
P31

80. Final Insulation Resistance Test

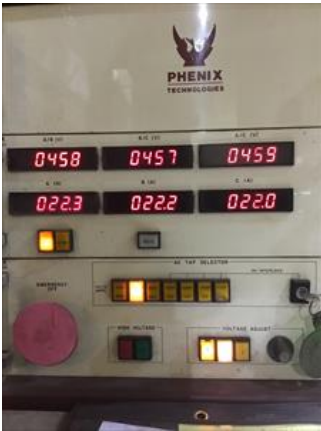
83. Test Run Voltage P56

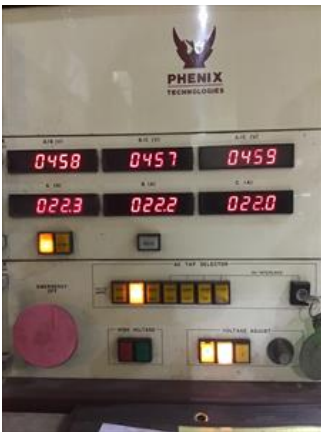
84. Test Run Amperage P65

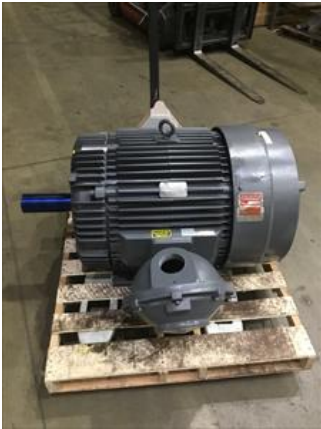
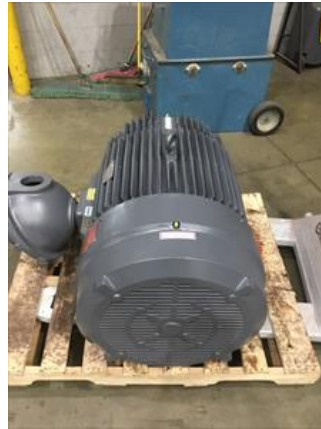
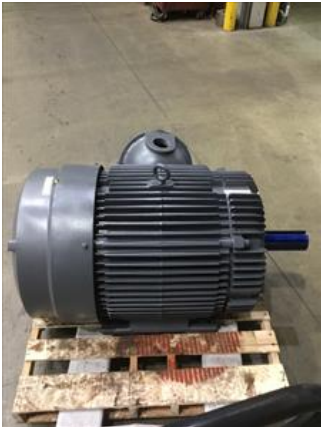
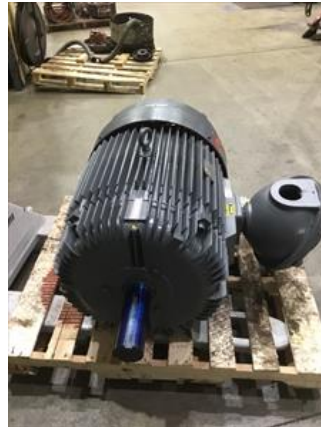
P130

90. Document Final Condition with Pictures after paint
