AC Inspection as Found
Bryce Corporation (10053-BRC)
450 S. Benton
Searcy, AR 72143

AC Inspection - Rev. 2

Description: 55KW SIEMENS 3570RPM W/
FANTASTIC

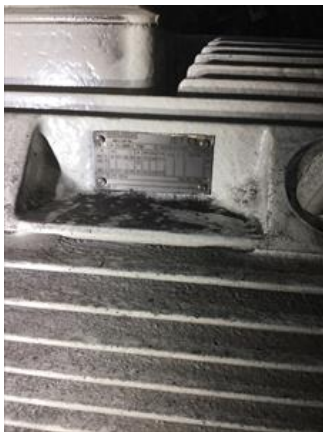
1. Report Date 11/11/2024
2. Nameplate Picture P37

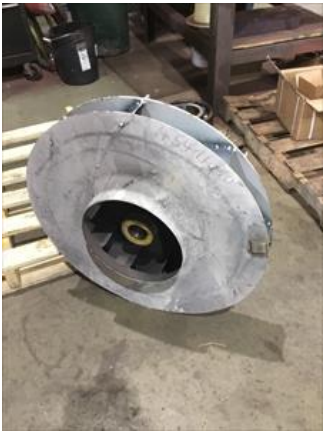
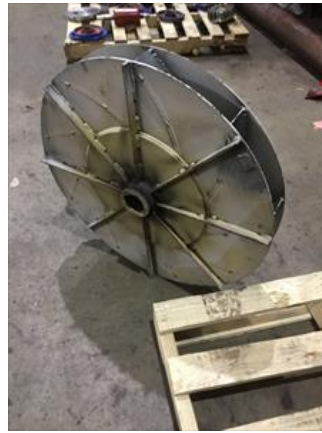
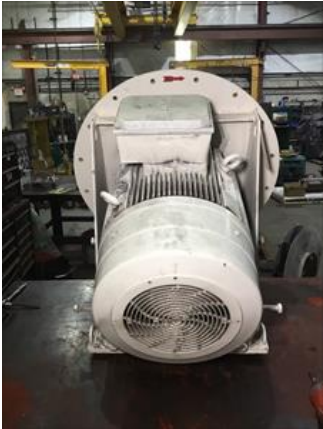
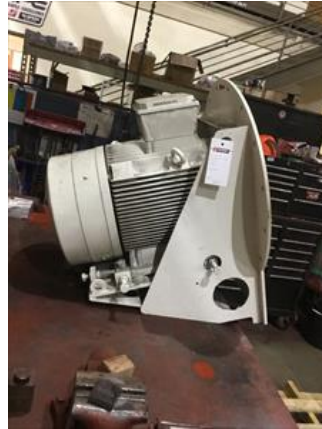
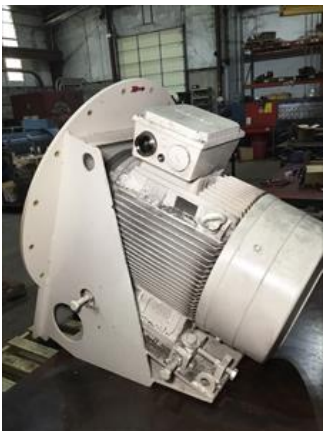
3. Photos of all six sides of the machine. P45

4. Describe the Overall Condition of the Equipment as Received
Serviceable

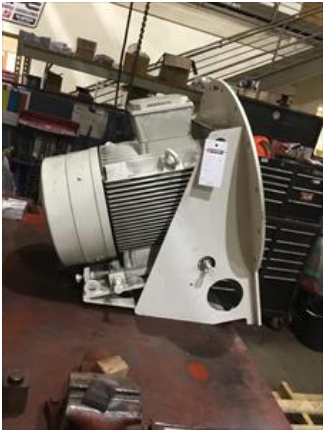
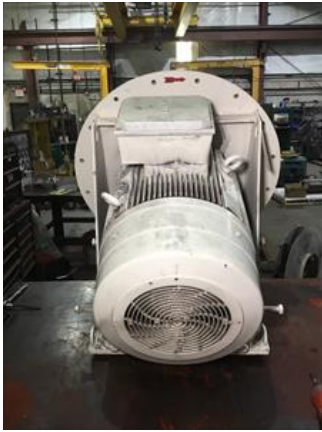
5. Distance from the end of the shaft to the Coupling/Sheave inches
Fan assembly was removed by customer.

Removed by customer

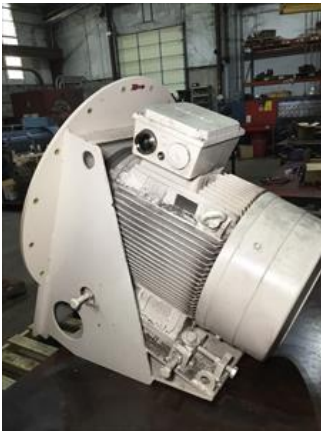
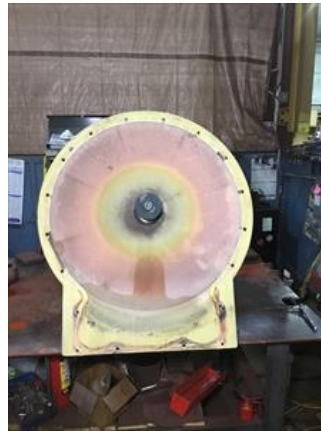
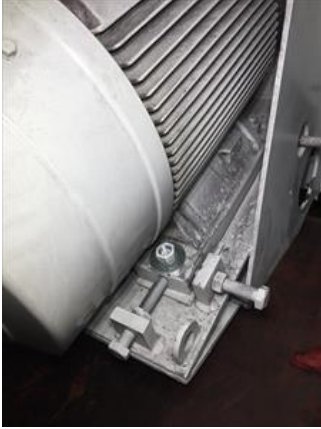
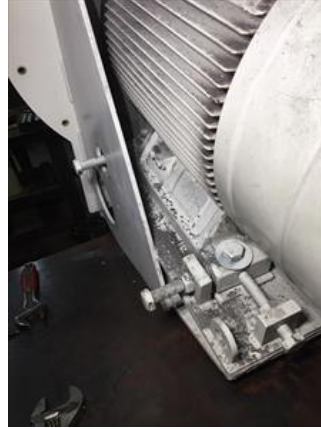
8.	Does Shaft Have Visible Damage?	(No) No	
9.	Assembled Shaft Runout	0.001 Inches	
10.	Assembled Shaft End Play	0 inches	
11.	Air Gap Variation <10%	yes	P60

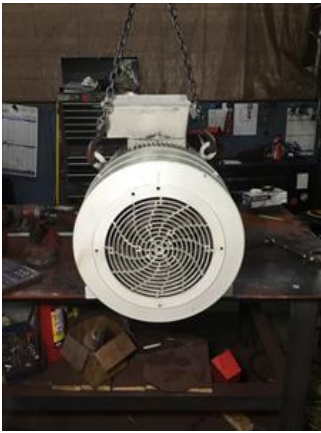
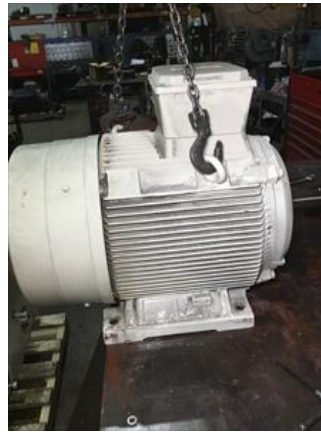
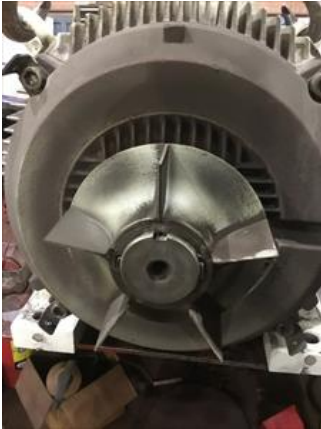
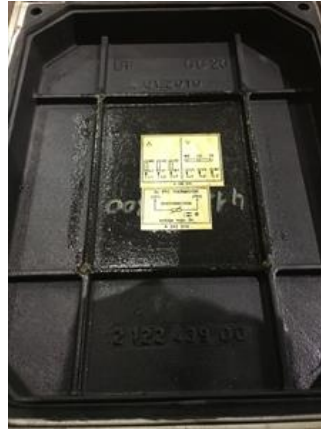
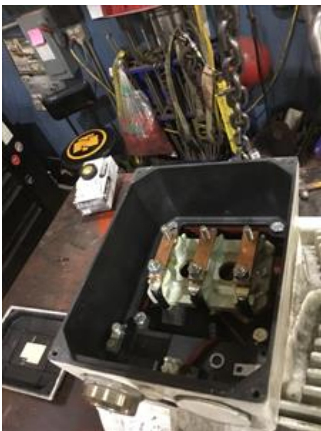
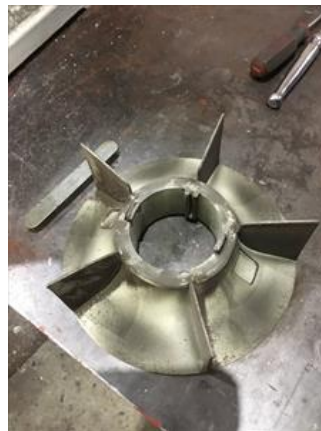
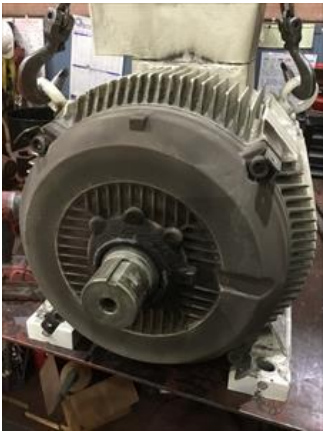
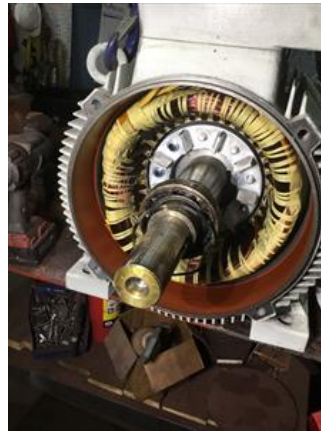
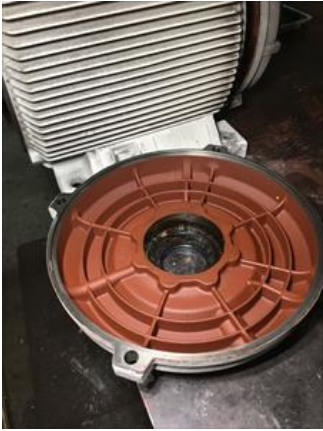
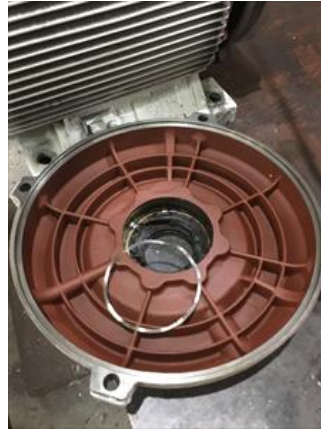
12.	Lead Condition	(P) Pass	
13.	Lead Length	Inches	
14.	Does it have Lugs?, If so what is the Stud Size?	(Yes) Yes	
15.	Lead Numbers	U1-V1-W1. U2-V2-W2	
16.	Frame Condition	pass	
17.	Fan Condition	(P) Pass	P115

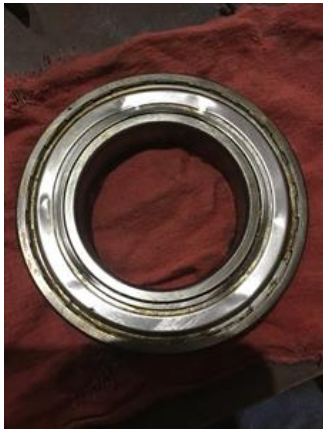
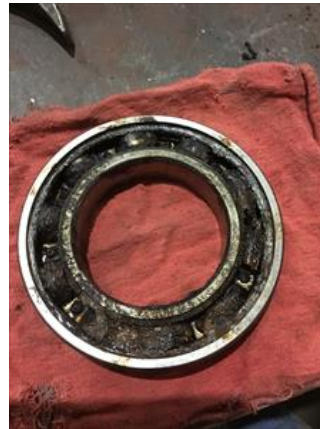
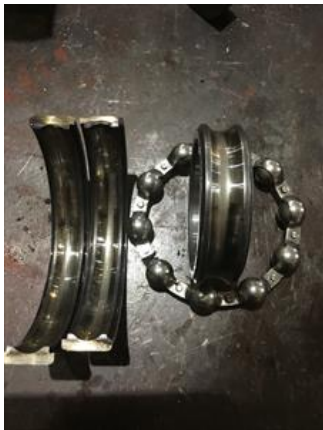
27. Drive End Bearing Brand

ORS Turkey

28. Drive End Bearing Number-

6215 SO C3

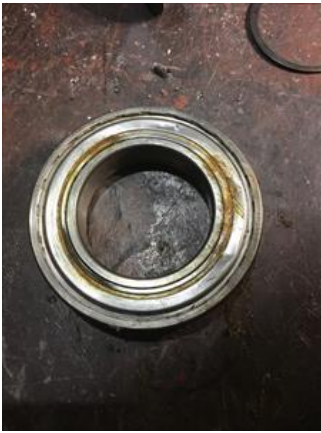
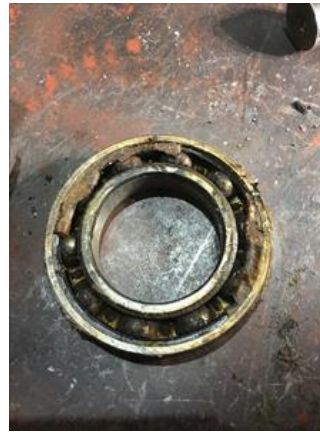
40.	Opposite Drive End Bearing Insulation or Grounding Device?	none	
41.	Opposite Drive End Wavy Washer/Snap-Ring Other Retention Device?		
	2) <i>snap rings.</i>		
42.	Opposite Drive End Bearing Condition	replace	
43.	Drive End Seal	dust seal	P120

76.	Failure locations <i>Both bearings show signs of excessive wear and fluting.</i>		
77.	Root cause of failure <i>Contaminated bearing grease and fluting.</i>		
Dynamic Balance Report

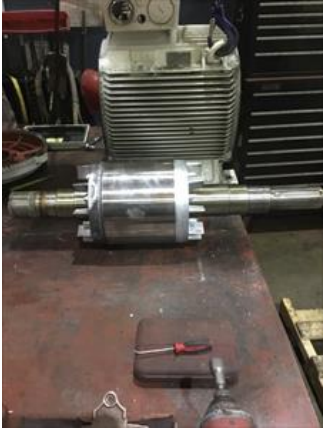
50. ODE Sleeve Bearing Outside Diameter	0 degrees	120 degrees	240 degrees
51. ODE Sleeve Bearing Housing Inside Diameter	0 degrees	120 degrees	240 degrees
52. ODE Sleeve Bearing to Housing Clearance	0 degrees	120 degrees	240 degrees
Rotor Inspection			
53. Rotor Type/Material	(Squirrel Aluminum) Squirrel Cage Aluminum Die Cast		P3

54. Growler Test	(Pass) Pass		
55. Number of Rotor Bars	28		
56. Rotor Condition	pass		
57. List the Parts needed for the Repair Below			
58. Signature of Technician that Disassembled Motor	Terrence Holland
