Hi-Speed Industrial Service
7030 Ryburn Dr
Millington, Tn 38053
901-873-5300

AC Inspection as Found
MIDDLETON INCORPORATED
P.O. BOX 506
BRYANT, AR 72089

AC Inspection - Rev. 2

Location: MOTOR SHOP LR
Serial Number: N2208270121-003
Description: HP 1.5

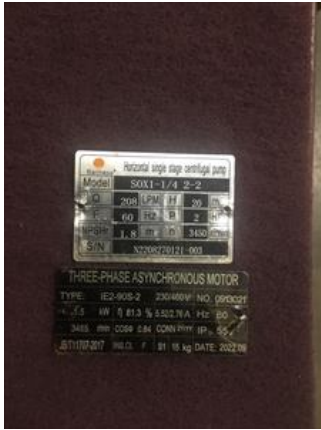
P37

2. Nameplate Picture

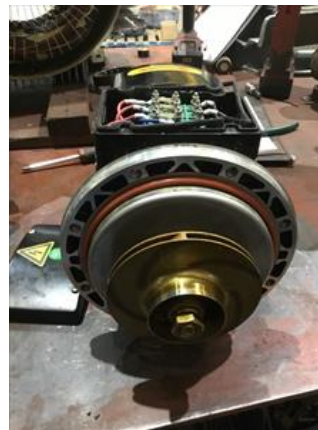
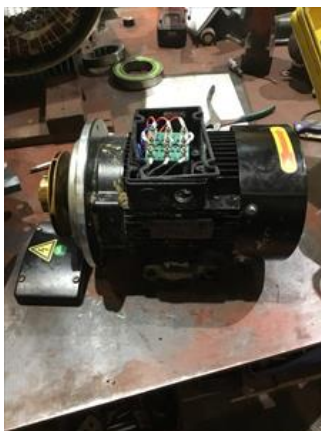
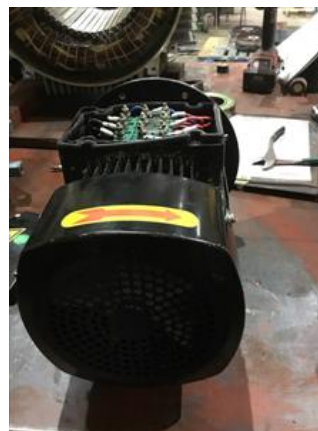
P45

3. Photos of all six sides of the machine.

4. Describe the Overall Condition of the Equipment as Received
Wet but serviceable

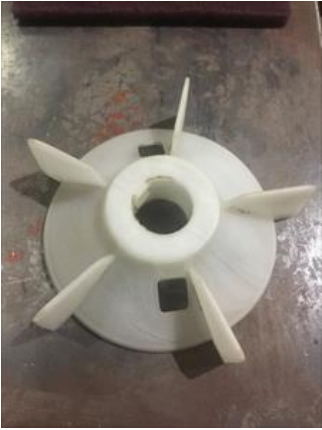
13.	Does it have Lugs?, If so what is the Stud Size?	(Yes) Yes	
14.	Lead Numbers	1-9	
15.	Frame Condition	pass	
16.	Fan Condition	(P) Pass	P115

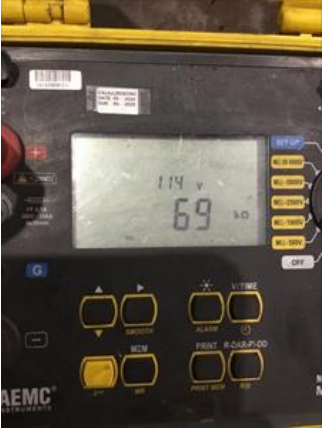
18.	Insulation Resistance/Megger	Megohms	P8

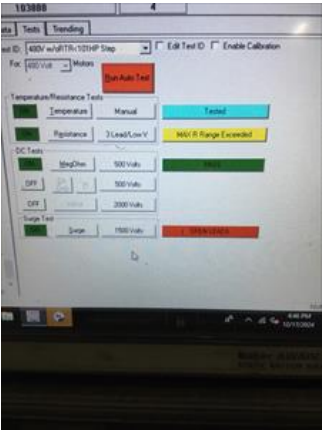
19.	Winding Resistance		
	1-2	1-3	2-3
20.	Perform Surge Test	(F) Fail	P57

21.	Number of Stator Slots	36	
22.	Stator Condition	rewind	
23.	Stator Thermistors/Ohms		
24.	Stator Overloads/Ohms		
Mechanical Inspection			
25.	Drive End Bearing Brand	NSK	P12
<div style="display: flex; justify-content: space-around;">

66.	Failure locations		
	Connection box.		
67.	Root cause of failure		
	Connection box seal gasket improperly installed allowing moisture to saturate the stator windings.		
Dynamic Balance Report

6205 & 6305 2Z/C3
Rewind stator

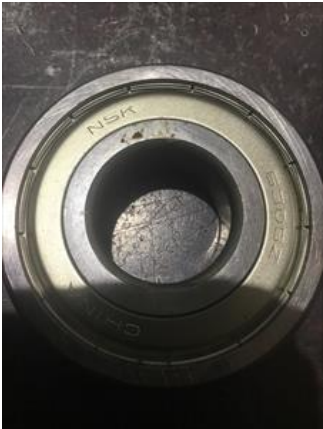
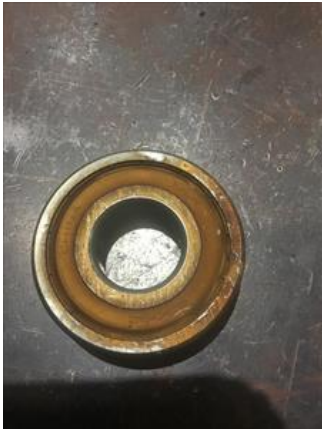
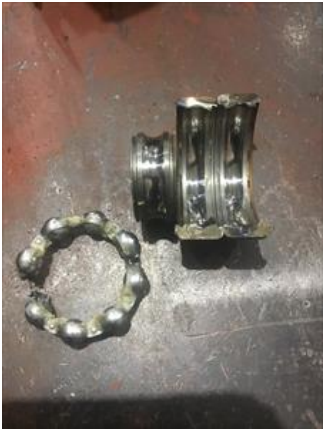
</div>			
26.	Drive End Bearing Number-	6305	
27.	Drive End Bearing Qty.	1	
28.	Drive End Bearing Type	(Ball) Ball Bearing	
29.	Drive End Lubrication Type	(Grease) Grease Lubricated	
30.	Drive End Bearing Insulation or Grounding Device?	none	
31.	Drive End Wavy Washer/Snap-Ring Other Retention Device?	snap ring	
32.	Drive End Bearing Condition	wet & rusted	
33.	Opposite Drive End Bearing Brand	NSK	P92

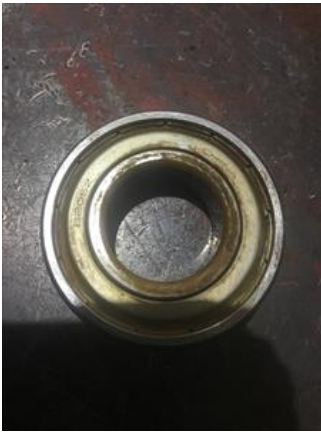
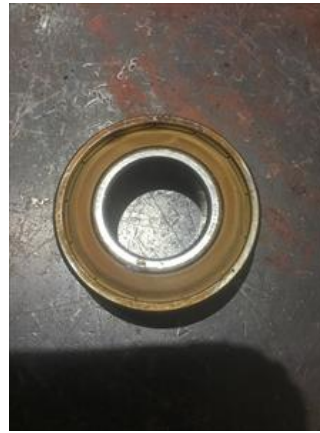
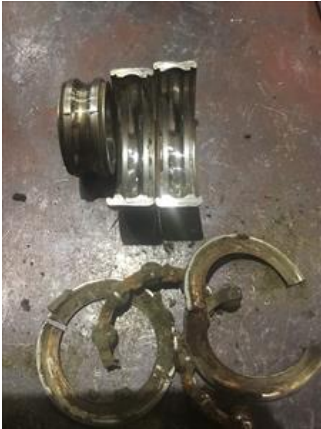
34. Opposite Drive End Bearing Number-	6205
35. Opposite Drive End Bearing Qty.	1
36. Opposite Drive End Bearing Type	(Ball) Ball Bearing
37. Opposite Drive End Lubrication Type	(Grease) Grease Lubricated
38. Opposite Drive End Bearing Insulation or Grounding Device?	none
39. Opposite Drive End Wavy Washer/Snap-Ring Other Retention Device?	wavy washer
40. Opposite Drive End Bearing Condition	wet & rusted
41. Drive End Seal	P120

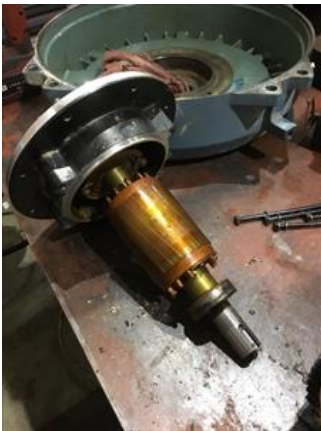
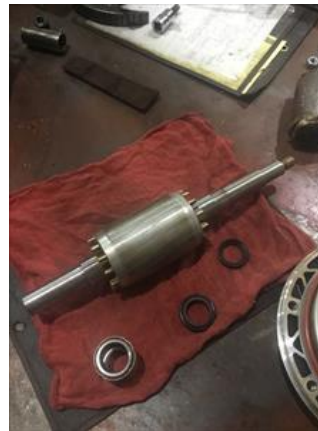
P3

43. Rotor Type/Material

(Squirrel Aluminum) Squirrel
Cage Aluminum Die Cast

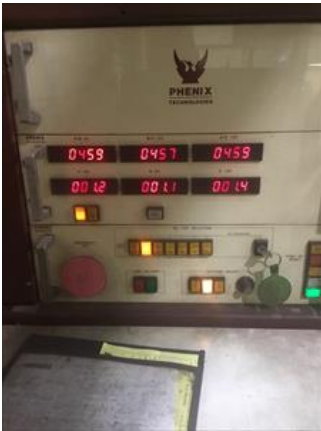
85. Test Run Voltage P56

Volts	Volts	Volts
459	457	459

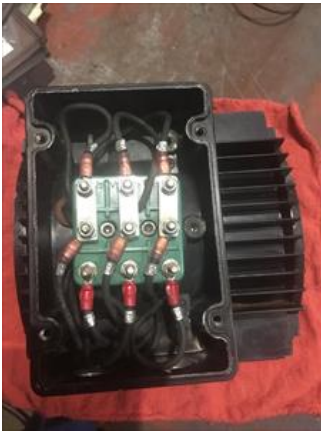
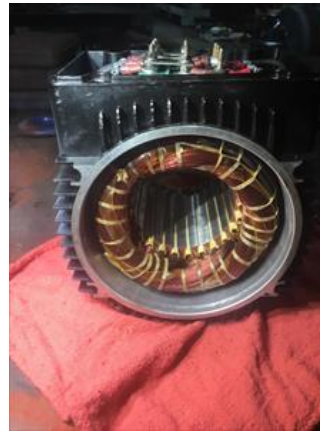
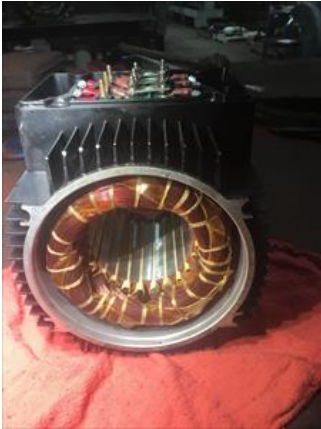
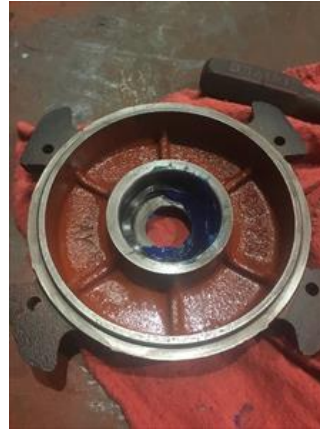
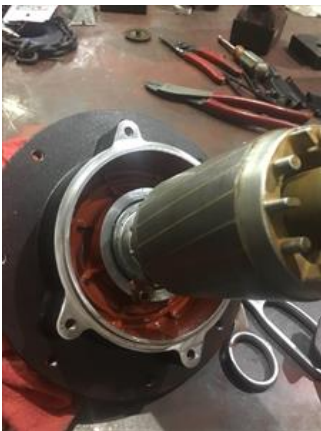
P129

92. Document Final Condition with Pictures after paint
