AC Inspection as Found
MIDDLETON INCORPORATED
P.O. BOX 506
BRYANT, AR 72089

AC Inspection - Rev. 2

Location: MOTOR SHOP LR

Description: 1.5KW

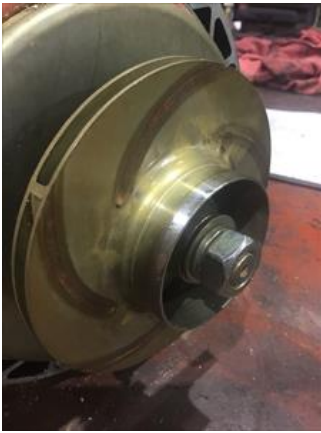
5. Distance from the end of the shaft to the Coupling/Sheave inches P76

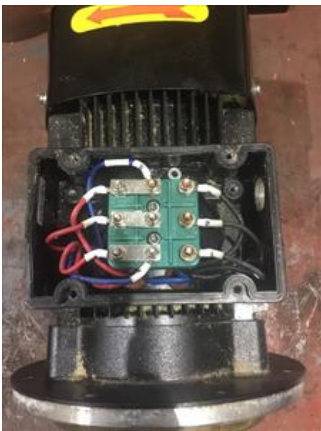
6.	Does Shaft Turn Freely?	(Y) Yes	
7.	Does the shaft require T.I.R in Lathe to identify additional repairs?		
8.	Does Shaft Have Visible Damage?	(No) No	
9.	Assembled Shaft Runout	0.002 Inches	
10.	Assembled Shaft End Play	0 inches	
11.	Air Gap Variation <10%		
12.	Lead Condition	(P) Pass	P69

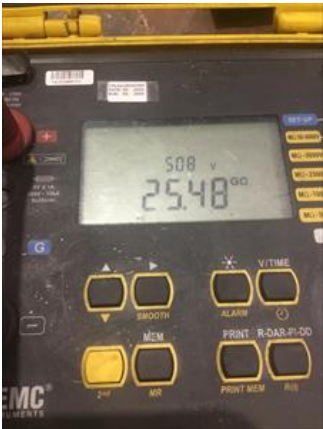
19. Insulation Resistance/Megger

25.48 Gigohms

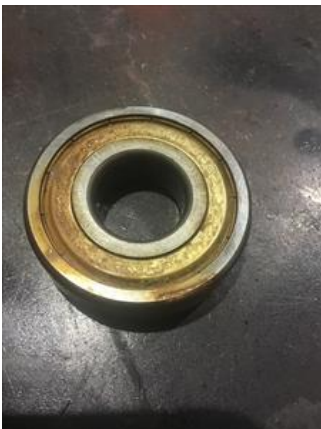
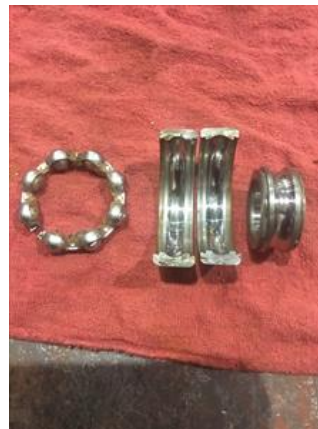
33. Drive End Bearing Condition

fail/rusted

<i>6205 & 6305 2Z bearings.
Rewind stator.</i> | |

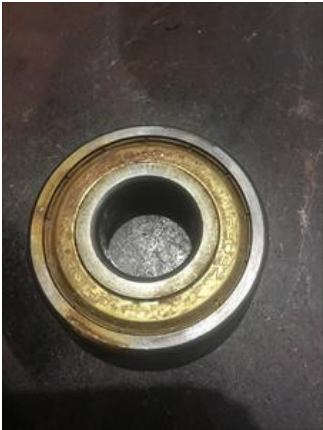
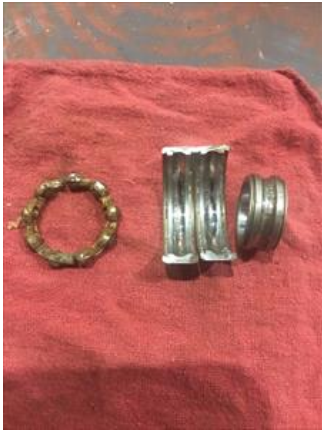
35.	Opposite Drive End Bearing Number-	6205	
36.	Opposite Drive End Bearing Qty.	1	
37.	Opposite Drive End Bearing Type	(Ball) Ball Bearing	
38.	Opposite Drive End Lubrication Type	(Grease) Grease Lubricated	
39.	Opposite Drive End Bearing Insulation or Grounding Device?	none	
40.	Opposite Drive End Wavy Washer/Snap-Ring Other Retention Device?	wavy washer	
41.	Opposite Drive End Bearing Condition	fail / rusted	P118

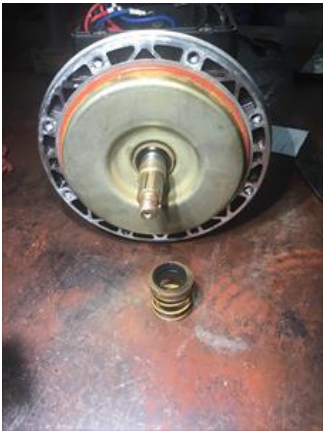
42.	Drive End Seal		P120
-----	----------------	--	------

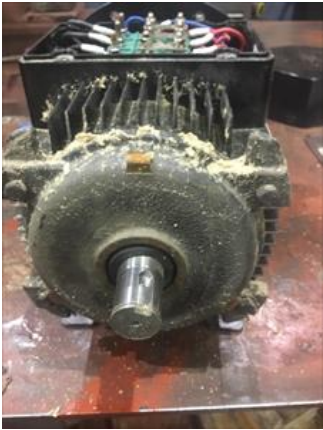
43.	Opposite Drive End Seal		P123
-----	-------------------------	--	------

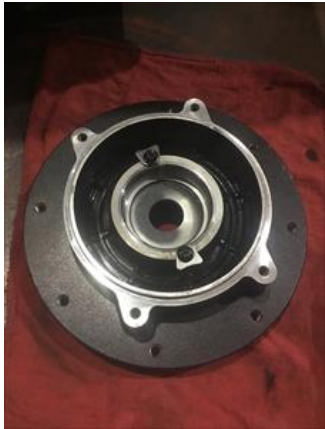
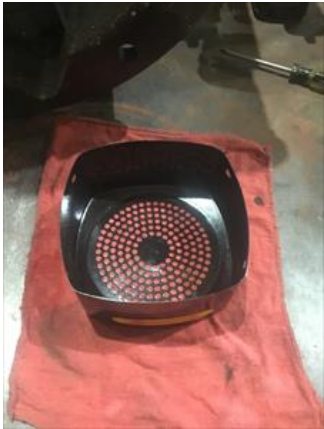
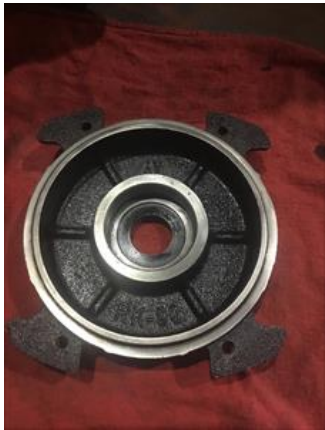
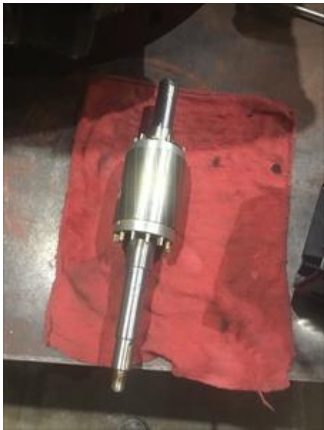
82. Photograph All Major Components prior to assembly

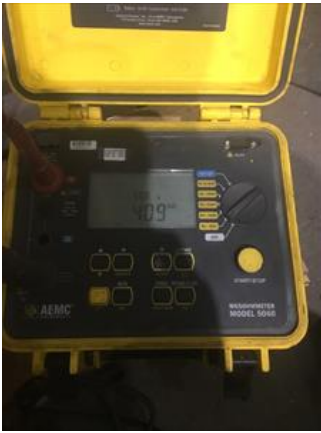
83. Final Insulation Resistance Test

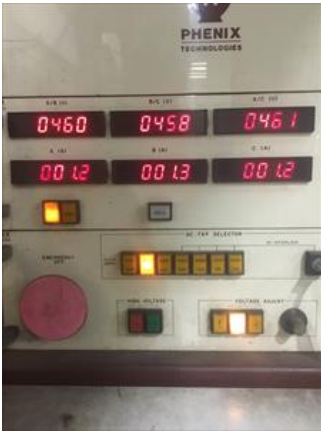
86. Test Run Voltage P56

Volts	Volts	Volts
460	458	461

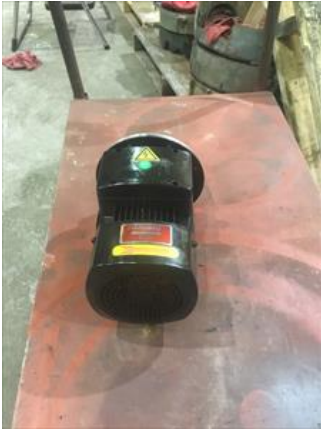
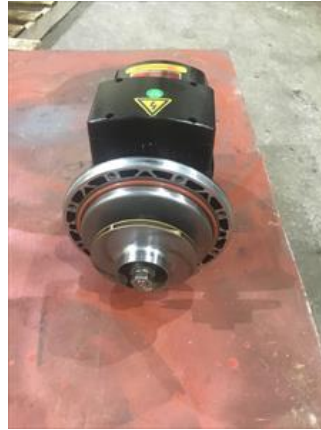
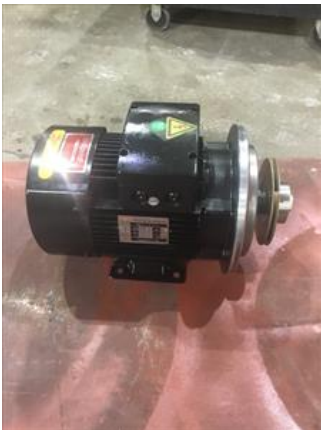
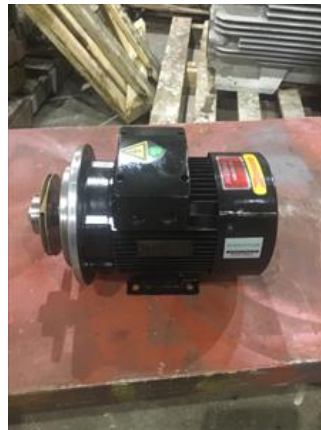
93. Document Final Condition with Pictures after paint
