## AC Inspection as Found

HISPEED LRMR  
6812 LINDSEY RD  
LITTLE ROCK, AR 72206

Location: Motor Shop  
Serial Number:  
Description: 100 Hp Siemens From little Rock

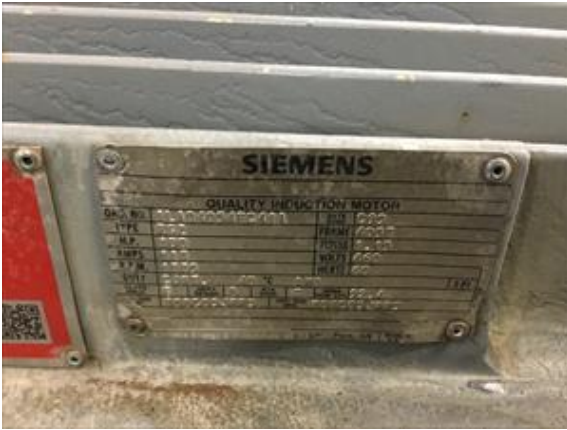
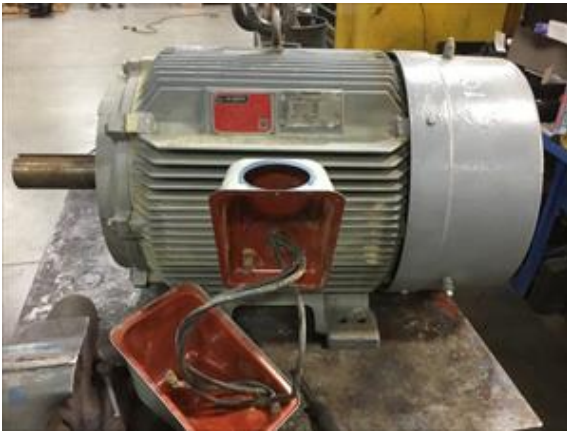
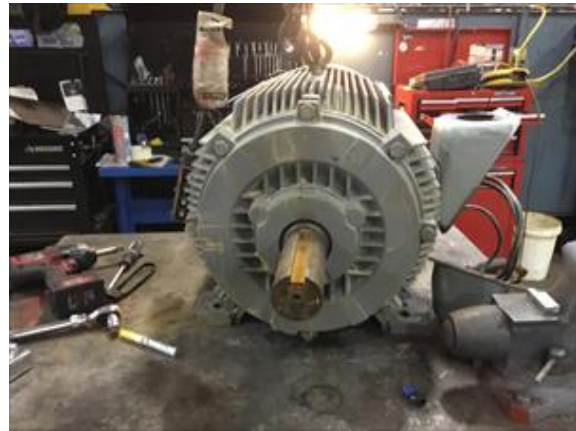
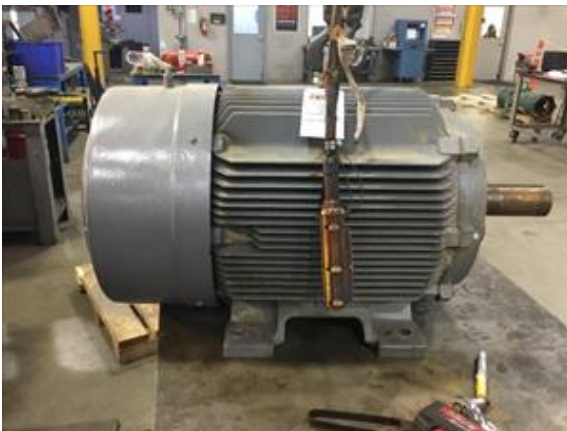
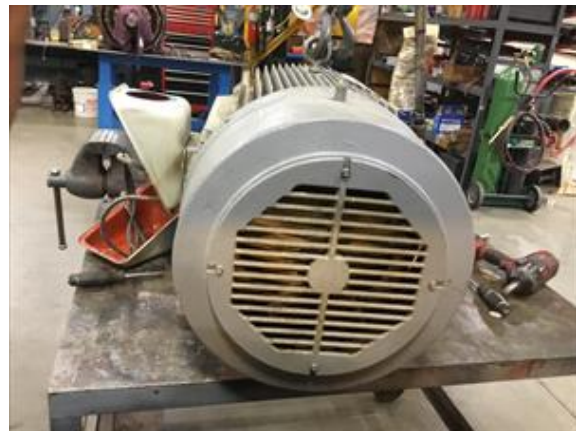
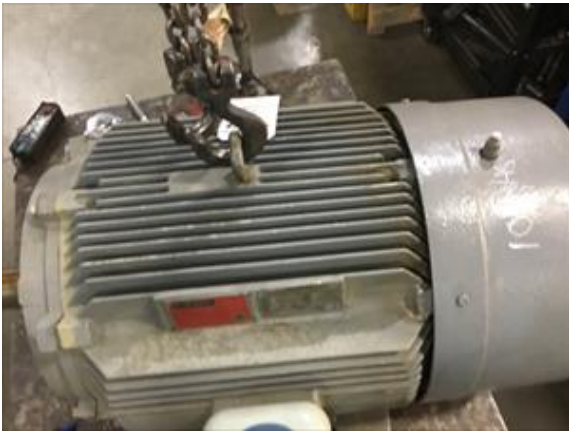
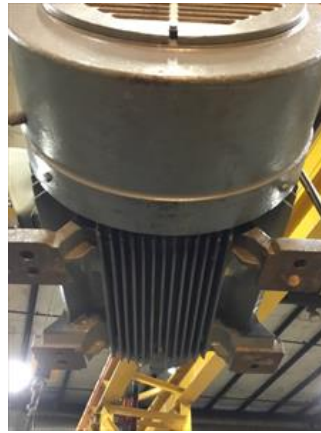
4. Describe the Overall Condition of the Equipment as Received  
*Good*

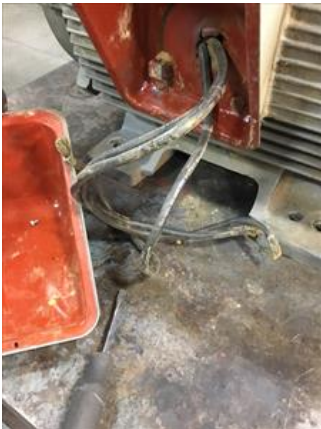
5. Does Shaft Turn Freely?	(Y) Yes	
6. Does the shaft require T.I.R in Lathe to identify additional repairs?	(No) No	
7. Does Shaft Have Visible Damage?	(No) No	
8. Assembled Shaft Runout	0.002 Inches	
9. Assembled Shaft End Play	0.005 inches	
10. Air Gap Variation <10%		
11. Lead Condition	(P) Pass	P11

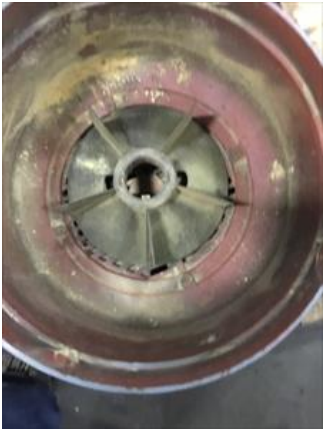
12. Lead Length	26 Inches	
13. Does it have Lugs?, If so what is the Stud Size?	(No) No	
14. Lead Numbers	1-3	
15. Frame Condition	good

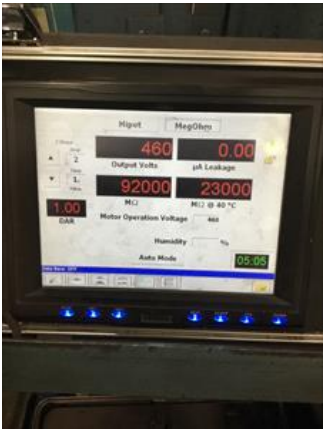
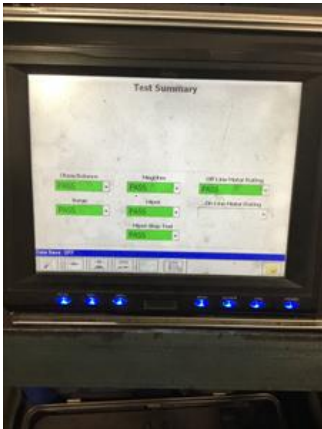
Initial Electrical Inspection

1-2	1-3	2-3
.064460	.064440	.064230

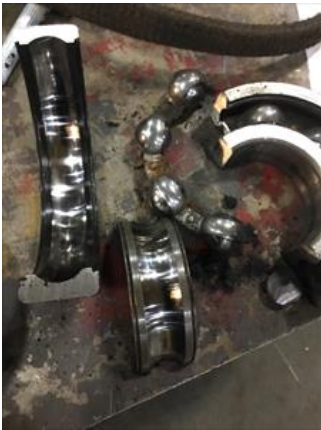
25.	Drive End Bearing Brand	ntn	
26.	Drive End Bearing Number-	6316	
27.	Drive End Bearing Qty.	1	
28.	Drive End Bearing Type	(Ball) Ball Bearing	
29.	Drive End Lubrication Type	(Grease) Grease Lubricated	
30.	Drive End Bearing Insulation or Grounding Device?	no	
31.	Drive End Wavy Washer/Snap-Ring Other Retention Device?	none	
32.	Drive End Bearing Condition	good	P32

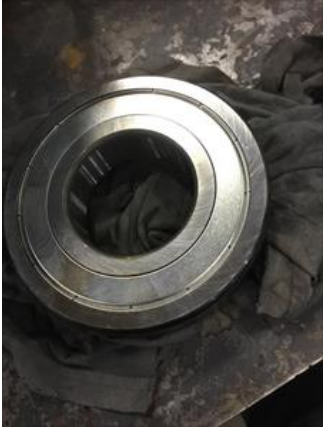
● 35. Opposite Drive End Bearing Qty.	1	
36. Opposite Drive End Bearing Type	<b>(Ball) Ball Bearing</b>	
● 37. Opposite Drive End Lubrication Type	<b>(Grease) Grease Lubricated</b>	
● 38. Opposite Drive End Bearing Insulation or Grounding Device?	<b>none</b>	
● 39. Opposite Drive End Wavy Washer/Snap-Ring Other Retention Device?	<b>wavy washer</b>	P39

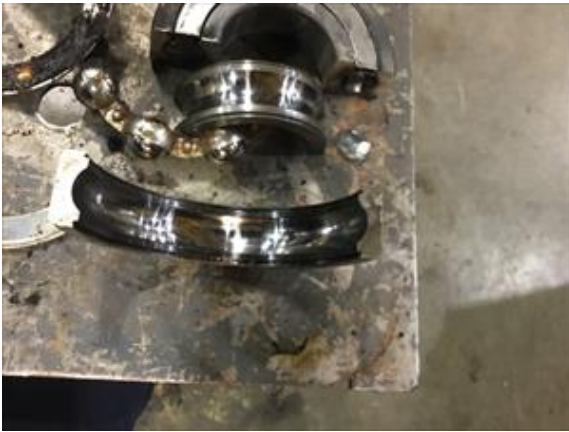
P54

53. Drive End Bearing Shaft Fit

0 Degrees	60 Degrees	120 Degrees
-----------	------------	-------------

3.15	3.1498	3.1499
------	--------	--------

54. Drive End Bearing Shaft Fit Condition (P) Pass

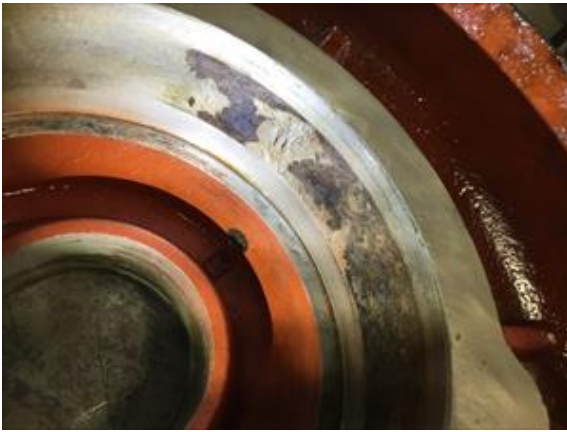
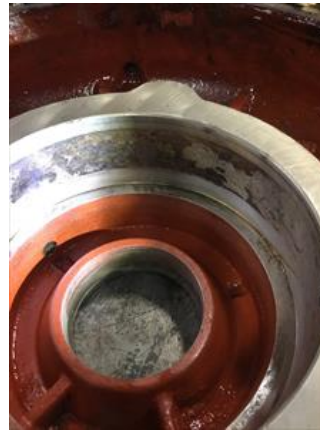
60. Opposite Drive End - Endbell Bearing Fit

6.6992

6.6994

6.6929/6.9939

61. Opposite Drive End - Endbell Bearing Fit Condition

(F) Fail

Bearing housing

Bore and bush

Opposite drive endbell bore and bush to 6316 bearing.
