AC Inspection as Found
UNITED SOLUTIONS
1052 INDUSTRIAL PARK RD
SARDIS, MS 38666

AC Inspection - Rev. 2

Hi-Speed Job Number:	153300
Manufacturer:	Other
Product Number:	WK 315M/4-550T
Spec/ID #:	7215392
HP/kW:	400 (HP)
RPM:	1780 (RPM)
Frame:	550T
Voltage:	460
Current:	450 (Amps)
Phase:	Three
Hz:	60 (Hz)
# of Leads:	12
J-box Included:	Complete
Coupling/Sheave:	Coupling
Date Received:	07/25/2024
Bearing RTDs:	No
Stator RTDs:	No
Repair Stage:	Teardown Inspection
Rewind:	Yes
Shaft Machined Fit Repairs Required:	No
Bearing Housing Machined Fit Repairs Required:	No
Heaters:	No
Winding Type :	Random Wound
Bearing Type:	Rolling Element

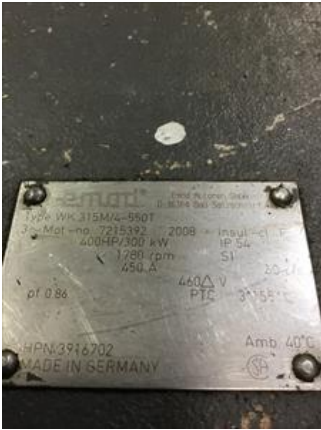
P2

2. Nameplate Picture

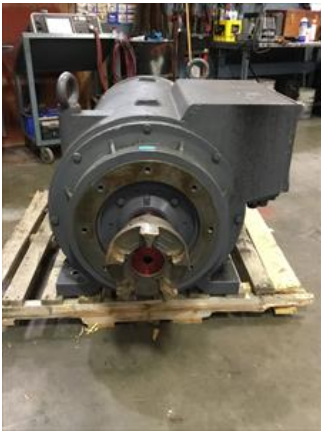
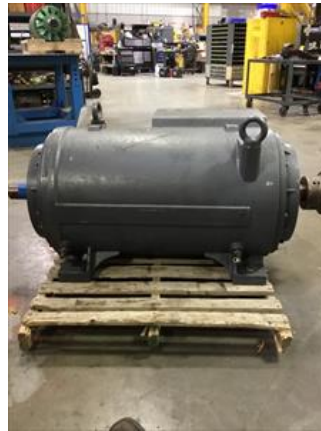
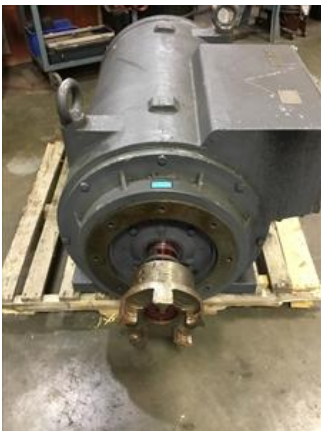
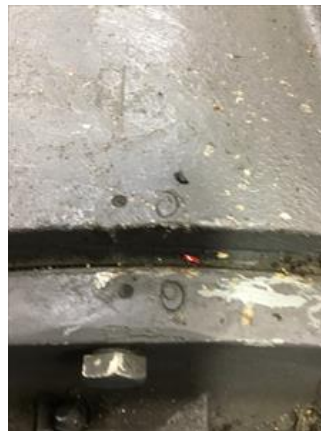
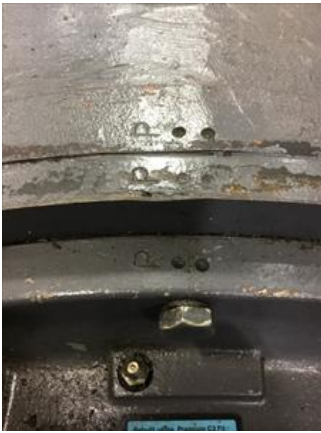
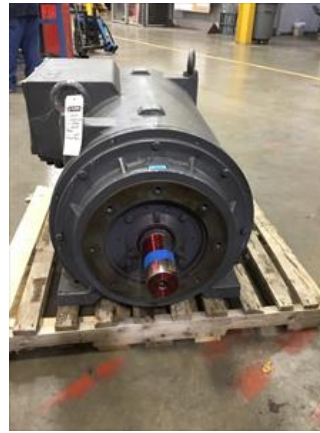
P3

3. Photos of all six sides of the machine.

Stator windings blown in center of iron. Requires extensive repair work or restack. Rotor has several rotor bars broken and requires extensive repair or replacement.

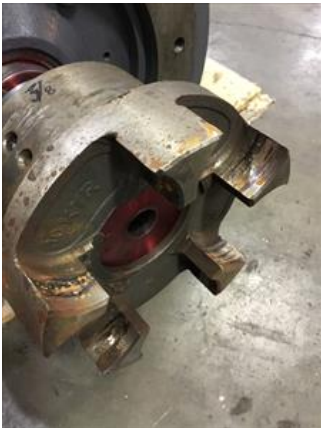
P5

5. Distance from the end of the shaft to the Coupling/Sheave

-0.25 inches

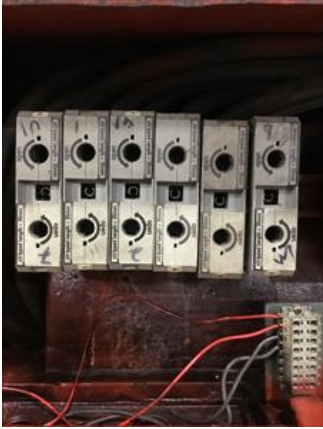
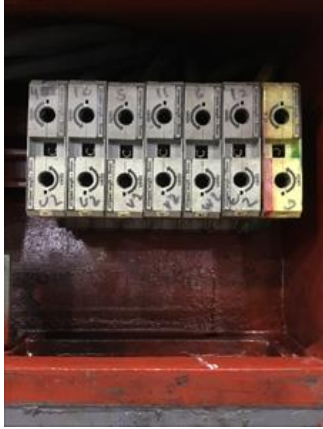
12.	Air Gap Variation <10%	No Provisions for Measurement	
● 13.	Lead Condition	(P) Pass	
14.	Lead Length	24 Inches	
● 15.	Does it have Lugs?, If so what is the Stud Size?	(No) No	
16.	Lead Numbers		P16
<div>

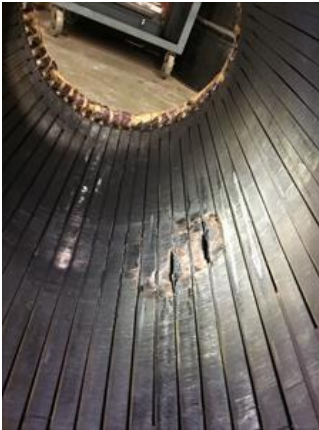
20.	Insulation Resistance/Megger	0 Megohms	
21.	Winding Resistance		
	1-2	1-3	2-3
	0	0	0
● 22.	Perform Surge Test	(F) Fail	
23.	Number of Stator Slots	60

24.	Stator Condition	Requires rewind	P27
	Additionally stator will require extensive iron work or restock!!!

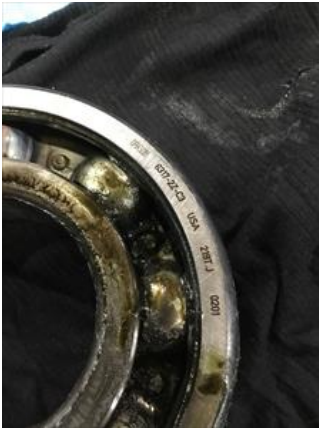
25.	Stator Thermistors/Ohms	186	
26.	Stator Overloads/Ohms	N/A	
Mechanical Inspection			
27.	Drive End Bearing Brand	FAG	P30

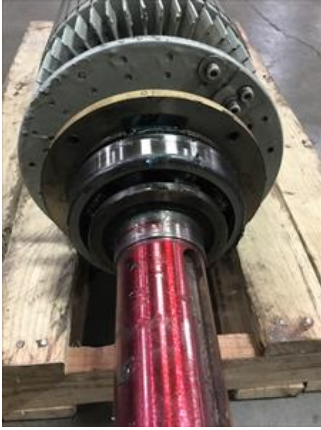
P36

33. Drive End Wavy Washer/Snap-Ring Other Retention Device?

34. Drive End Bearing Condition

Normal wear

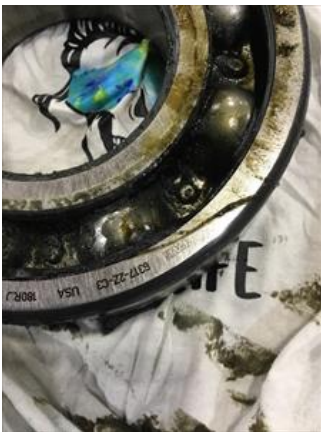
P38

35. Opposite Drive End Bearing Brand

FAG

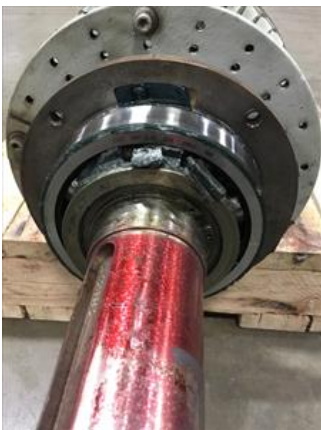
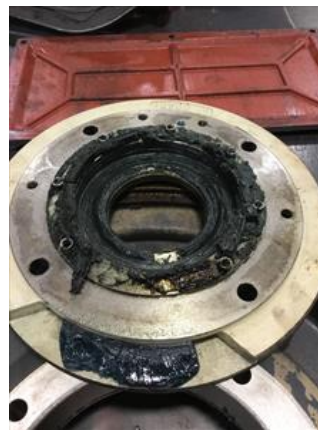
P44

41. Opposite Drive End Wavy Washer/Snap-Ring Other Retention Device?

42. Opposite Drive End Bearing Condition

Normal wear

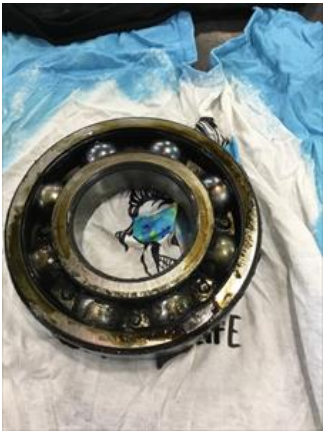
P45

43.	Drive End Seal	va 85
44.	Opposite Drive End Seal	va 85
Rotor Inspection

2- Va 85
2- 6317 c3

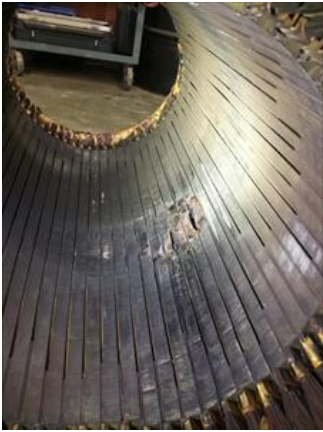
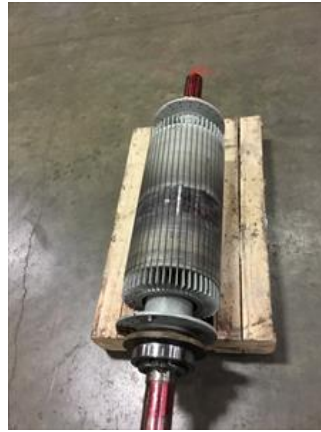
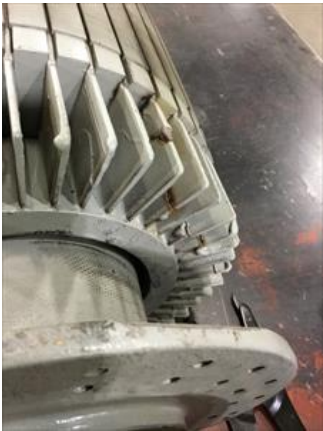
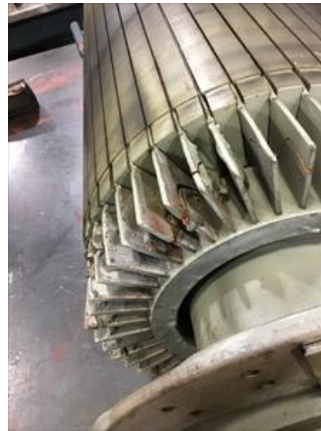
P59

48. Rotor Condition

requires extensive repair

Several rotor bars broken.

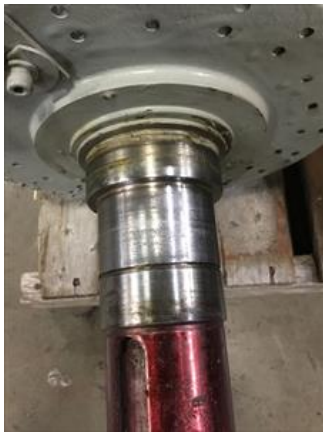
P66

55. Drive End Bearing Shaft Fit

0 Degrees	60 Degrees	120 Degrees
3.3467	3.3467	3.3467

Tolerance is 3.3466-4.3472

56. Drive End Bearing Shaft Fit Condition **(P) Pass**

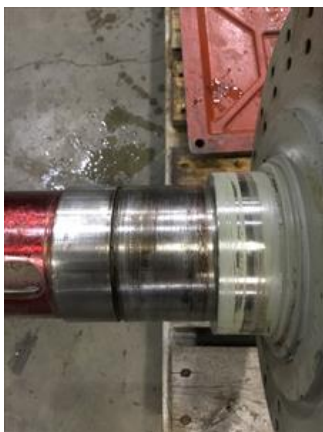
P68

57. Opposite Drive End Bearing Shaft Fit

0 Degrees	60 Degrees	120 Degrees
3.3468	3.3468	3.3468

Tolerance is 3.3466-4.3472

58. Opposite Drive End Bearing Shaft Fit Condition **(P) Pass**

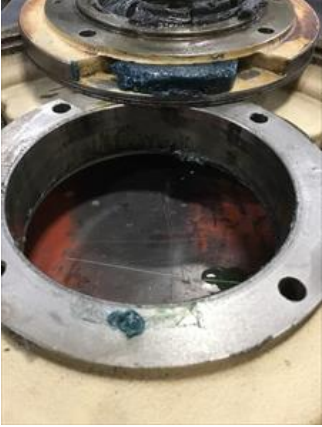
59.	Shaft Air Seal Fits		
	Drive End Air Seal	Opposite Drive End Air Seal	
	Pass	Pass	
Mechanical Fits- Bearing Housings			
60.	Drive End - Endbell Bearing Fit		P71
	0 Degrees	60 Degrees	120 Degrees
	7.0872	7.0872	7.0872
	Tolerance is 7.0866-7.0876

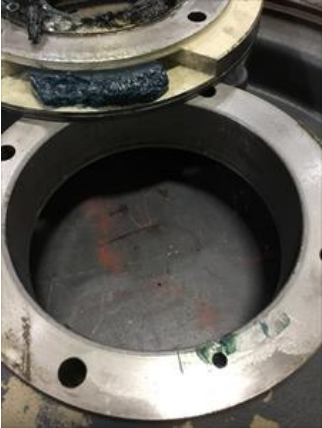
61.	Drive End - Endbell Bearing Fit Condition		(P) Pass
62.	Opposite Drive End - Endbell Bearing Fit		P73
	0 Degrees	60 Degrees	120 Degrees
	7.0871	7.0871	7.0871
	Tolerance is 7.0866-7.0876
