## AC Inspection as Found

Greenbrier Central LLC

### AC Inspection - Rev. 2

Description: 10 Hp

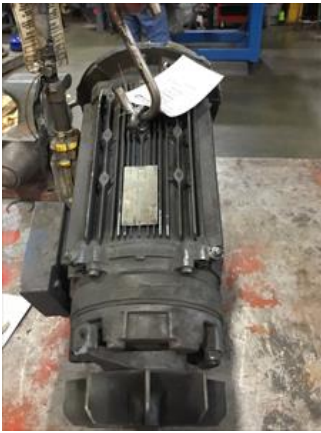
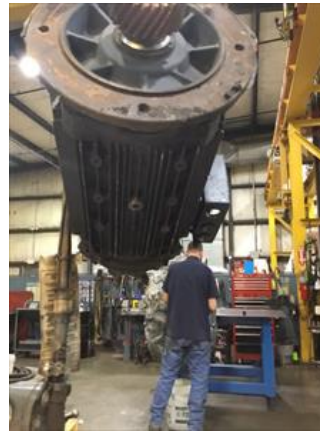
4.	Describe the Overall Condition of the Equipment as Received		
	<i>Good</i>		
5.	Distance from the end of the shaft to the Coupling/Sheave		
6.	Report Date [COPY]		
<b>Initial Mechanical/Electrical</b>			
7.	Does Shaft Turn Freely?	(Y) Yes	
8.	Does the shaft require T.I.R in Lathe to identify additional repairs?	(No) No	
9.	Does Shaft Have Visible Damage?	(No) No	
10.	Assembled Shaft Runout	Inches	
11.	Assembled Shaft End Play		
12.	Air Gap Variation <10%		
13.	Lead Condition		
14.	Lead Length	5 Inches	
15.	Does it have Lugs?, If so what is the Stud Size?		
16.	Lead Numbers	1-6	
17.	Frame Condition	good	
18.	Fan Condition	(F) Fail	P18

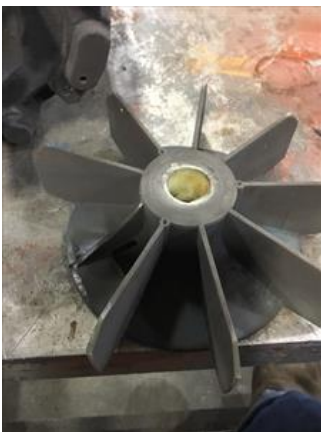
19.	Broken or Missing Components	Fan bad and cover was missing when recieved.	
-----	------------------------------	--	--

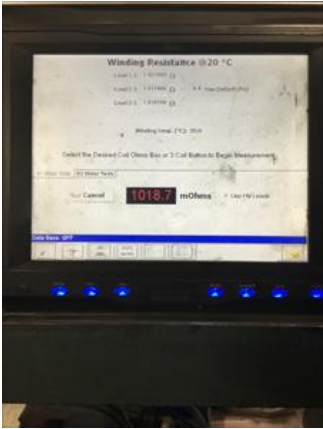
23. Number of Stator Slots	36
24. Stator Condition	good
25. Stator Thermistors/Ohms	
26. Stator Overloads/Ohms

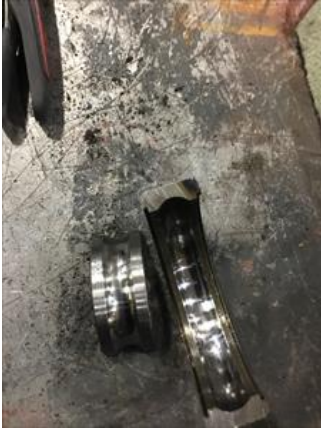
28.	Drive End Bearing Number-	6308	
29.	Drive End Bearing Qty.	1	
30.	Drive End Bearing Type	(Ball) Ball Bearing	
31.	Drive End Lubrication Type	(Grease) Grease Lubricated	
32.	Drive End Bearing Insulation or Grounding Device?	none	
33.	Drive End Wavy Washer/Snap-Ring Other Retention Device?	none	
34.	Drive End Bearing Condition	good	P34

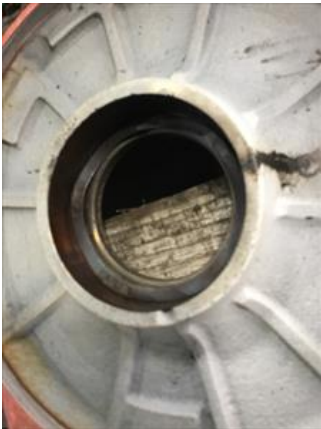
35.	Opposite Drive End Bearing Brand	Hoyt	
36.	Opposite Drive End Bearing Number-	6207 2rsr	
37.	Opposite Drive End Bearing Qty.	1	
38.	Opposite Drive End Bearing Type	(Ball) Ball Bearing	
39.	Opposite Drive End Lubrication Type	(Grease) Grease Lubricated	
40.	Opposite Drive End Bearing Insulation or Grounding Device?	insulated bearing	
41.	Opposite Drive End Wavy Washer/Snap-Ring Other Retention Device?	wavy washer	P41

42.	Opposite Drive End Bearing Condition	good	P42
-----	--------------------------------------	------	-----
