Hi-Speed Industrial Service
7030 Ryburn Dr
Millington, Tn 38053
901-873-5300

AC Inspection as Found

NUCOR Memphis (003974-1)

Description: 125 Hp

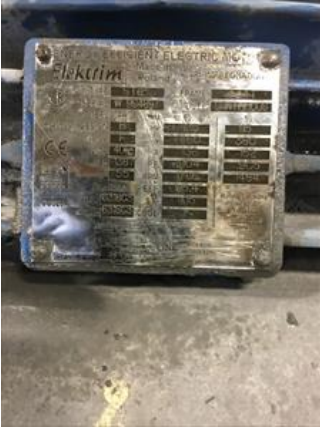
P2

2. Nameplate Picture

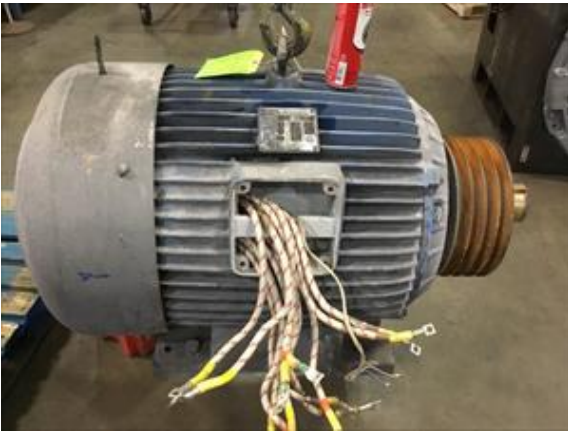
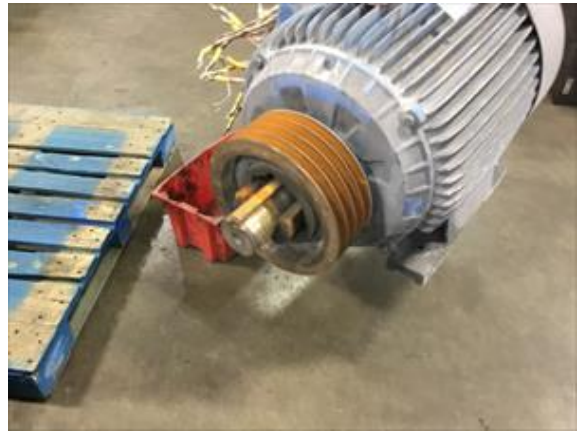
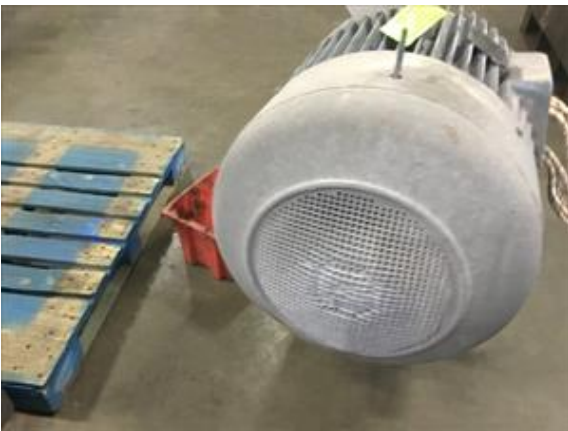
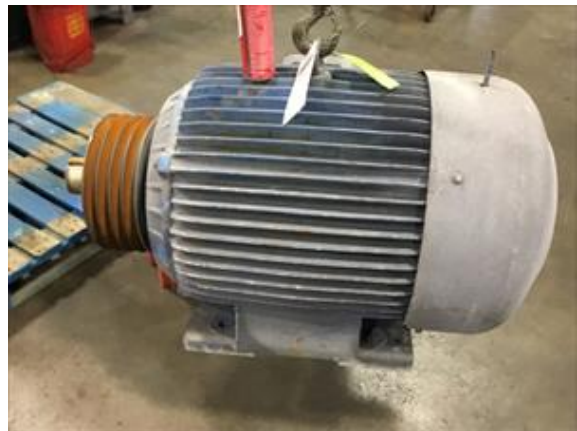
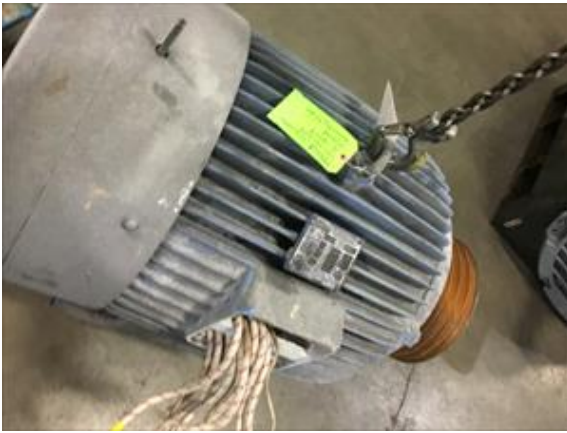
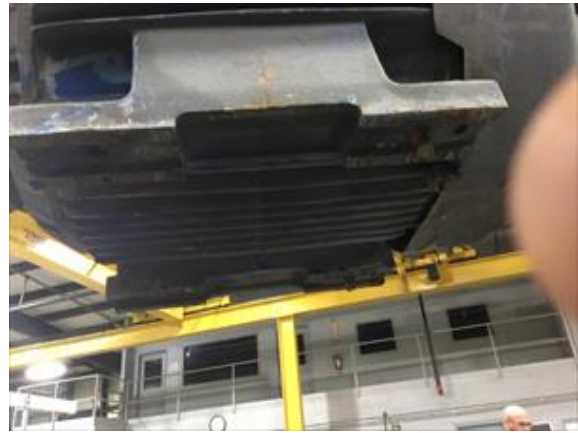
P3

3. Photos of all six sides of the machine.

4.	Describe the Overall Condition of the Equipment as Received		
	<i>Good</i>		
5.	Distance from the end of the shaft to the Coupling/Sheave	inches	
6.	Report Date [COPY]		
Initial Mechanical/Electrical			
7.	Does Shaft Turn Freely?	(Y) Yes	
8.	Does the shaft require T.I.R in Lathe to identify additional repairs?	(No) No	
9.	Does Shaft Have Visible Damage?	(No) No	
10.	Assembled Shaft Runout	0.002 Inches	
11.	Assembled Shaft End Play	0.02 inches	
12.	Air Gap Variation <10%		
13.	Lead Condition	(P) Pass	
14.	Lead Length	20 Inches	
15.	Does it have Lugs?, If so what is the Stud Size?	(Yes) Yes	
	1/2		
16.	Lead Numbers	1-12	
17.	Frame Condition	good	
18.	Fan Condition	(P) Pass	P18

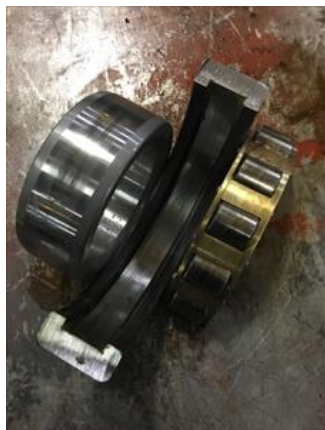
29.	Drive End Bearing Number-	318 nu roller	
30.	Drive End Bearing Qty.	1	
31.	Drive End Bearing Type	(Roller) Roller Bearing	
32.	Drive End Lubrication Type	(Grease) Grease Lubricated	
33.	Drive End Bearing Insulation or Grounding Device?	none	
34.	Drive End Wavy Washer/Snap-Ring Other Retention Device?	none	
35.	Drive End Bearing Condition	good	P34

●	50. List the Parts needed for the Repair Below 1- sheave 1- 318 NU Roller 1- 6318p63e1	
●	51. Signature of Technician that Disassembled Motor <div style="text-align: center; margin-top: 20px;">

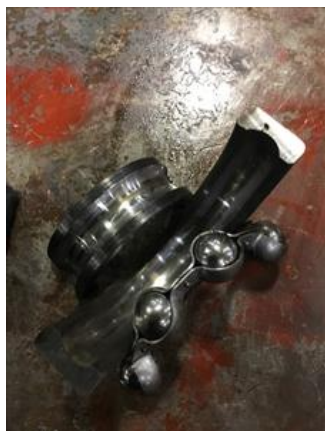
36.	Opposite Drive End Bearing Brand	Roland	
37.	Opposite Drive End Bearing Number-	6318p63e1	
38.	Opposite Drive End Bearing Qty.	1	
39.	Opposite Drive End Bearing Type	(Ball) Ball Bearing	
40.	Opposite Drive End Lubrication Type	(Grease) Grease Lubricated	
41.	Opposite Drive End Bearing Insulation or Grounding Device?	none	
42.	Opposite Drive End Wavy Washer/Snap-Ring Other Retention Device?	none	
43.	Opposite Drive End Bearing Condition	good	P42
