## AC Inspection as Found

Peco Foods (004801)

### AC Inspection - Rev. 2

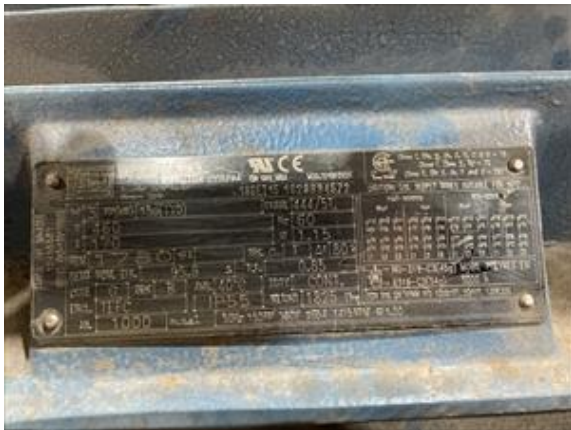
- Report Date 11/25/2024
- Nameplate Picture P2

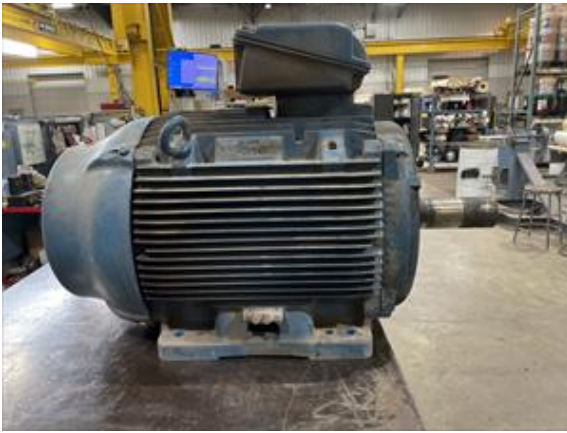
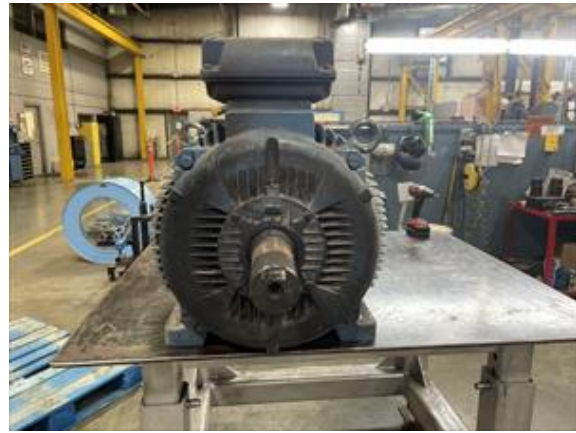
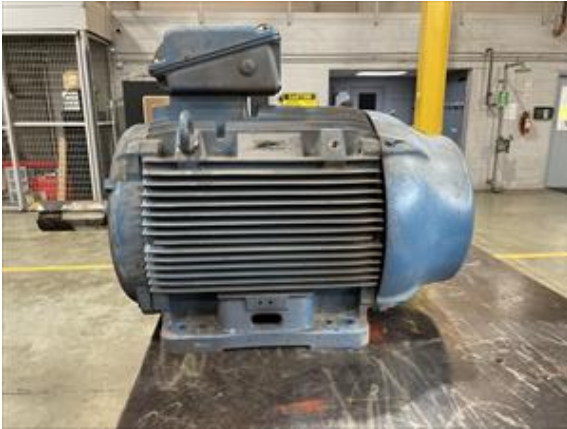
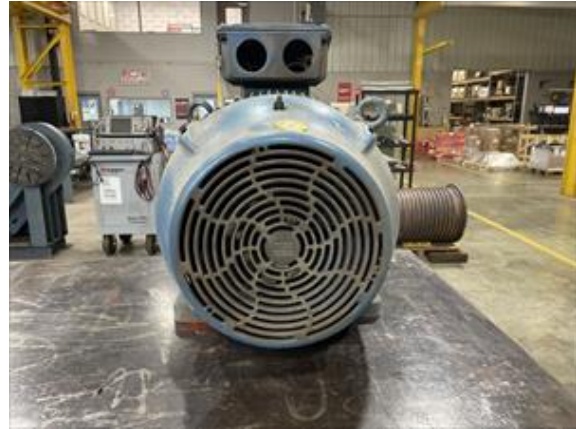
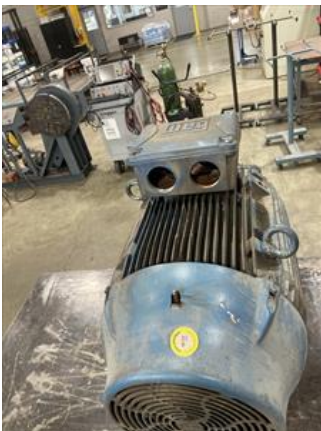
- Photos of all six sides of the machine. P3

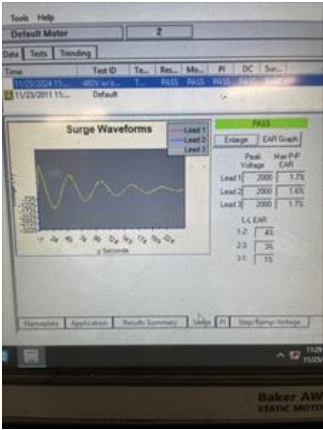
19.	Winding Resistance		P23
-----	--------------------	--	-----

1-2

1-3

2-3

.0335

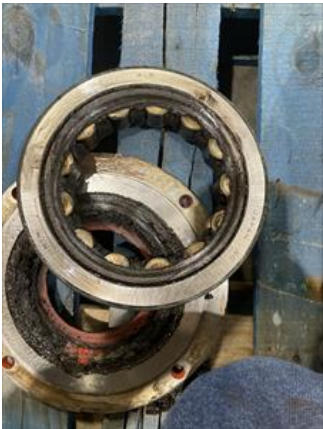
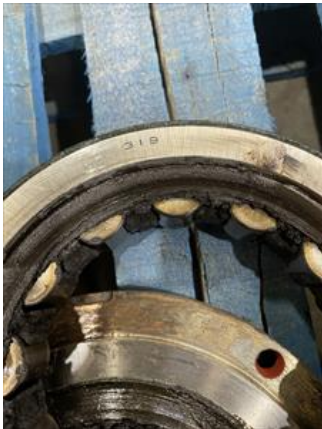
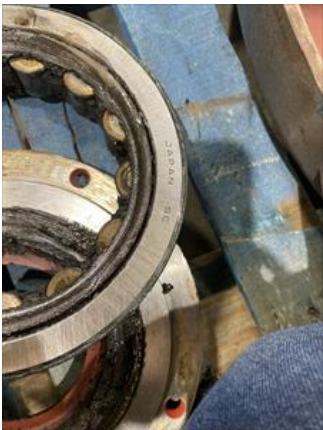
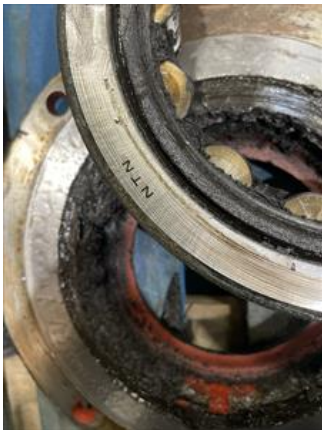
25.	Drive End Bearing Brand	NTN	
26.	Drive End Bearing Number-	319	P30
	<i>Roller bearing</i>

27. Drive End Bearing Qty.	1
28. Drive End Bearing Type	(Roller) Roller Bearing

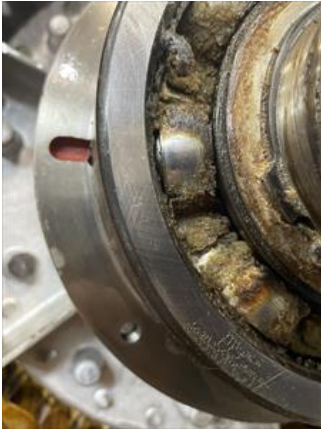
29.	Drive End Lubrication Type	(Grease) Grease Lubricated	
30.	Drive End Bearing Insulation or Grounding Device?	none present	
31.	Drive End Wavy Washer/Snap-Ring Other Retention Device?	none present	
32.	Drive End Bearing Condition	good	
33.	Opposite Drive End Bearing Brand	NSK	P37

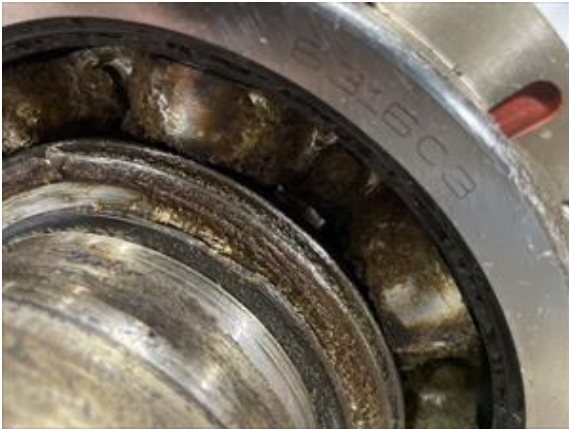
34.	Opposite Drive End Bearing Number-	6316c3	P38
-----	------------------------------------	--------	-----

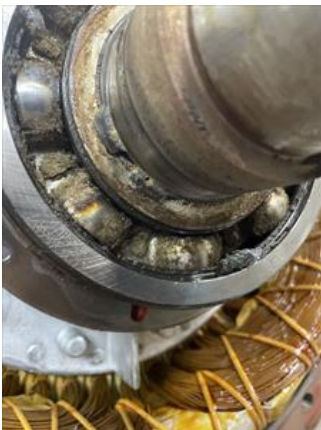
35.	Opposite Drive End Bearing Qty.	1	
36.	Opposite Drive End Bearing Type	(Ball) Ball Bearing	
37.	Opposite Drive End Lubrication Type	(Grease) Grease Lubricated	
38.	Opposite Drive End Bearing Insulation or Grounding Device?	none	
39.	Opposite Drive End Wavy Washer/Snap-Ring Other Retention Device?	snap ring	P43

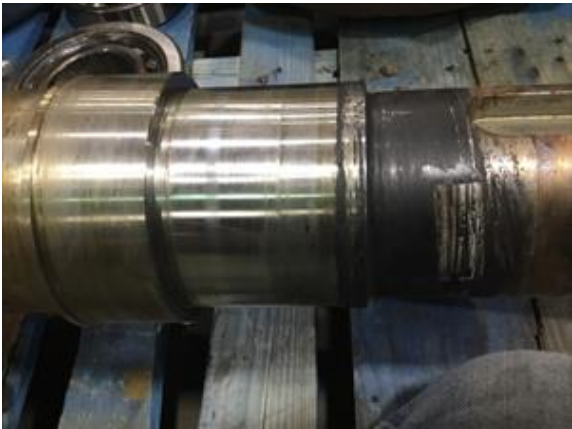
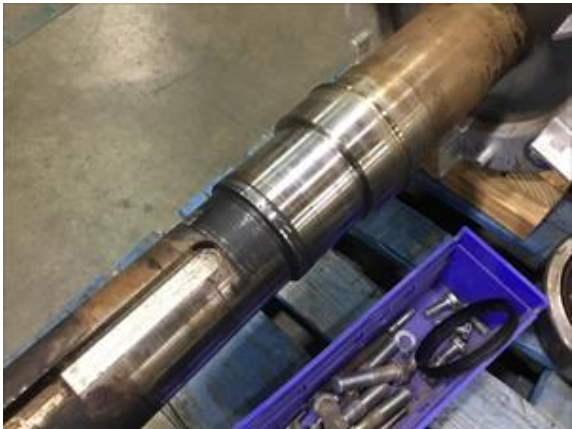
3.375	3.375	3.375
53.	Drive End Bearing Shaft Fit		
	0 Degrees	60 Degrees	120 Degrees
	3.7411	3.7411	3.7411
	95mm = 3.7401 Pressfit tolerance is from 3.7411 to 3.7420

54.	Drive End Bearing Shaft Fit Condition		(P) Pass

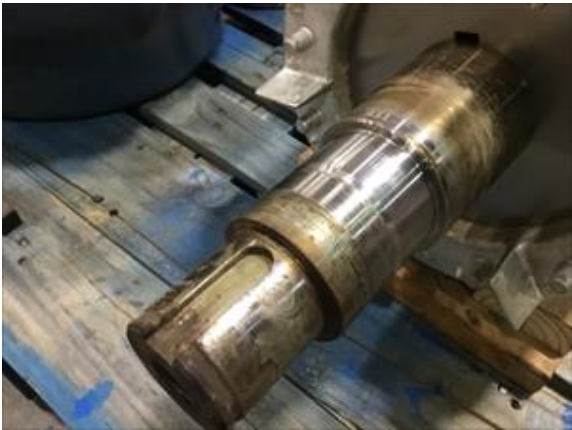
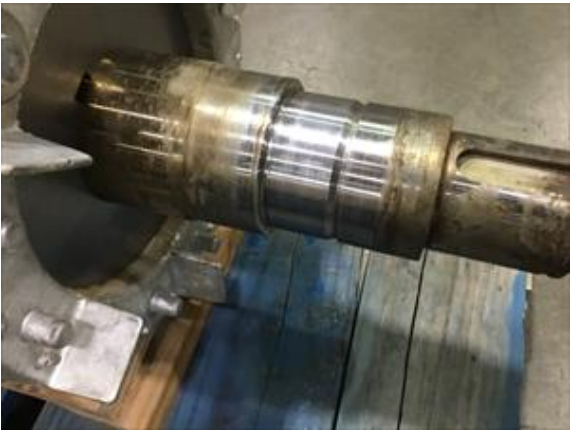
55. Opposite Drive End Bearing Shaft Fit

0 Degrees	60 Degrees	120 Degrees
3.1499	3.1497	3.1496

80mm = 3.1496 Pressfit tolerance is from 3.1497 to 3.1502

56. Opposite Drive End Bearing Shaft Fit Condition

(P) Pass

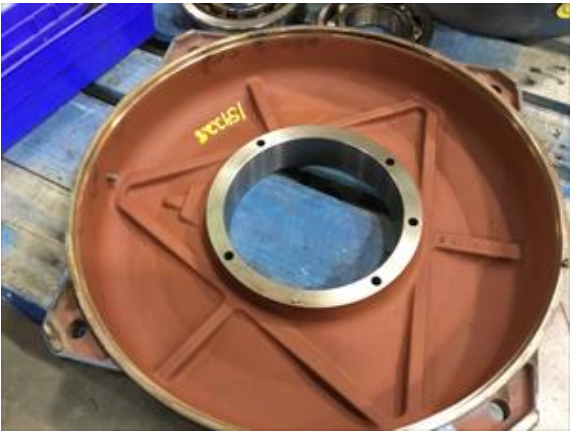
58. Drive End - Endbell Bearing Fit

0 Degrees	60 Degrees	120 Degrees
7.875	7.875	7.875

200mm = 7.8740 Tolerance is from 7.8740 to 7.8751

59. Drive End - Endbell Bearing Fit Condition

(P) Pass

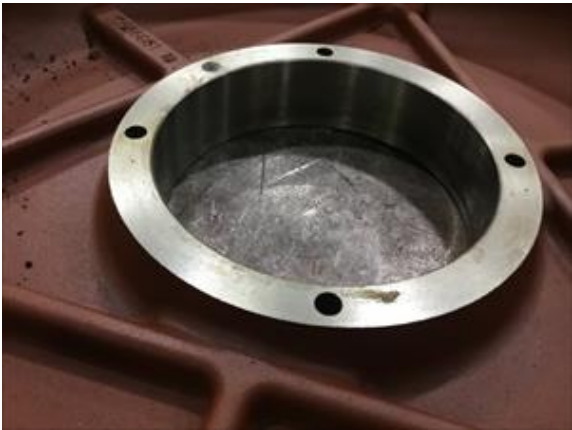
60. Opposite Drive End - Endbell Bearing Fit

170mm = 6.6929    Tolerance Is from 6.6929 to 6.6939

61. Opposite Drive End - Endbell Bearing Fit Condition

(P) Pass
