December 2024 Infrared Survey Report Greenville, MS Plant

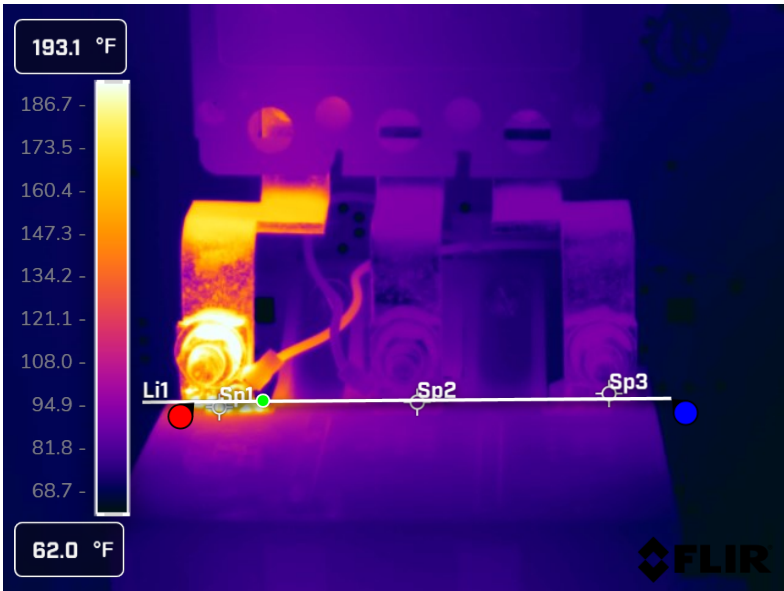
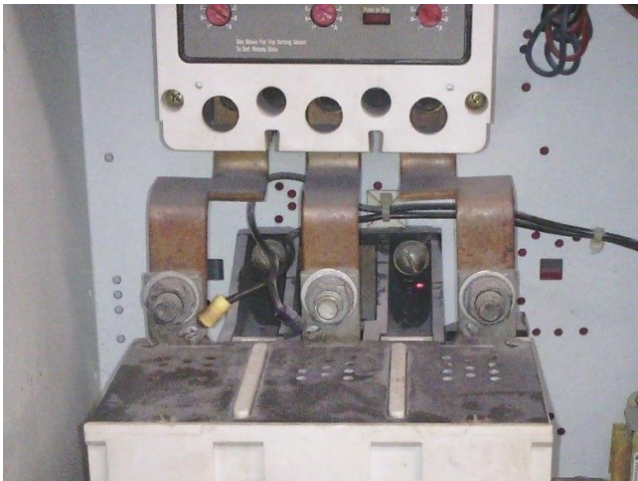
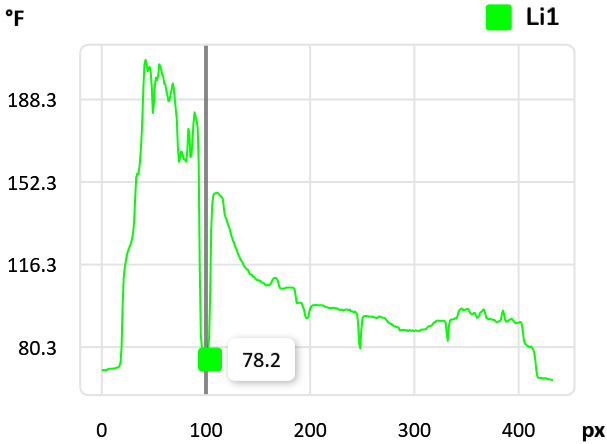
#7 Expander Fan M2248

Starter

Li1	
Max	205.6 °F
Avg	108.8 °F
Min	66.0 °F
Sp1	190.8 °F
Sp2	97.3 °F
Sp3	90.8 °F

Faulty Connection

CLASS II

Recheck image shows issue still exists and appears to be worse than before. The A phase lug may have an internal fault inside the starter unit. It is recommended to repair/replace starter and or starter components as needed.
