## AC Inspection as Found

Delta Plastics (11016)

### AC Inspection - Rev. 2

Location: MOTOR SHOP LR  
Serial Number: B889014-010002 HQ  
Description: 150HP BALDOR 1750RPM

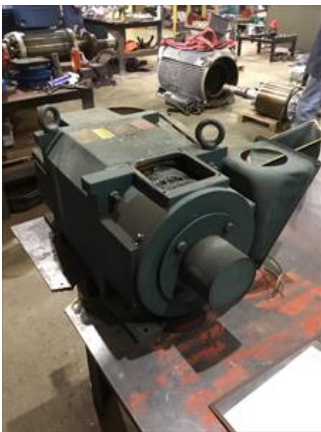
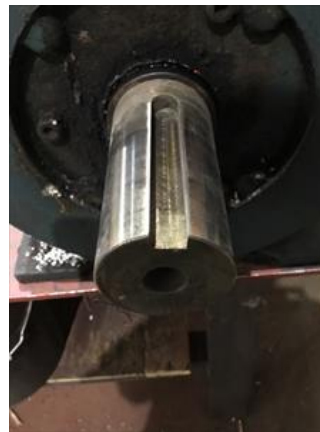
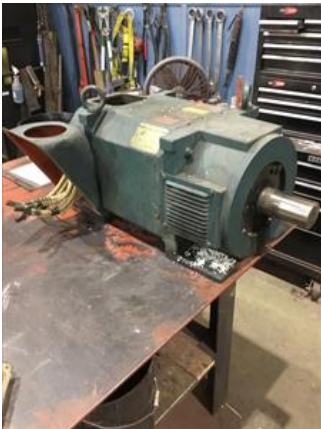
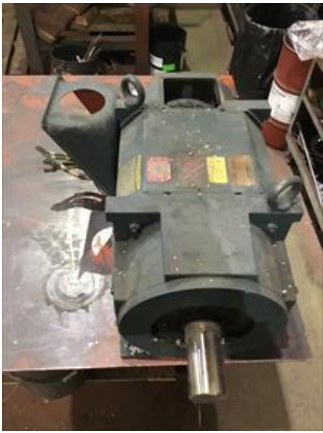
3. Photos of all six sides of the machine.

**Marked backwards**

*Dirty*

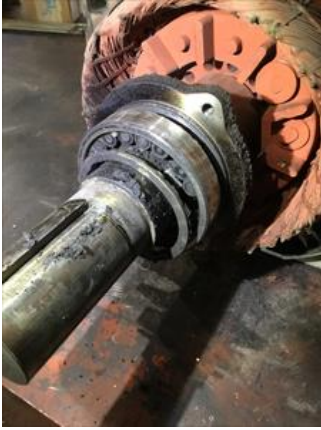
25. Drive End Bearing Brand

FAG

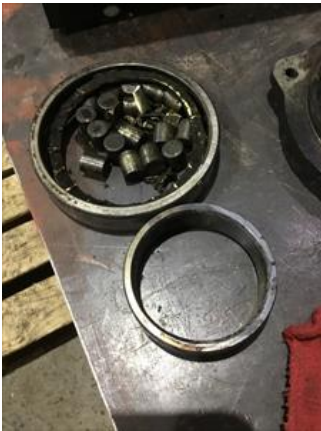
26. Drive End Bearing Number-

NU215

cage failed

66.	Failure locations <i>Bearings and bearing fits</i>		
67.	Root cause of failure <i>Cage failed on DE bearing</i>		
<b>Dynamic Balance Report</b>

45. Number of Rotor Bars	40
46. Rotor Condition	needs cleaned
47. List the Parts needed for the Repair Below	
NU215 6211 Bearing sleeves for both end bell bearing fits

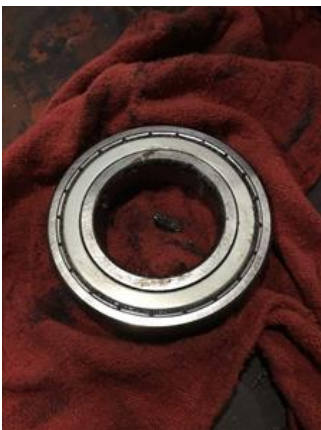
33. Opposite Drive End Bearing Brand

SKF

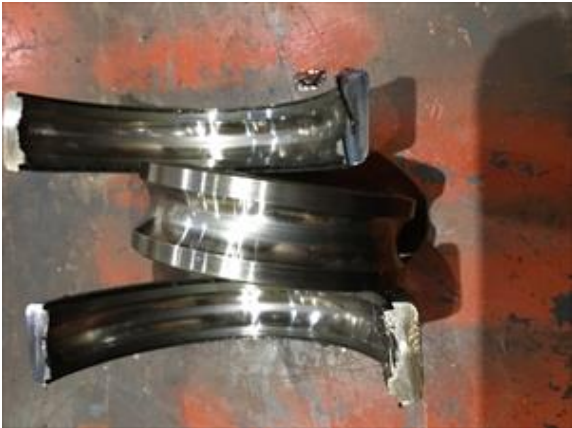
39. Opposite Drive End Wavy Washer/Snap-Ring Other Retention Device?	
40. Opposite Drive End Bearing Condition	P118

Primarily contamination and early signs of frosting

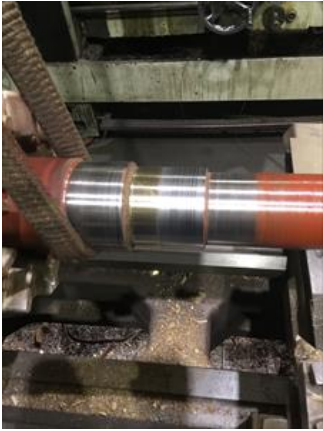
75. Coupling Fit Closest to the end of the Shaft Post Repair

0 Degrees	60 Degrees	120 Degrees
2.9543	2.9543	2.9543

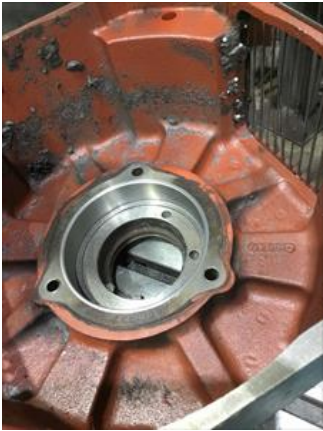
80. Drive End - Endbell Bearing Fit Post Repair

Excessive lip worn into fit

0 Degrees	60 Degrees	120 Degrees
5.1186	5.1186	5.1186

64.	List Machine Work Needed Below <i>Both end bell bearing fits and DE shaft bearing fit</i>		
65.	Technician		Cw

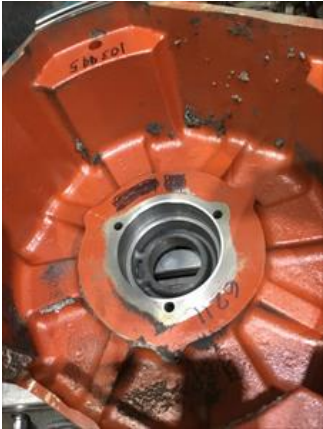
81. Opposite Drive End - Endbell Bearing Fit Post Repair

Signs of excessive wear

0 Degrees	60 Degrees	120 Degrees
3.9377	3.9378	3.9377

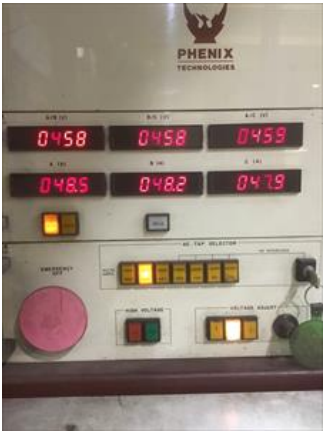
90. Test Run Voltage P56

Volts	Volts	Volts
458	458	459

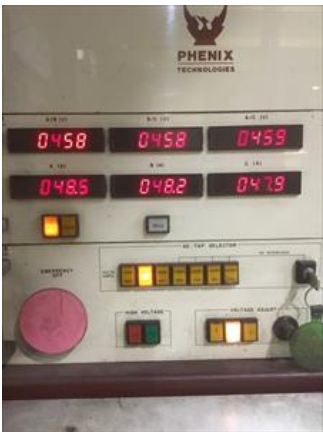
91. Test Run Amperage P65

Amps	Amps	Amps
48.5	48.2	47.9

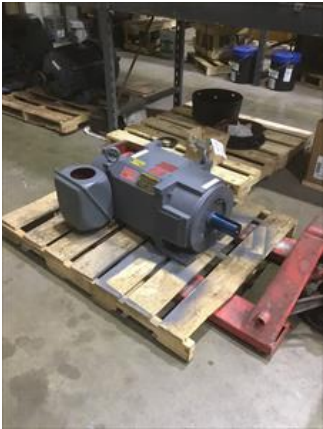
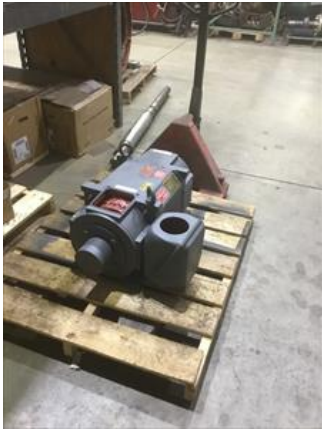
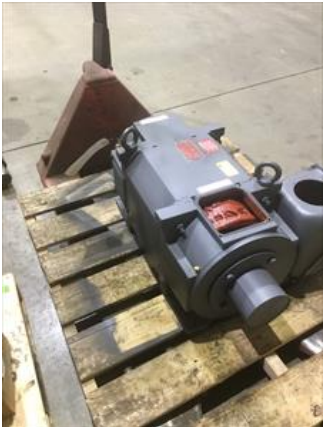
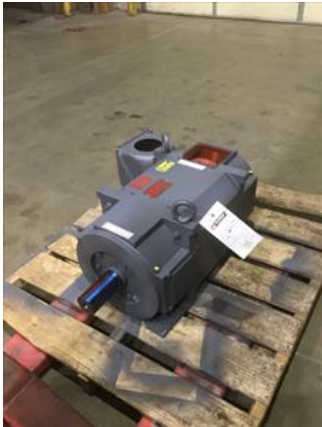
93. Opposite Drive End Vibration Readings - Inches Per Second			
Horizontal	Vertical	Axial	
94. Ambient Temperature - Fahrenheit			
95. Drive End Bearing Temps - Fahrenheit			
5 Minutes	10 Minutes	15 Minutes	
96. Opposite Drive End Bearing Temps - Fahrenheit			
5 Minutes	10 Minutes	15 Minutes	
97. Document Final Condition with Pictures after paint	P129		
<div>
