AC Inspection as Found
CERTAINTED (10520)
2701 E ROOSEVELT ROAD
LITTLE ROCK, AR 72206

AC Inspection - Rev. 2

Location: LR Motor Shop

Description: 2.5 HP DERRICK

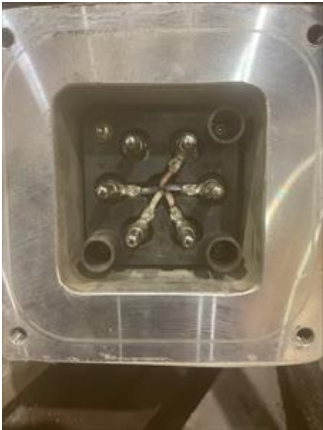
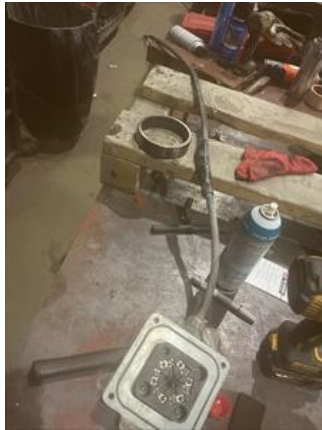
5.	Does Shaft Turn Freely?	(Y) Yes
6.	Does the shaft require T.I.R in Lathe to identify additional repairs?	(No) No
7.	Does Shaft Have Visible Damage?	(No) No
8.	Assembled Shaft Runout	Inches
	<i>Na</i>	
9.	Assembled Shaft End Play	inches
	<i>Na</i>	
10.	Air Gap Variation <10%	
	<i>Na</i>	
11.	Lead Condition	(P) Pass
12.	Lead Length	6 Inches
13.	Does it have Lugs?, If so what is the Stud Size?	(Yes) Yes

60 " of 14/4 power cord

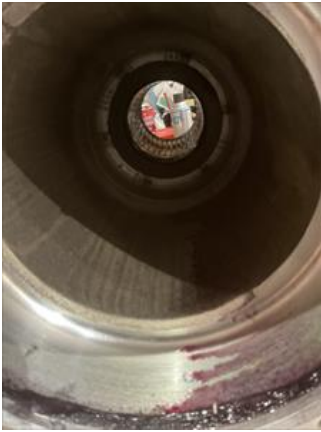
P84

23. Stator Condition

**Rewind**

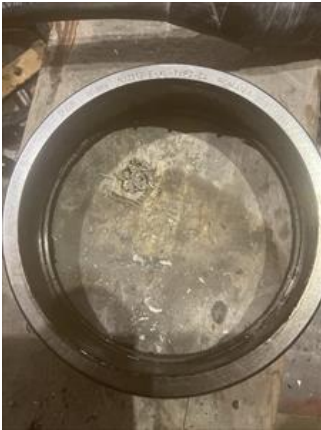
P32

27. Drive End Bearing Number-

NJ2213-E-XL-TVP2-C4

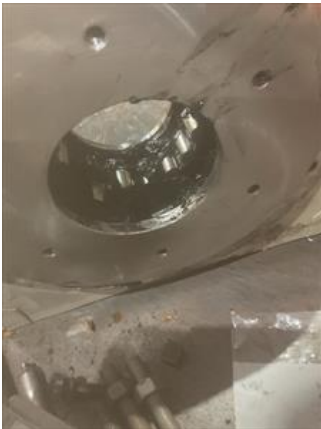
34. Opposite Drive End Bearing Brand	FAG	
35. Opposite Drive End Bearing Number-	NJ2213-E-XL-TVP2-C4	
36. Opposite Drive End Bearing Qty.	1	
37. Opposite Drive End Bearing Type	(Roller) Roller Bearing	
38. Opposite Drive End Lubrication Type	(Grease) Grease Lubricated	
39. Opposite Drive End Bearing Insulation or Grounding Device?	na	
40. Opposite Drive End Wavy Washer/Snap-Ring Other Retention Device?	a	
41. Opposite Drive End Bearing Condition	normal wear	P118

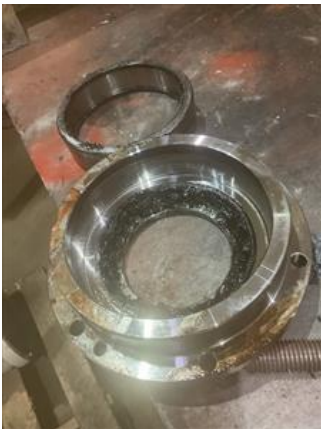
P15

60. Drive End - Endbell Bearing Fit Condition **(P) Pass**

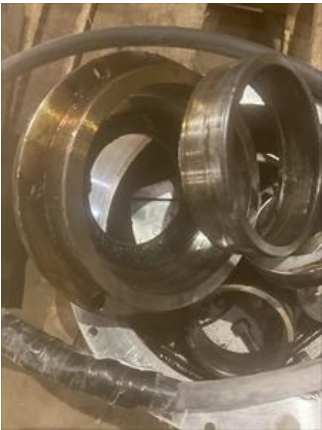
61.	Opposite Drive End - Endbell Bearing Fit		
	0 Degrees	60 Degrees	120 Degrees
	4.7243	4.7243	4.7243
62.	Opposite Drive End - Endbell Bearing Fit Condition		(P) Pass P39

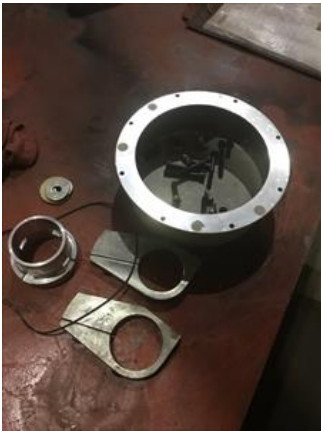
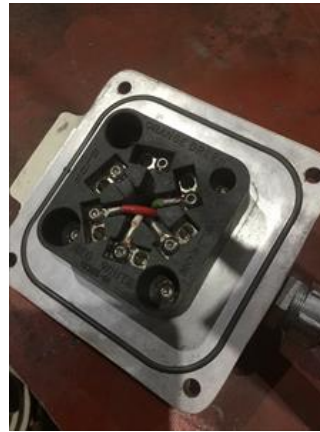
P17

82. Photograph All Major Components prior to assembly
