AC Inspection as Found
PRODUCERS RICE STUTTGART
603 N. PARK AVE
STUTTGART, AR 72160

AC Inspection - Rev. 2

Description: KICE IND.
NO HEADPLATE DATA

Product Number: PD-4000

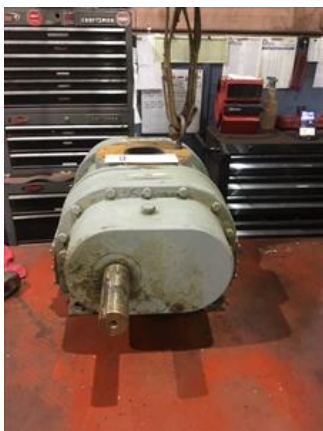
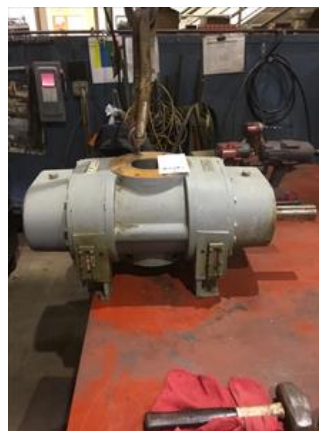
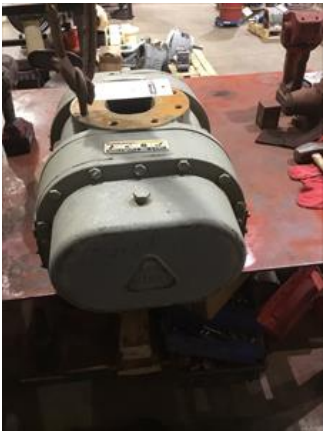
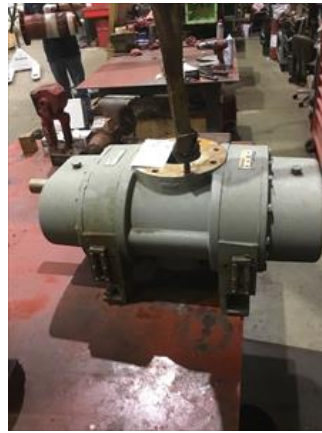
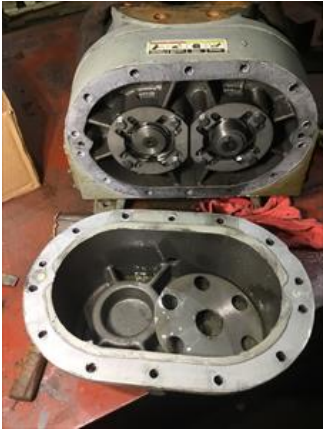
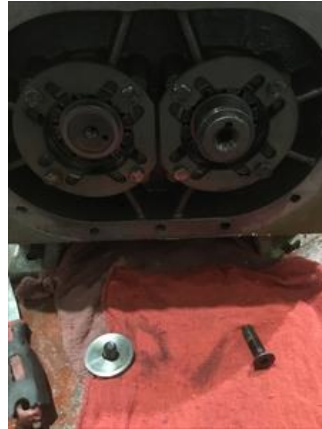
3. Photos of all six sides of the machine.

4. Describe the Overall Condition of the Equipment as Received <i>Rotors locked up and rusted.</i>		
5. Distance from the end of the shaft to the Coupling/Sheave		inches
Initial Mechanical/Electrical		
6. Does Shaft Turn Freely?		(N) No
7. Does the shaft require T.I.R in Lathe to identify additional repairs?		(Yes) Yes
8. Does Shaft Have Visible Damage?		(Yes) Yes
<div>

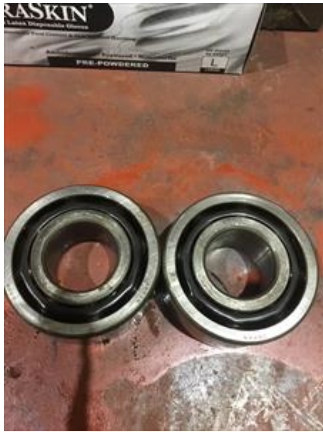
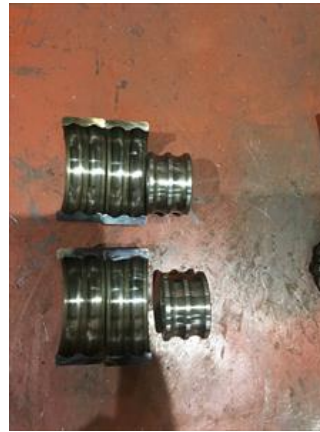
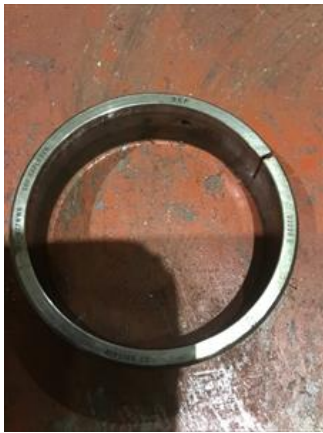
P32

(2) Koyo 5308
(1) SKF 22209 E

30. Drive End Bearing Qty.	2
31. Drive End Bearing Type	(Ball) Ball Bearing
32. Drive End Lubrication Type	(Oil) Oil Lubricated
33. Drive End Bearing Insulation or Grounding Device?	none
34. Drive End Wavy Washer/Snap-Ring Other Retention Device?	none
35. Drive End Bearing Condition	replace
36. Opposite Drive End Bearing Brand	SKF

(2) gears			
	(2) 5308 bearings			
	(2) 308 EC bearings and (2) NJ 308 ECJ races			
	(1) SKF 17293 seal and replace multiple broken bolts and parts

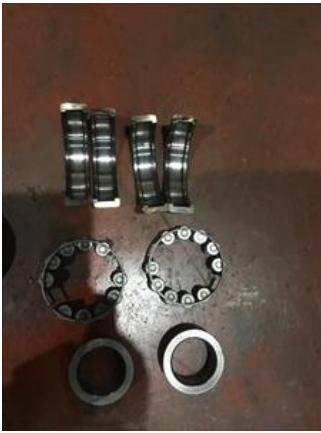
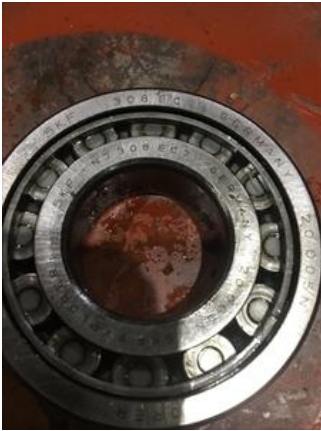
P99

308 EC

*Bearing: 308 EC
Race: NJ 308 ECJ*

replace

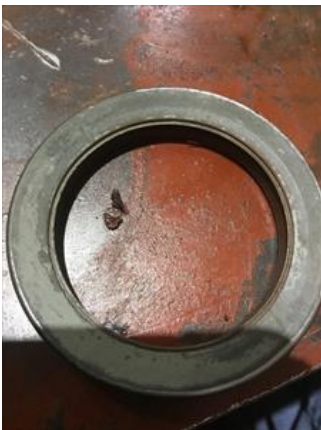
P120

SKF 17293

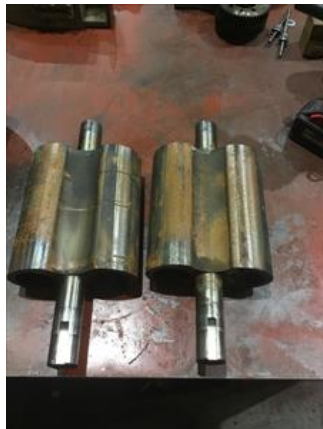
P3

55.	Growler Test			
56.	Number of Rotor Bars			
57.	Rotor Condition	rusted but serviceable		
58.	List the Parts needed for the Repair Below

Root Cause of Failure		
77.	Failure locations <i>Rotor key ways wallowed</i> <i>Both gears worn and missing teeth</i> <i>Multiple broken bolts on gear end and housing fits out of tolerance</i> <i>Replace broken parts. (Need breakdown to identify.)</i>

78.	Root cause of failure <i>Broken bolts on gears allowed parts to wedge themselves in the gears</i>	
Dynamic Balance Report		
79.	Rotor Weight and Balance Grade	
	Rotor Weight	Balance Grade

74.	End Bell Air Seal Fits	
	Drive End Air Seal	Opposite Drive End Air Seal
75.	List Machine Work Needed Below <i>Machine housing fit for 22209 bearing</i> <i>Repair wallowed key ways on both rotors</i> <i>Machine both housing fits on ODE</i>
