AC Inspection as Found

American Kraft Paper

AC Inspection - Rev. 2

Description: 125HP TECO 1780RPM

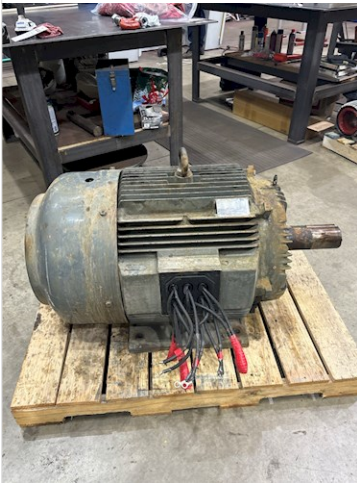
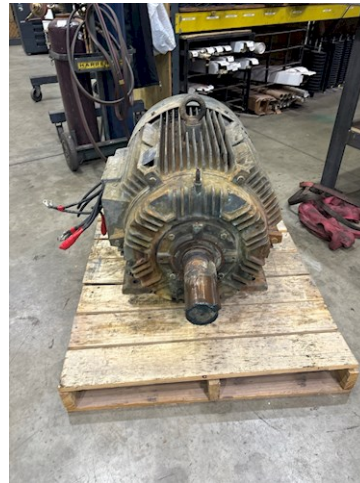
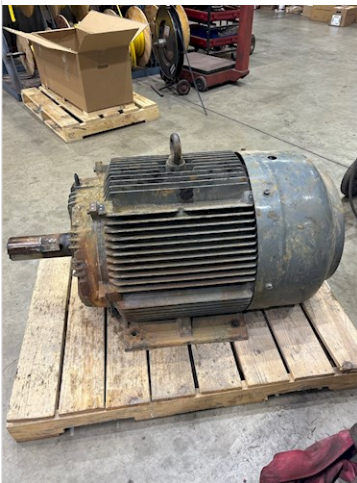
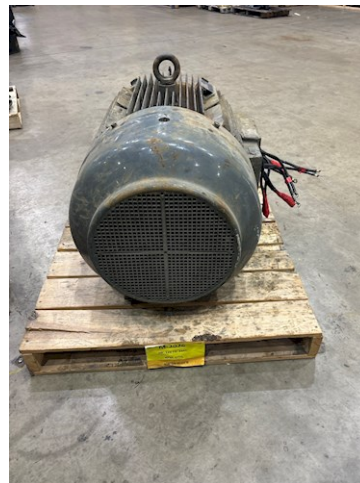
3. Photos of all six sides of the machine.

4. Describe the Overall Condition of the Equipment as Received
Windings are shorted. Needs rewind and bearings.

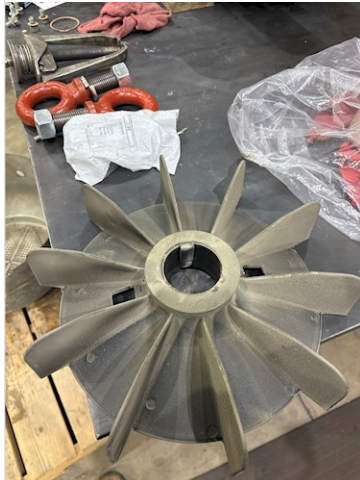
12.	Lead Length	12 Inches	
13.	Does it have Lugs?, If so what is the Stud Size?	(Yes) Yes	
	3/8		
14.	Lead Numbers	not ledge able	
15.	Frame Condition	Good	
16.	Fan Condition	(P) Pass	P115

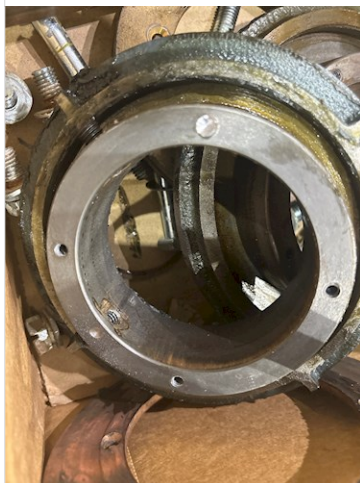
17.	Does motor have internal fan?	(No) No	
18.	Broken or Missing Components	broken screw shaft air fit seal. no j-box	P124

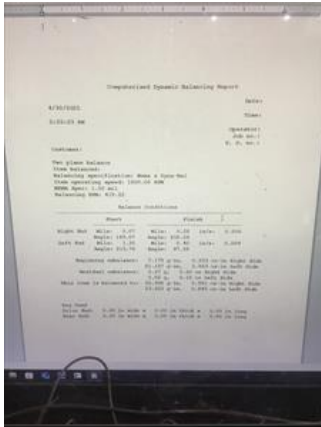
70. Initial Balance Readings

1.35

.40

71. Final Balance Readings

.07

.28

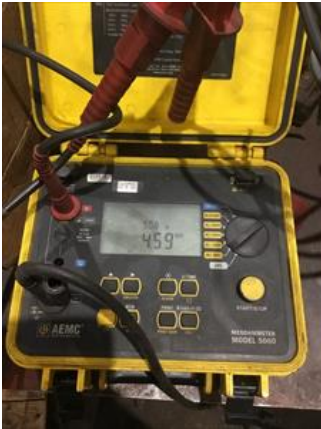
83. Final Insulation Resistance Test

4.59 Gigohms

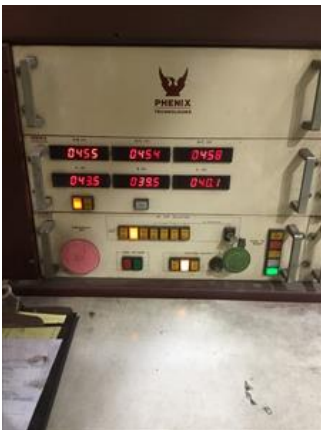
86. Test Run Voltage

455

454

458

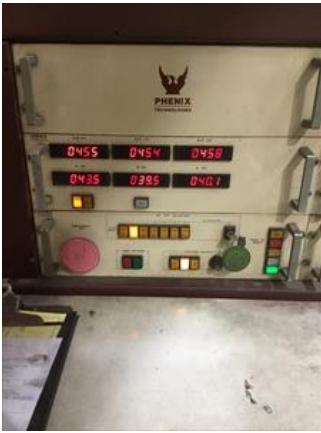
87. Test Run Amperage

43.5

39.5

40.1
