AC Inspection as Found

Riceland Foods (11100-RLF)

AC Inspection - Rev. 2

Description: 50HP US 1770 RPM

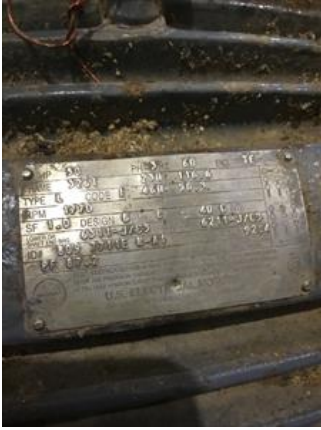
P37

2. Nameplate Picture

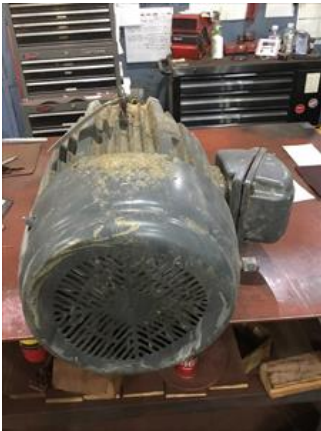
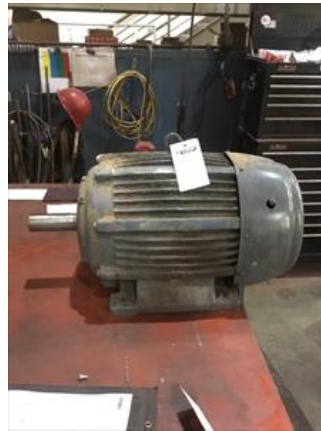
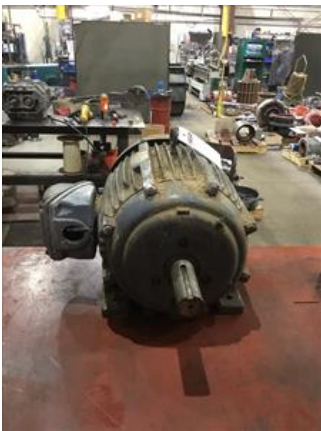
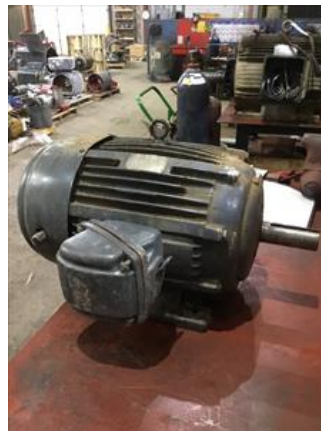
P45

3. Photos of all six sides of the machine.

<div><div></div></div>	4. Describe the Overall Condition of the Equipment as Received	
	Serviceable	
Initial Mechanical/Electrical		<div><div></div></div>
<div><div></div></div>	5. Does Shaft Turn Freely?	(N) No
<div><div></div></div>	Fan assembly rubbing against dented in fan cover.	
<div><div></div></div>	6. Does the shaft require T.I.R in Lathe to identify additional repairs?	(No) No

Fan cover is dented but can be straightened.

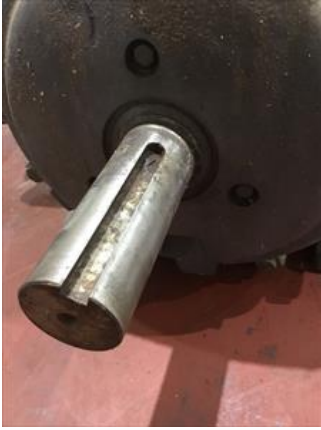
P26

7. Does Shaft Have Visible Damage?

(No) No

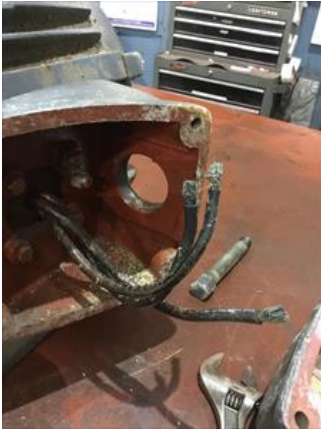
P69

11. Lead Condition (P) Pass

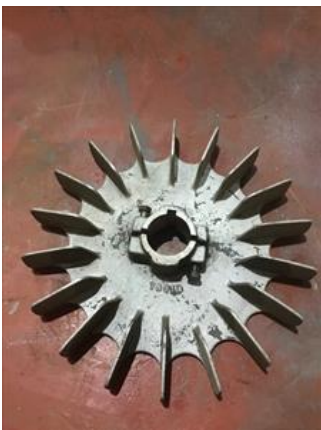
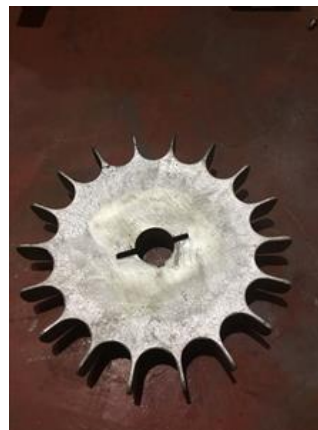
P115

16. Fan Condition (P) Pass

211 & 311 2RS bearings
Remove multiple dents from fan cover and replace grease overload tube. Recondition motor | |

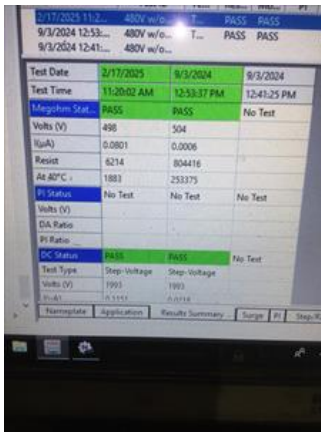
P8

19. Insulation Resistance/Megger

Test Date	2/17/2025	9/3/2024	9/3/2024
Test Time	11:20:02 AM	12:53:37 PM	12:41:25 PM
Megohm Stat.	PASS	PASS	No Test
Volts (V)	498	504	
Isp(A)	0.0801	0.0006	
Resist	6214	804416	
At 80°C	1881	253375	
PI Status	No Test	No Test	No Test
Volts (V)			
Isp(A)			
PI Ratio			
DC Status	PASS	PASS	No Test
Test Type	Step-Voltage	Step-Voltage	
Volts (V)	1991	1993	
Isp(A)	0.1157	0.0158

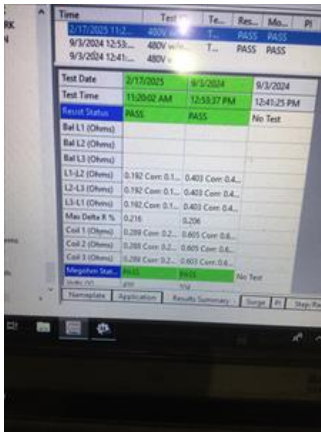
P20

20. Winding Resistance

Test Date	2/17/2025	9/3/2024	9/3/2024
Test Time	11:20:02 AM	12:53:37 PM	12:41:25 PM
Resist Status	PASS	PASS	No Test
Bal L1 (Ohms)			
Bal L2 (Ohms)			
Bal L3 (Ohms)			
L1-L2 (Ohms)	0.182 Conn 0.1... 0.403 Conn 0.4...		
L2-L3 (Ohms)	0.182 Conn 0.1... 0.403 Conn 0.4...		
L3-L1 (Ohms)	0.182 Conn 0.1... 0.403 Conn 0.4...		
Max Delta % %	0.216	0.206	
Coil 1 (Ohms)	0.288 Conn 0.2... 0.805 Conn 0.8...		
Coil 2 (Ohms)	0.288 Conn 0.2... 0.805 Conn 0.8...		
Coil 3 (Ohms)	0.288 Conn 0.2... 0.805 Conn 0.8...		
Megohm Stat.	PASS	PASS	No Test

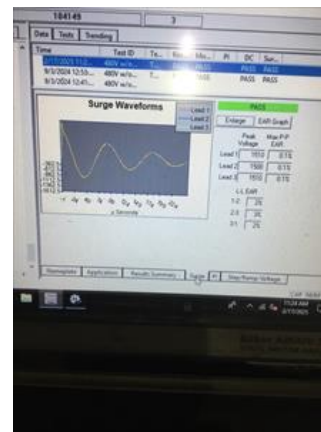
P57

21. Perform Surge Test

(P) Pass

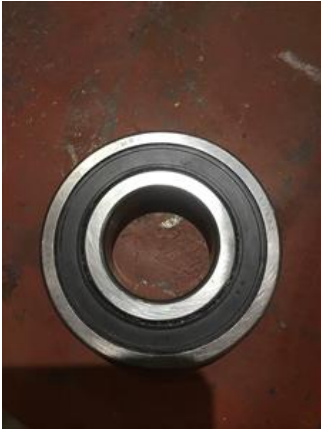
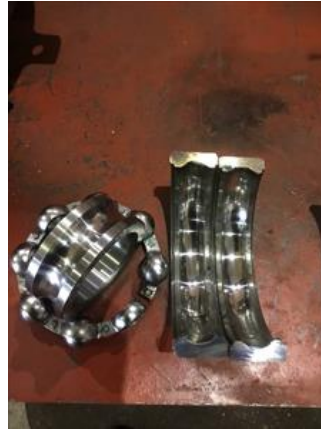
P12

26. Drive End Bearing Brand

MRC

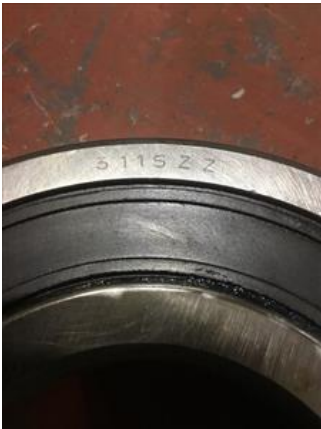
P32

27. Drive End Bearing Number-

311 S ZZ

33. Drive End Bearing Condition

replace

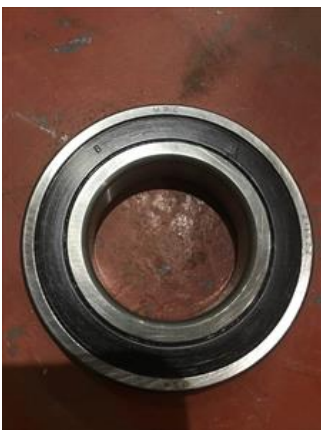
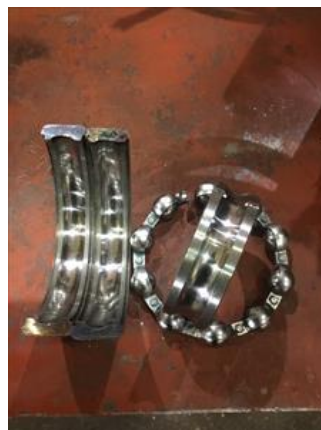
P92

34. Opposite Drive End Bearing Brand

MRC

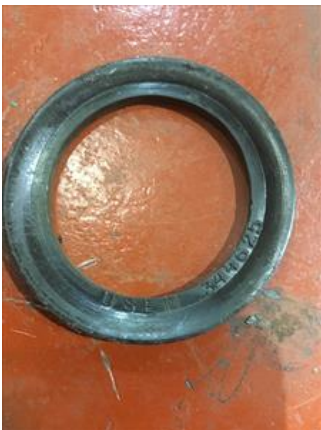
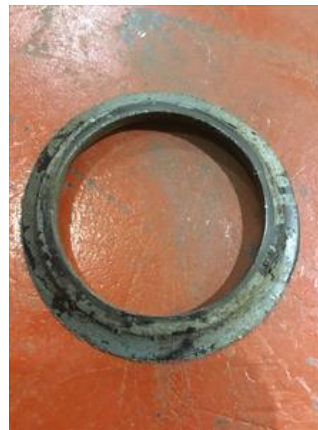
P120

36. Opposite Drive End Bearing Qty.	1
37. Opposite Drive End Bearing Type	(Ball) Ball Bearing
38. Opposite Drive End Lubrication Type	(Grease) Grease Lubricated
39. Opposite Drive End Bearing Insulation or Grounding Device?	none
40. Opposite Drive End Wavy Washer/Snap-Ring Other Retention Device?	none
41. Opposite Drive End Bearing Condition	replace
42. Drive End Seal	USEM 344625

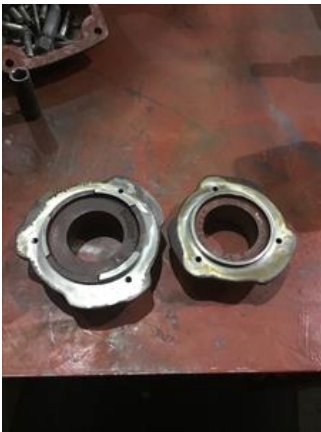
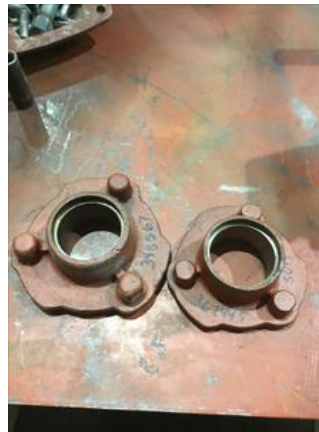
P52

63. Bearing Cap Condition

Drive End Bearing Cap

Opposite Drive End Bearing Cap

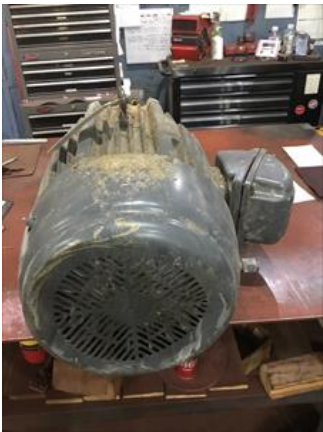
67. Failure locations

Fan cover

Fan cover was dented inward which allowed the fan to rub against the cover

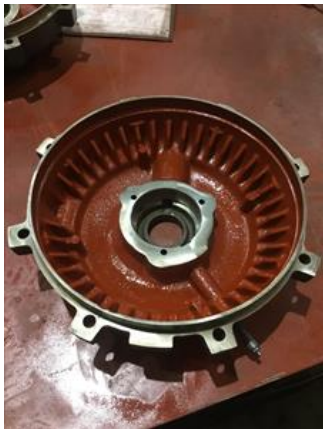
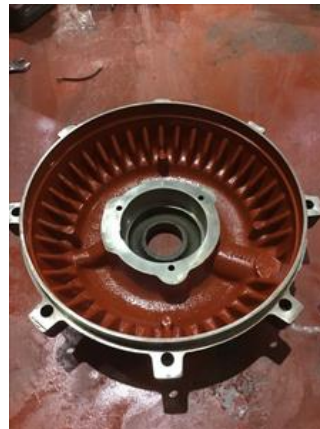
P17

74. Photograph All Major Components prior to assembly

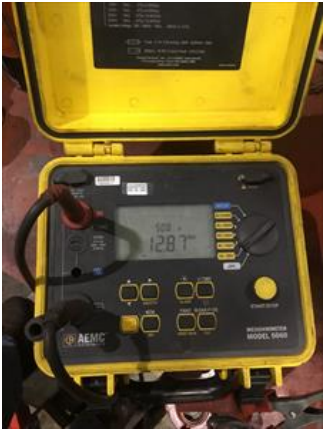
P31

75. Final Insulation Resistance Test

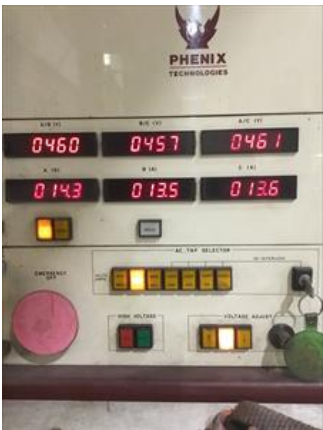
P55

78. Test Run Voltage

460

457

461

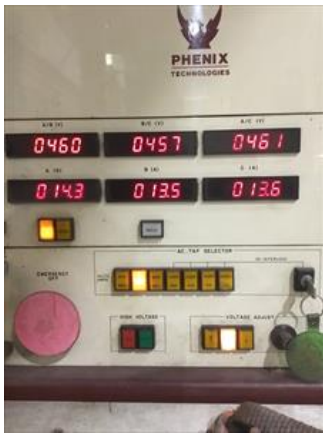
P65

79. Test Run Amperage

14.3

13.5

13.6

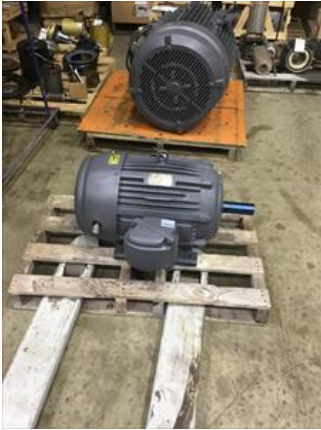
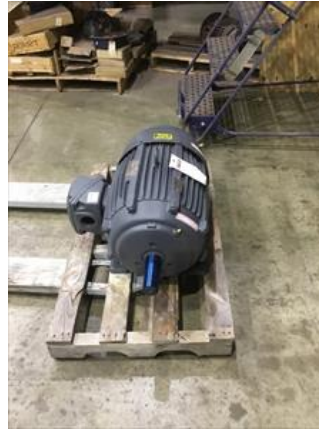
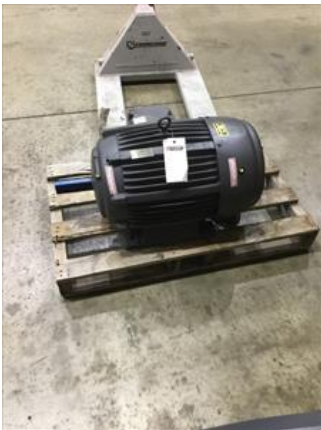
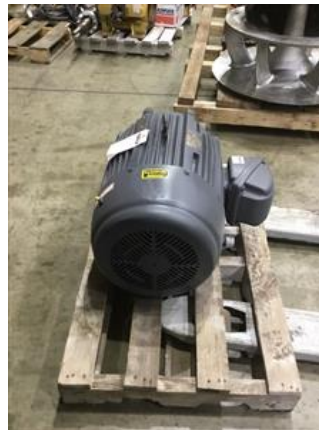
85. Document Final Condition with Pictures after paint
