## AC Inspection as Found

Tyson Foods (10914)

Location: LR MOTOR SHOP

Description: 40 HP BALDOR

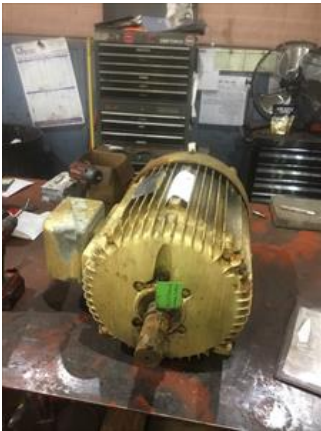
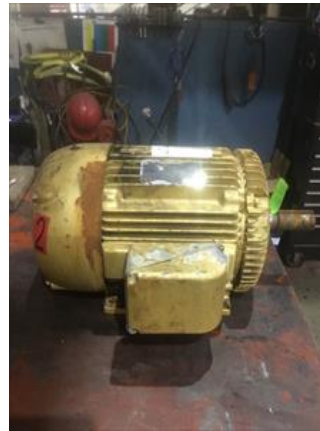
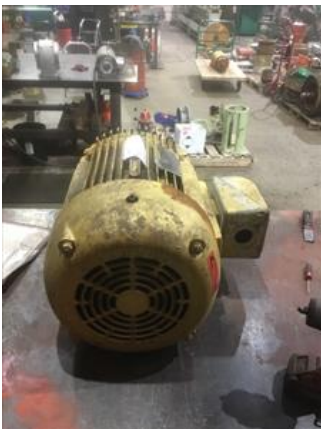
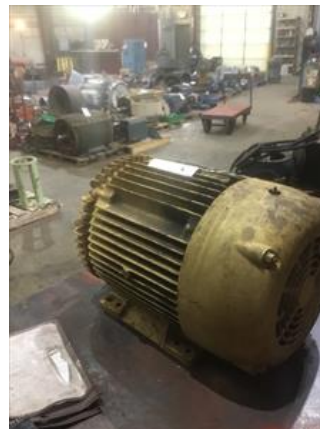
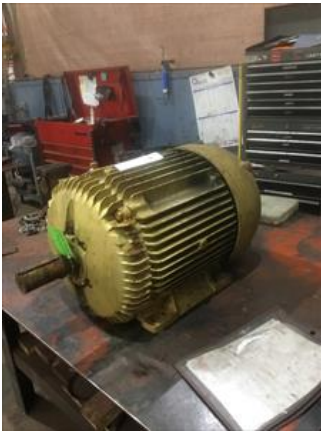
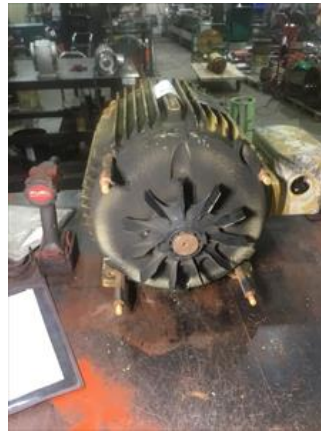
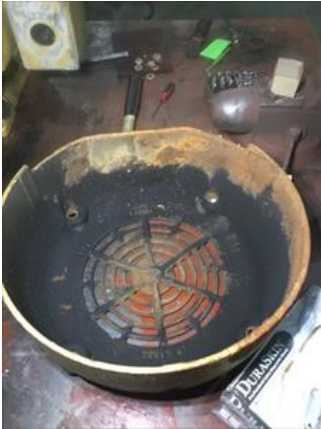
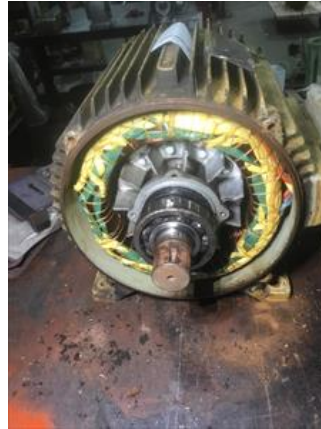
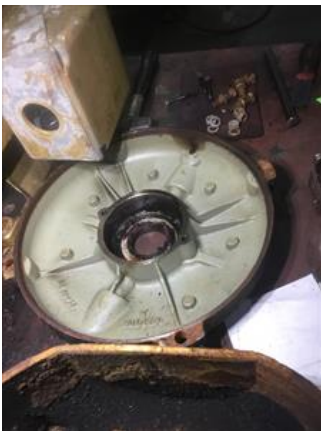
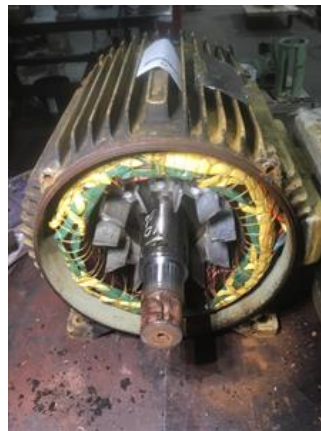
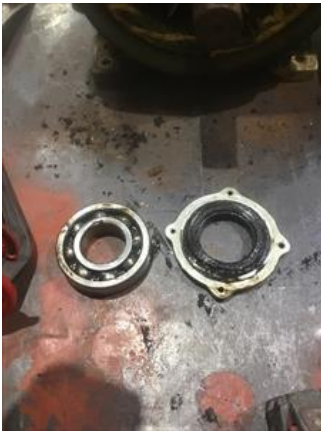
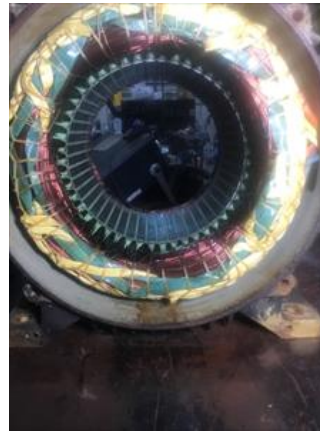
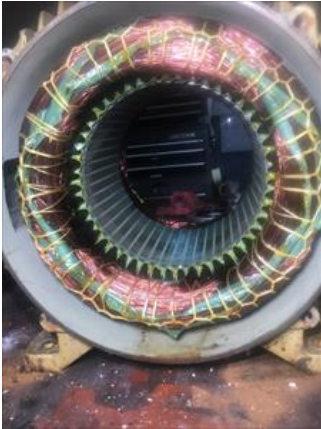
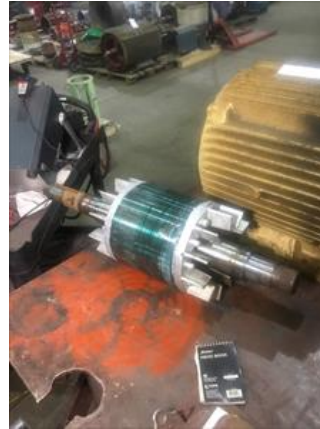
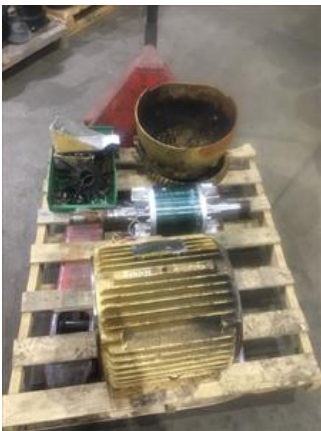
3. Photos of all six sides of the machine.

4.	Describe the Overall Condition of the Equipment as Received	
	<i>Serviceable</i>	
5.	Is this a UL Listed Motor	(No) No
6.	Is the motor water cooled or can be pressure checked before teardown	(No) No
<b>Initial Mechanical/Electrical</b>		
7.	Does Shaft Turn Freely?	(Y) Yes
8.	Does the shaft require T.I.R in Lathe to identify additional repairs?	(No) No
9.	Does Shaft Have Visible Damage?	(No) No
10.	Assembled Shaft Runout	0.002 Inches
11.	Assembled Shaft End Play	0 inches
12.	Air Gap Variation <10%

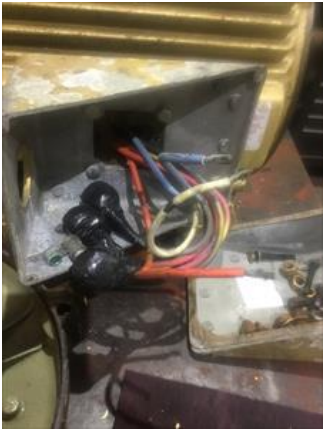
14.	Lead Length	11 Inches	
15.	Does it have Lugs?, If so what is the Stud Size?	(No) No	
16.	Lead Numbers	1-9	
17.	Are the Leads insulated with Chico or other material	(No) No	
18.	Frame Condition	pass	
19.	Fan Condition	(P) Pass	P115

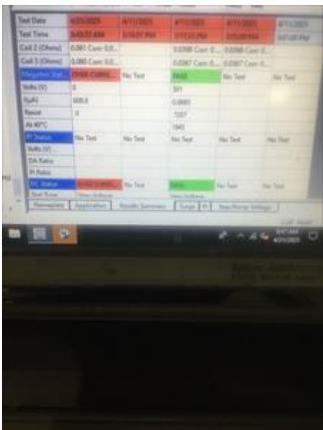
22. Insulation Resistance/Megger	Megohms	P8
----------------------------------	---------	----

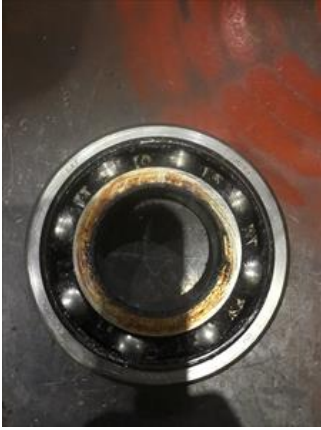
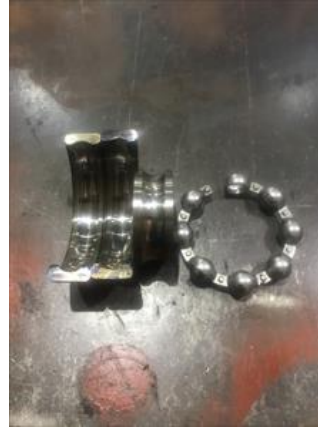
31. Drive End Bearing Qty.	1
32. Drive End Bearing Type	<b>(Ball) Ball Bearing</b>
33. Drive End Lubrication Type	<b>(Grease) Grease Lubricated</b>
34. Drive End Bearing Insulation or Grounding Device?	<b>none</b>
35. Drive End Wavy Washer/Snap-Ring Other Retention Device?	<b>none</b>
36. Drive End Bearing Condition	<b>evidence of frosting</b>
37. Opposite Drive End Bearing Brand	<b>FAG</b>

49.	Number of Rotor Bars	41	
50.	Rotor Condition	pass	
51.	List the Parts needed for the Repair Below 1) 6312/C3 1) 6311/C3 Rewind stator		
52.	Signature of Technician that Disassembled Motor	Terrence Holland

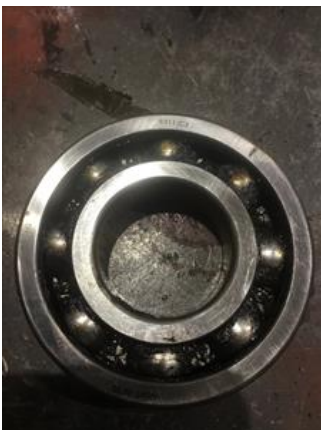
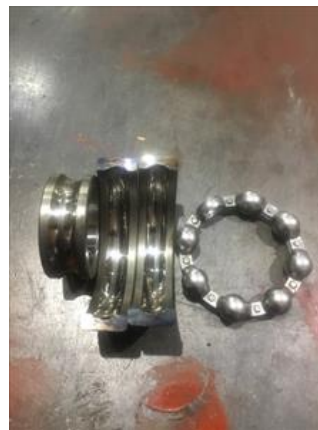
38. Opposite Drive End Bearing Number-

6311 C3

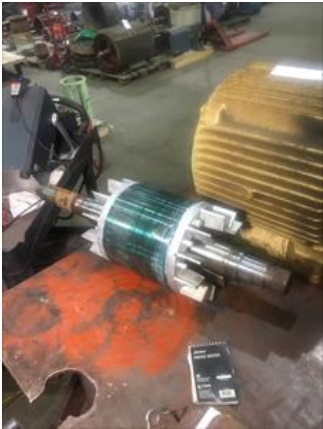
46. Opposite Drive End Seal		
<b>Rotor Inspection</b>		
47. Rotor Type/Material	(Squirrel Aluminum) Squirrel Cage Aluminum Die Cast	P3

48. Growler Test	(Pass) Pass
