## AC Inspection as Found

### Beasley Flooring (12083)

#### AC Inspection - Rev. 2

Description: 60 HP WEG

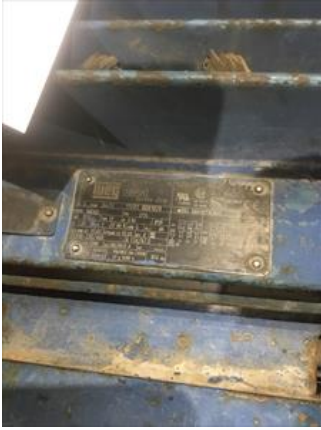
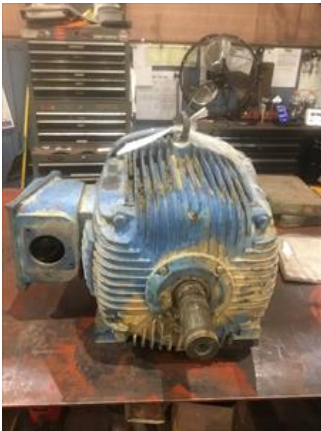
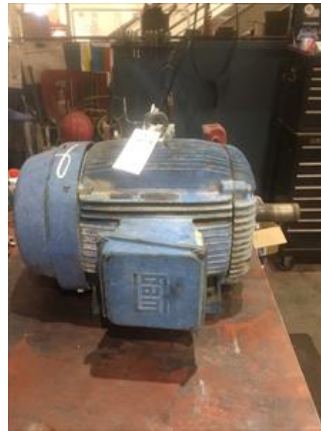
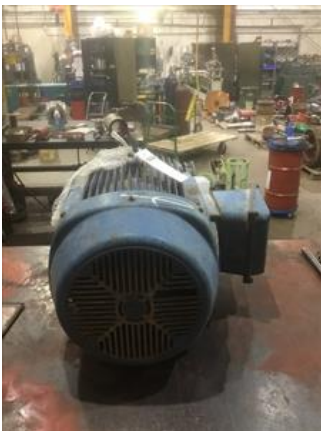
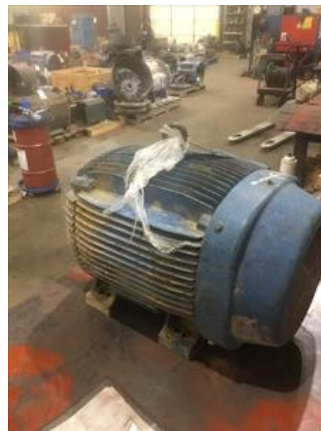
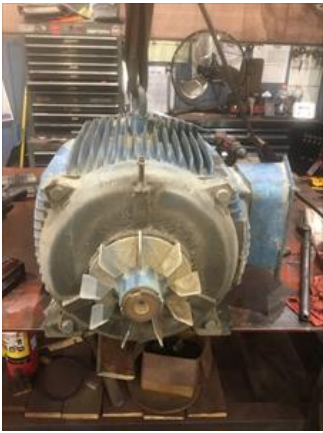
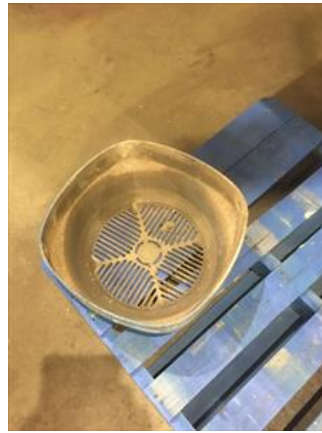
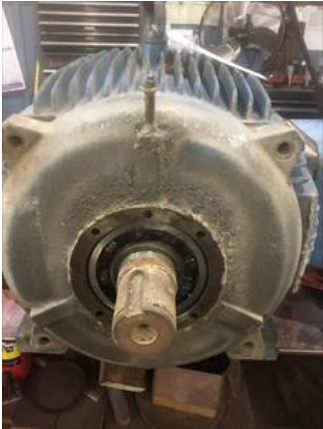
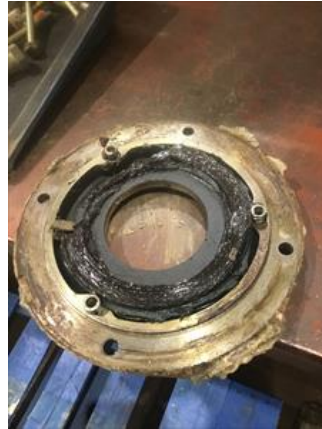
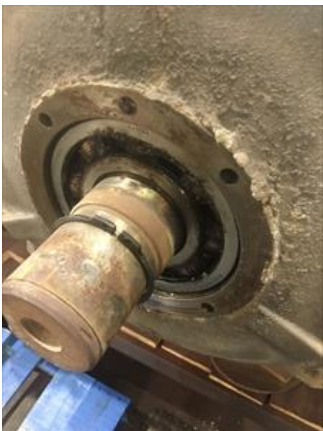
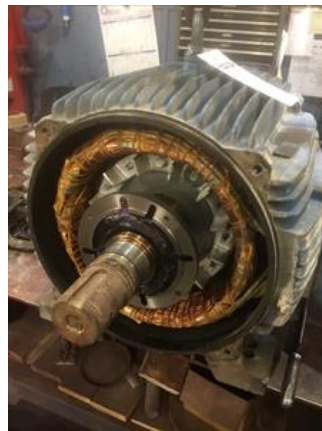
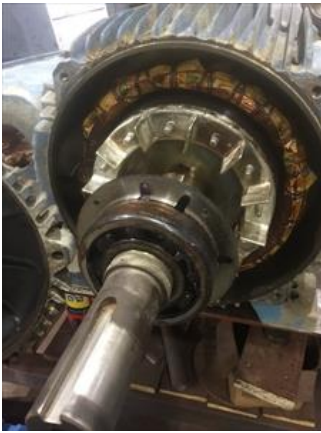
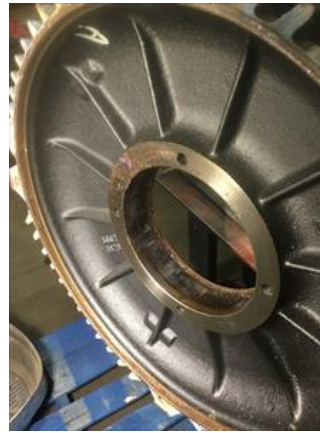
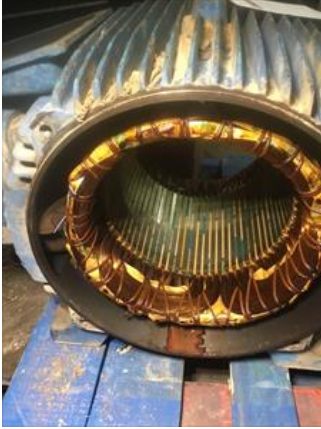
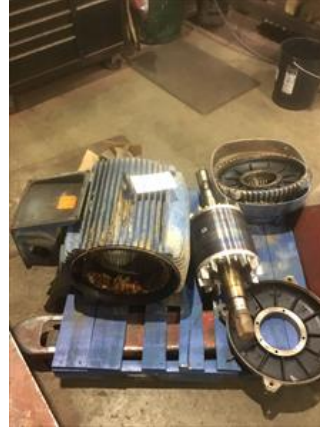
4.	Describe the Overall Condition of the Equipment as Received <i>Serviceable</i>	
5.	Is this a UL Listed Motor	(No) No
6.	Is the motor water cooled or can be pressure checked before teardown	(No) No
<b>Initial Mechanical/Electrical</b>		<input type="checkbox"/>
7.	Does Shaft Turn Freely?	(Y) Yes
8.	Does the shaft require T.I.R in Lathe to identify additional repairs?	(No) No
9.	Does Shaft Have Visible Damage?	(No) No
10.	Assembled Shaft Runout	0.001 Inches
11.	Assembled Shaft End Play	0 inches
12.	Air Gap Variation <10%

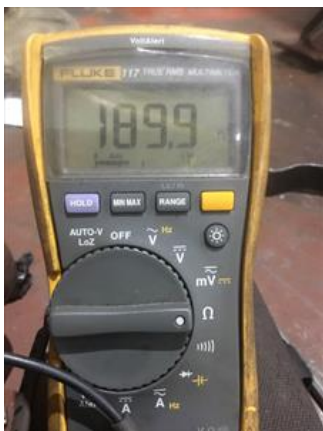
## 27. Stator Thermistors/Ohms

189.9

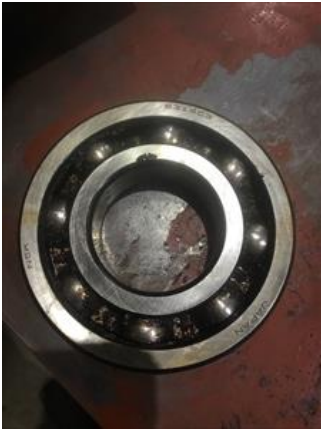
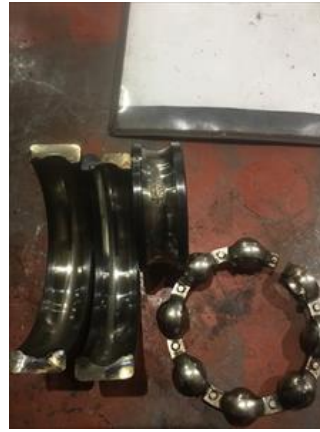
30. Drive End Bearing Number-	6314 C3
31. Drive End Bearing Qty.	1
32. Drive End Bearing Type	(Ball) Ball Bearing
33. Drive End Lubrication Type	(Grease) Grease Lubricated
34. Drive End Bearing Insulation or Grounding Device?	none
35. Drive End Wavy Washer/Snap-Ring Other Retention Device?	snap ring
36. Drive End Bearing Condition	worn
37. Opposite Drive End Bearing Brand	NSK

*Sub surface initiated fatigue in DE bearing & contaminated grease.*

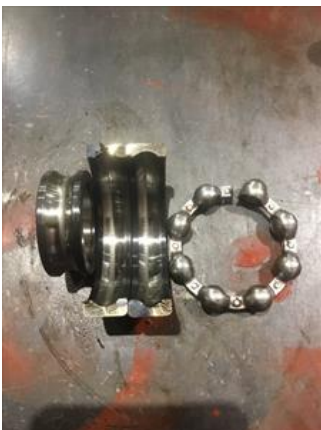
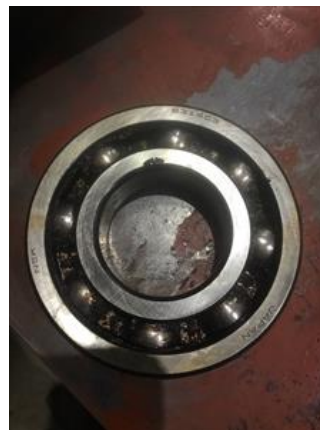
40. Opposite Drive End Bearing Type	<b>(Ball) Ball Bearing</b>	
41. Opposite Drive End Lubrication Type	<b>(Grease) Grease Lubricated</b>	
42. Opposite Drive End Bearing Insulation or Grounding Device?	<b>none</b>	
43. Opposite Drive End Wavy Washer/Snap-Ring Other Retention Device?	<b>spring loaded cap</b>	
44. Opposite Drive End Bearing Condition		P120

*Electrical fluting in ODE bearing*

*Recommend aegis grounding ring to alleviate the problem.*
