**AC Inspection as Found**  
**ARKANSAS INDUSTRIAL MACHINERY**  
3804 N. NONA ST  
NORTH LITTLE ROCK, AR 72118

**AC Inspection - Rev. 2**

Description: 75KW

Hi-Speed Job Number: 104724

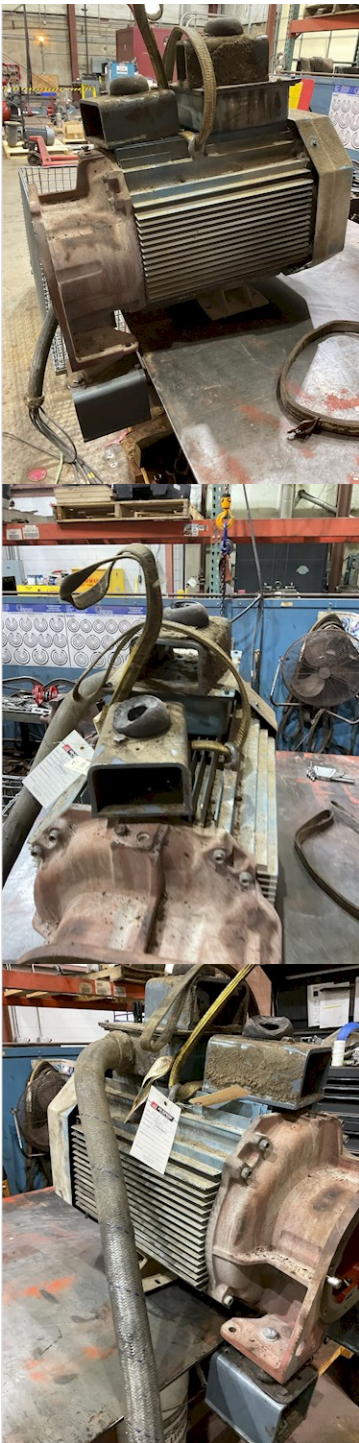
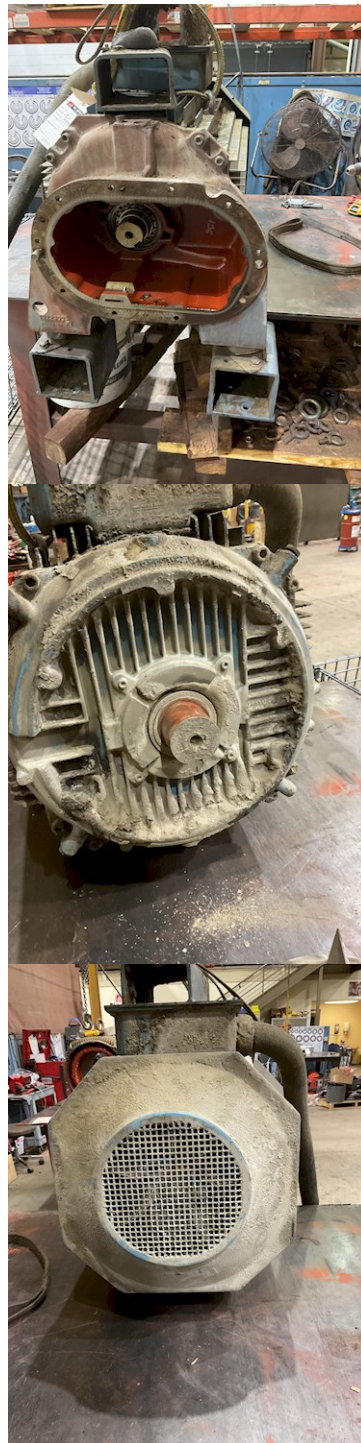
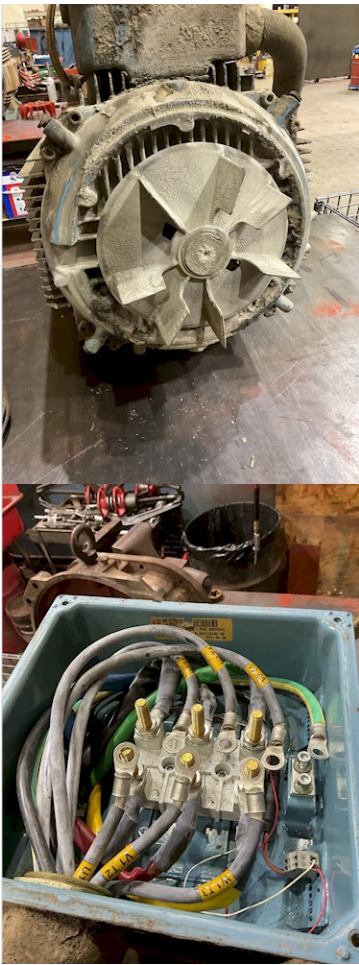
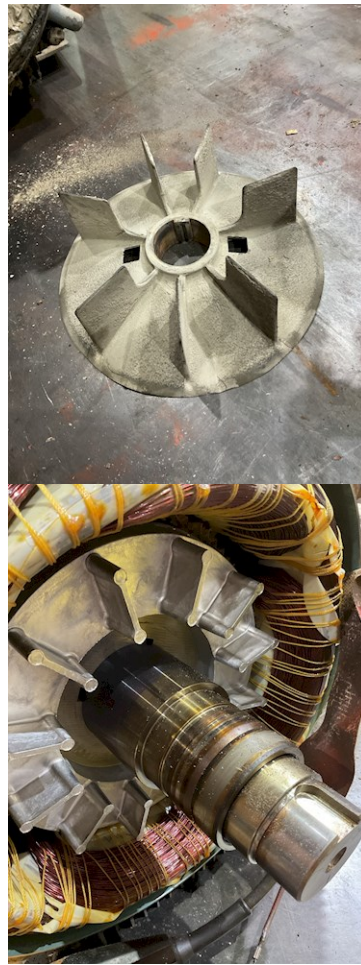
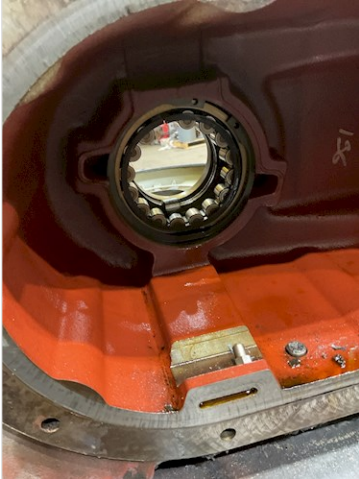
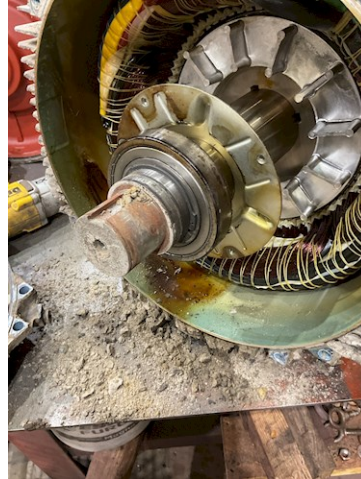
3. Photos of all six sides of the machine.

Received this way

4. Describe the Overall Condition of the Equipment as Received		
<i>Dirty but serviceable</i>		
5. Is this a UL Listed Motor	(No) No	
6. Is the motor water cooled or can be pressure checked before teardown	(No) No	
<b>Initial Mechanical/Electrical</b>		
7. Does Shaft Turn Freely?	(Y) Yes	
8. Does the shaft require T.I.R in Lathe to identify additional repairs?	(No) No	
9. Does Shaft Have Visible Damage?	(No) No	
10. Assembled Shaft Runout	0 Inches	
11. Assembled Shaft End Play	0 inches	
12. Air Gap Variation <10%		
13. Lead Condition	(P) Pass	
14. Lead Length	Inches	
15. Does it have Lugs?, If so what is the Stud Size?	(Yes) Yes	
16. Lead Numbers	1-6	
17. Are the Leads insulated with Chico or other material	(No) No	
18. Frame Condition	pass	
19. Fan Condition	(P) Pass	P119
20. Does motor have internal fan?	(No) No	
21. Broken or Missing Components	No

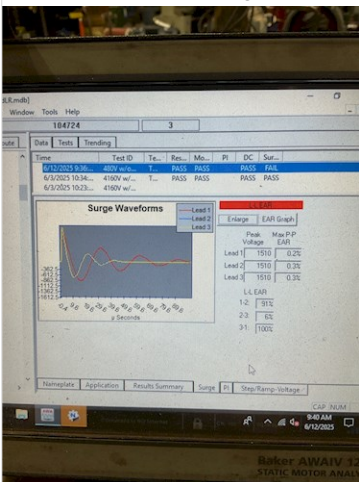
22.	Insulation Resistance/Megger	7392 Megohms	
23.	Winding Resistance		
	1-2	1-3	2-3
	0.0204	0.0207	0.0201
24.	Perform Surge Test	(F) Fail	P57

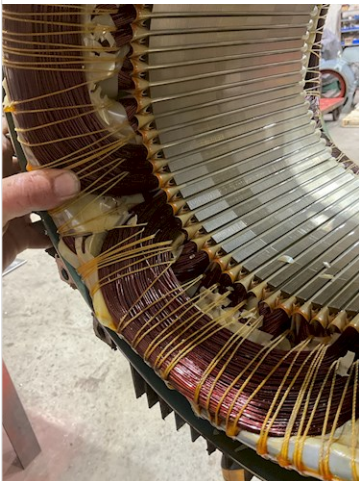
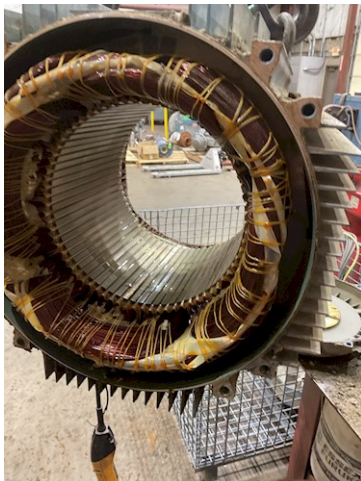
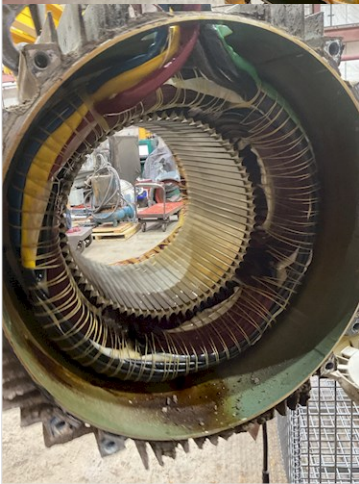
25.	Number of Stator Slots	72	
26.	Stator Condition	rewind .winding shorted internal	
	Insulation is brittle

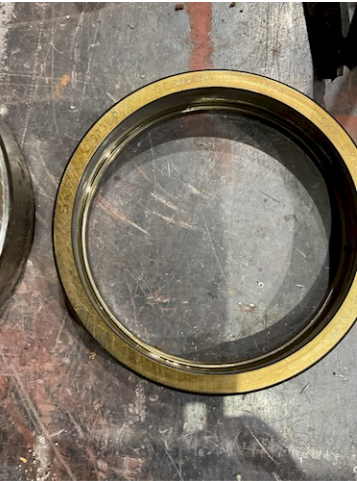
29. Drive End Bearing Brand	SKF	
30. Drive End Bearing Number-	NU213EC	P32

1-NU213C4 roller.bearing  
2-6215 ZZ C4 bearing

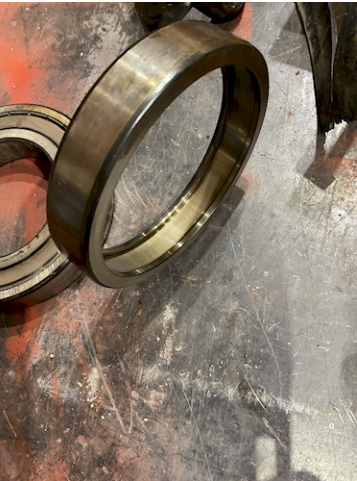
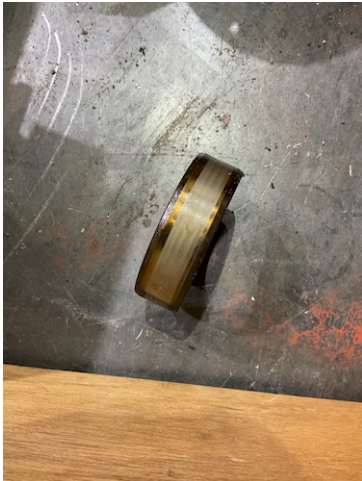
31. Drive End Bearing Qty.	1	
32. Drive End Bearing Type	(Roller) Roller Bearing	
33. Drive End Lubrication Type	(Oil) Oil Lubricated	
34. Drive End Bearing Insulation or Grounding Device?	NA	
35. Drive End Wavy Washer/Snap-Ring Other Retention Device?	SNAP RING	
36. Drive End Bearing Condition	FLUTING	P83
<div>

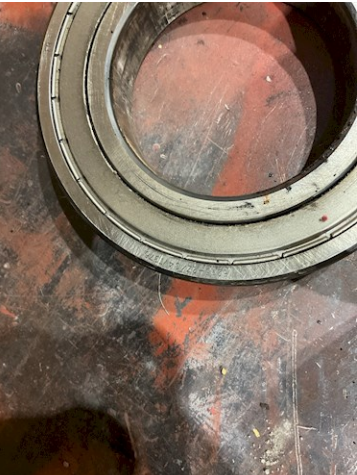
</div>		
37. Opposite Drive End Bearing Brand	SKF	
38. Opposite Drive End Bearing Number-	6215 ZZ C4	P101

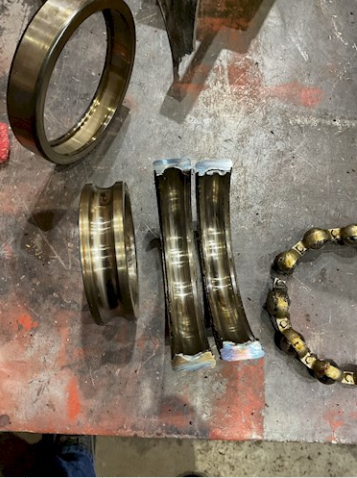
39.	Opposite Drive End Bearing Qty.	1	
40.	Opposite Drive End Bearing Type	(Ball) Ball Bearing	
41.	Opposite Drive End Lubrication Type	(Grease) Grease Lubricated	
42.	Opposite Drive End Bearing Insulation or Grounding Device?	na	
43.	Opposite Drive End Wavy Washer/Snap-Ring Other Retention Device?	Snap ring	
44.	Opposite Drive End Bearing Condition	axial load and some frosting	P120

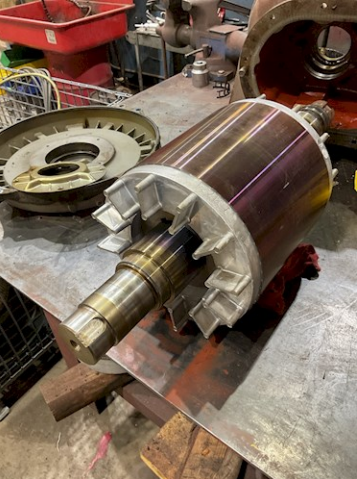
47.	Rotor Type/Material	(Squirrel Aluminum) Squirrel Cage Aluminum Die Cast	P3

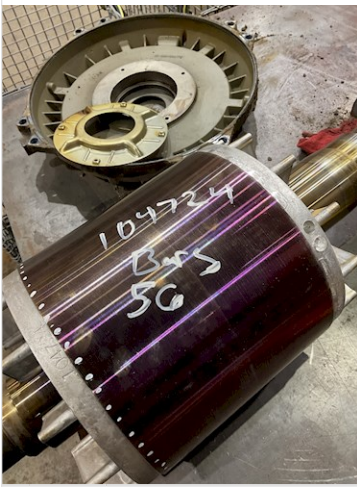
48.	Growler Test	(Pass) Pass

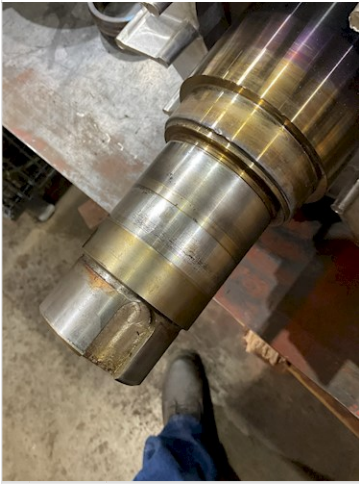
58. Drive End Bearing Shaft Fit Condition

(P) Pass

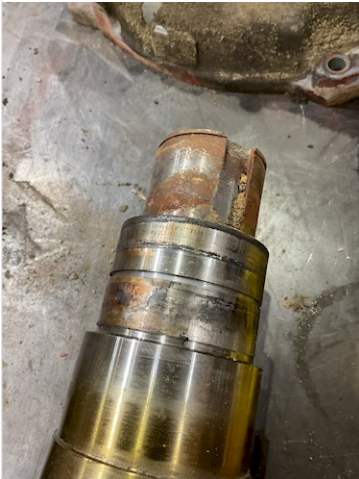
60. Opposite Drive End Bearing Shaft Fit Condition

(P) Pass

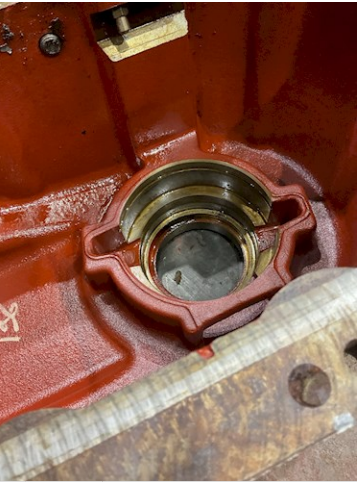
62. Drive End - Endbell Bearing Fit

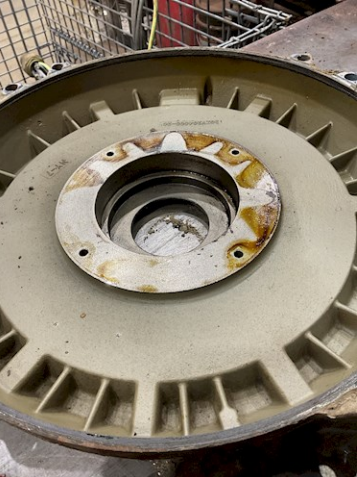
64. Opposite Drive End - Endbell Bearing Fit			
0 Degrees	60 Degrees	120 Degrees	
5.1186	5.1186	5.1186

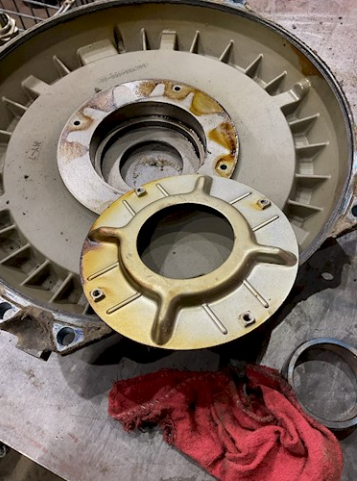
66. Bearing Cap Condition				P52
Drive End Bearing Cap	Opposite Drive End Bearing Cap			
	pass

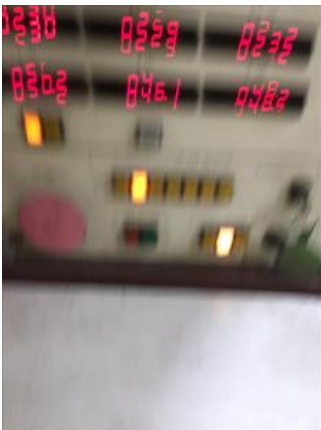
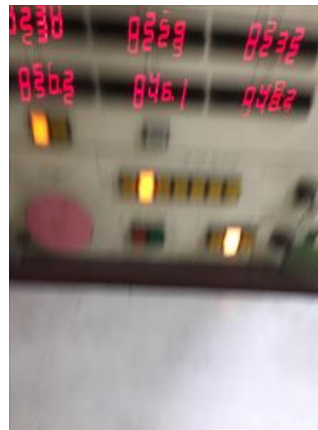
89. Test Run Voltage

**230**

**229**

**232**
