AC Inspection as Found

Sage V Foods

AC Inspection - Rev. 2

Description: 60 HP NIDEC MR W PUMP

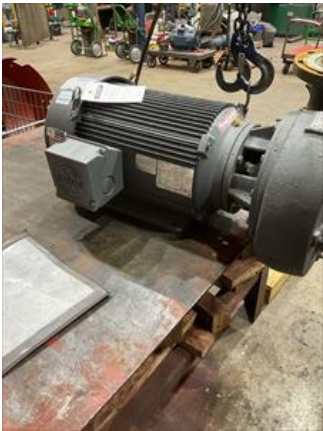
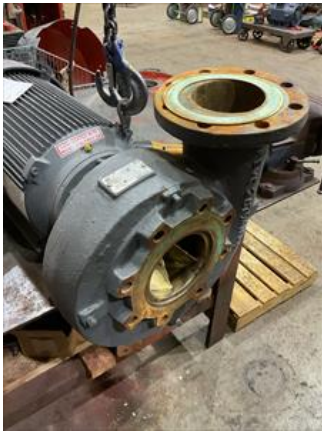
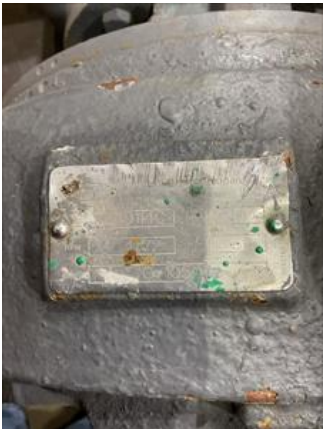
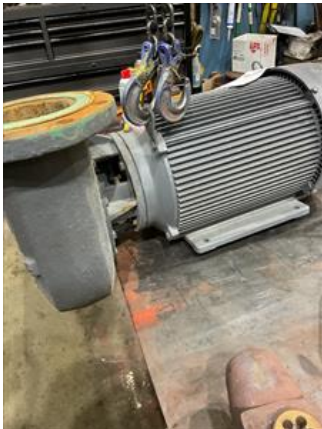
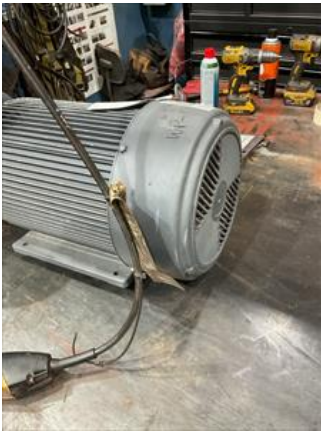
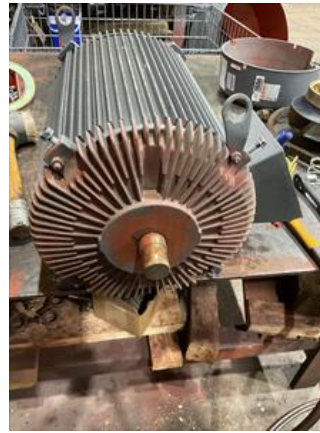
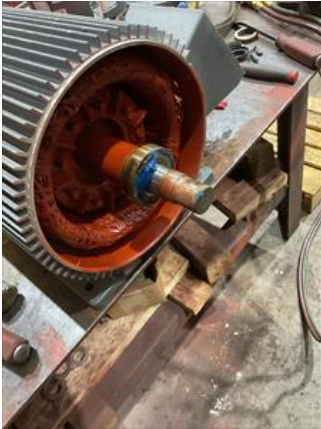
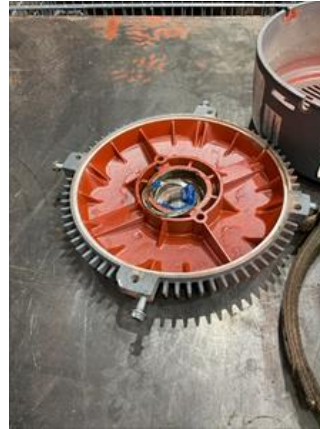
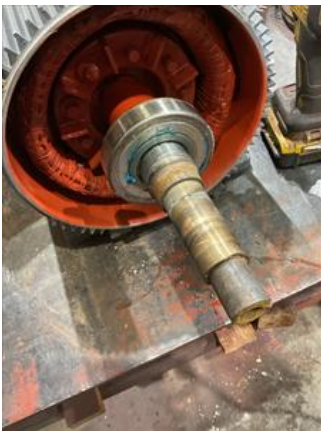
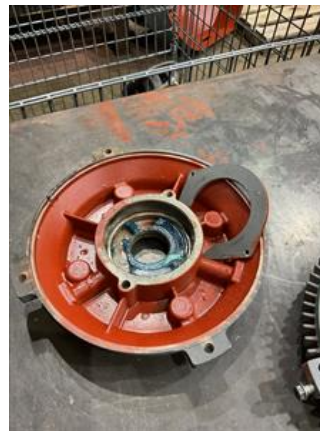
3. Photos of all six sides of the machine.

| 4. | Describe the Overall Condition of the Equipment as Received | |
| | <i>Serviceable</i> | |

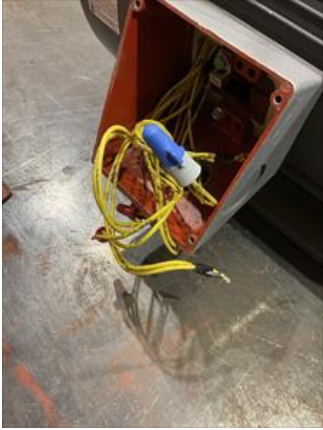
| ● 14. | Lead Condition | (P) Pass | |
| 15. | Lead Length | 16 Inches | P88 |

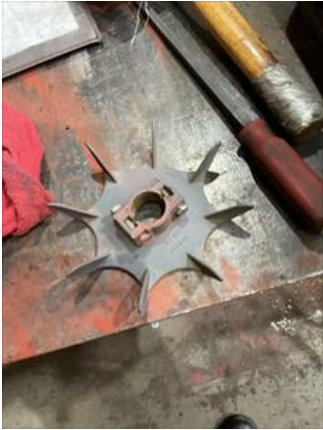
| ● 20. | Fan Condition | (P) Pass | P119 |

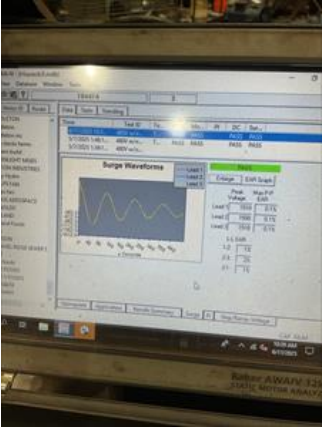
| 25. Perform Surge Test | (P) Pass | P57 |

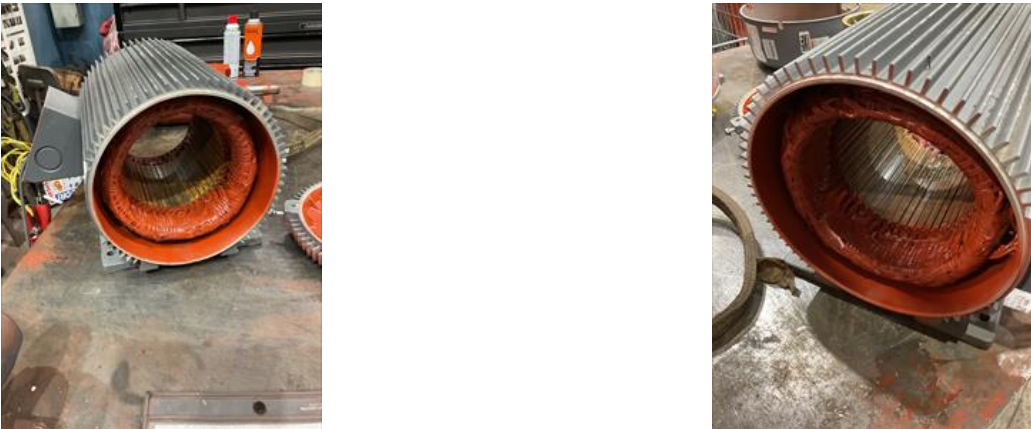
| 27. Stator Condition | wash and dry | P85 |

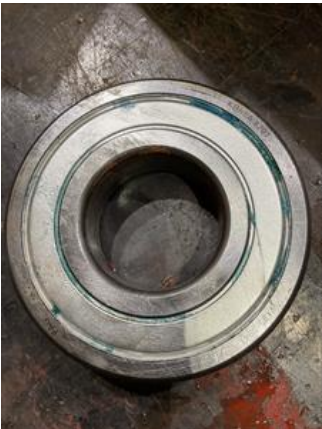
| 31. Drive End Bearing Number- | 6310 ZZ C3 | P32 |

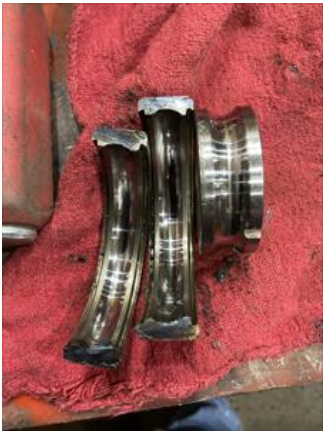
| 37. | Drive End Bearing Condition | water contamination and metal fatigue | P83 |
| 45. | Opposite Drive End Bearing Condition | the start of frosting | P120 |

Pump seal failed and leaked water in to the motor and bearings

*Seal leaking causing bearing failure***Dynamic Balance Report**

1-6310ZZ C3 BEARING
2-6207ZZ C3 BEARING

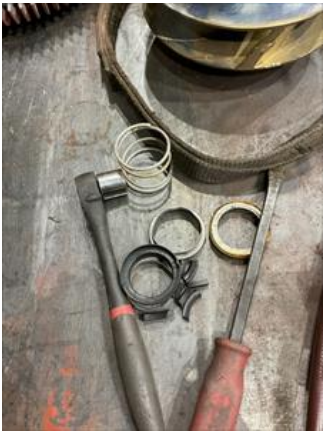
P123

46. Drive End Seal
 Shaft 1.500 seat 2.136

carbon ceramic

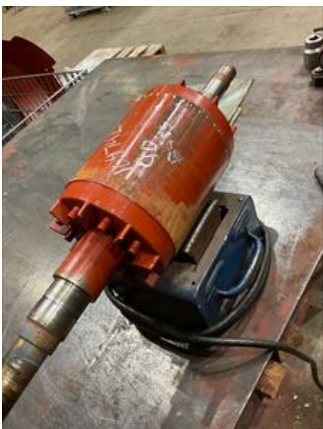
P3

48. Rotor Type/Material

(Squirrel Aluminum) Squirrel
 Cage Aluminum Die Cast

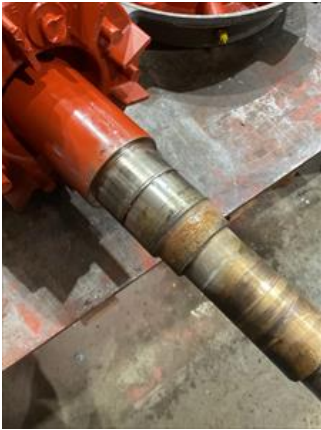
P81

59. Drive End Bearing Shaft Fit Condition

(P) Pass

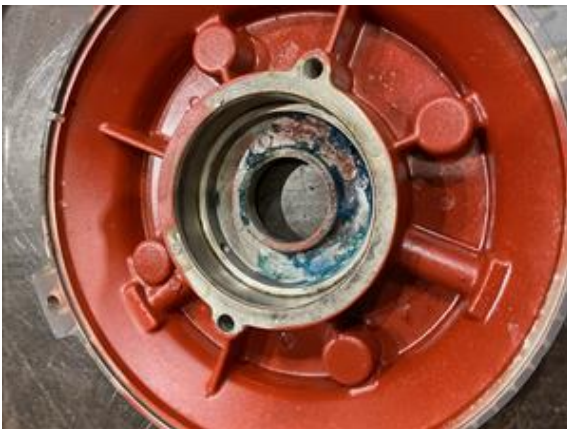
P15

64. Drive End - Endbell Bearing Fit Condition

(P) Pass

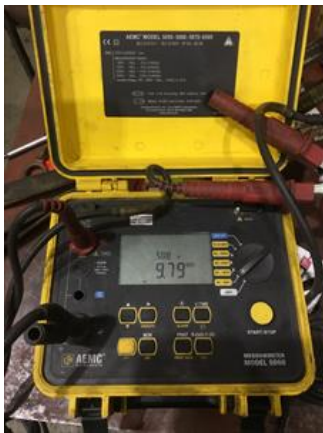
P200

79. Final Insulation Resistance Test

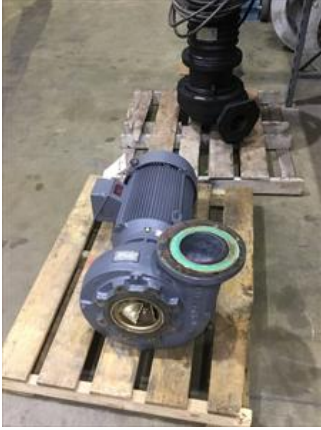
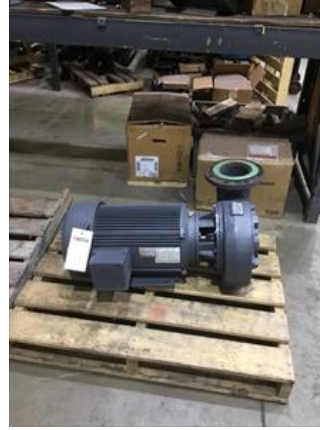
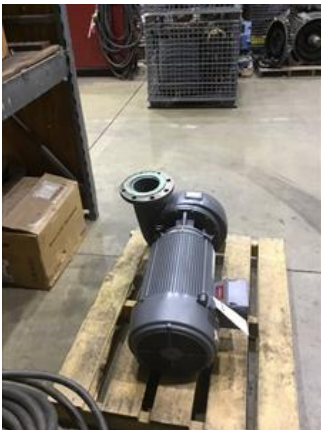
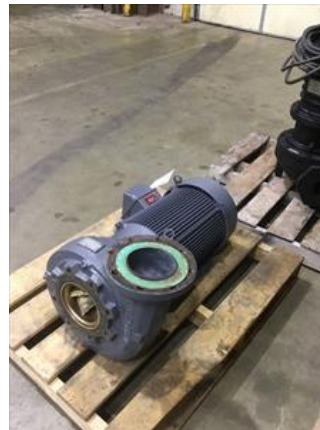
90. Document Final Condition with Pictures after paint
