Submersible Pump Repair Report

Georg Fischer Sloane (10754-GFS)
7777 Sloane Drive
Little Rock, AR 72206

Description: 3 HP PENTAIR SUBMERSIBLE PUMP

Model: 3WHU30M4-P3

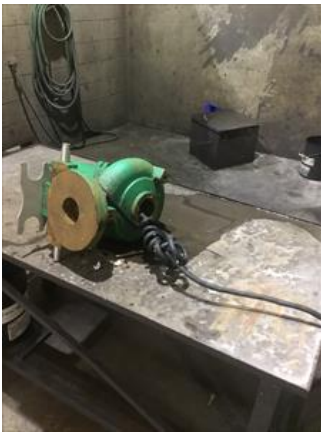
P37

7. Power Cord Condition

(F) Fail

Power cord was entangled in the impeller.

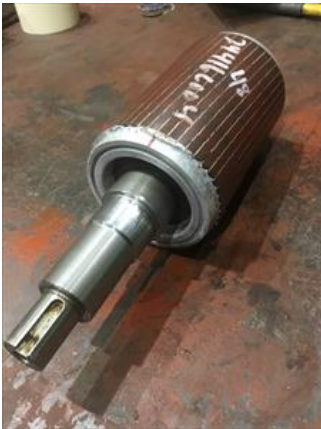
P94

Power cord cut from impeller.
Seal Ned's to be replaced

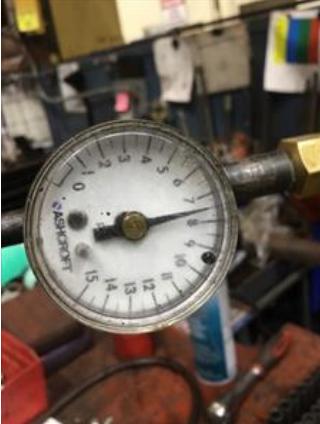
Balancing Report		
117. Balance Type		
118. Balance Operating Speed	RPM	
119. Start Left End	Mills	
120. Start Right End	Mills	
121. Balancing Specification		
122. Finish Left End	Mills	
123. Finish Right End	Mills	
124. Service Technician		
Assembly and Final Test		
125. Rotor and Impeller Balanced		
● 126. Stator Housing Refilled with Oil (if required)	(Y) Yes	
● 127. Stator Pressure Test	(P) Pass	P29

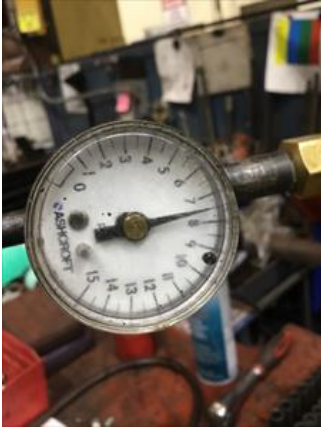
After 7 minutes

129. Time Under Pressure	7 min		
130. Overload Continuity	(N) NA		
131. Water Sensor Open?			
132. Meggar Testing Reading	Mohm		P61

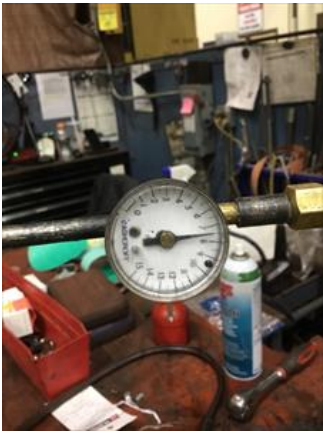
7 min. No leaks.

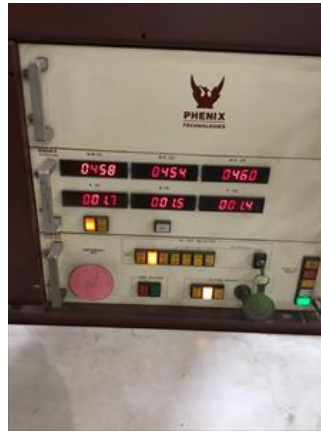
Finale run
