## AC Inspection as Found

Hormel (11974)  
8201 Fraizer Pike  
Little Rock, AR 72206

### AC Inspection - Rev. 2

Location: LR MOTOR SHOP  
Serial Number: TYPE-AEHH8N  
Description: 100 HP TECO WESTINGHOUSE

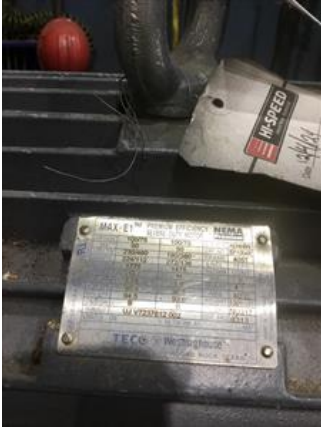
2. Nameplate Picture

P38

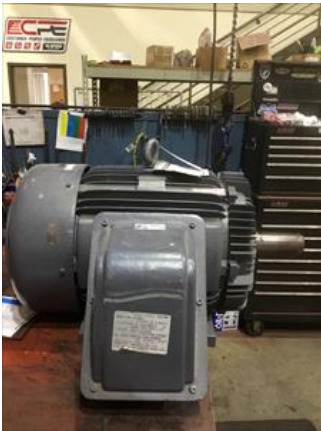
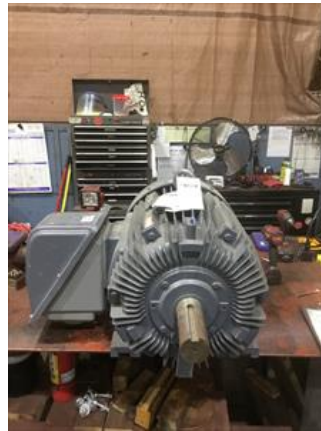
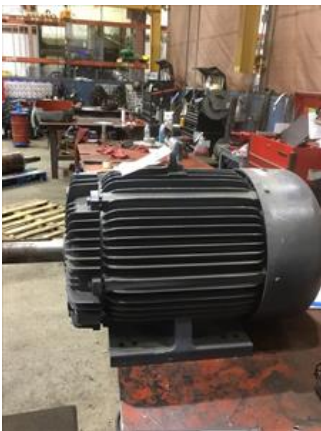
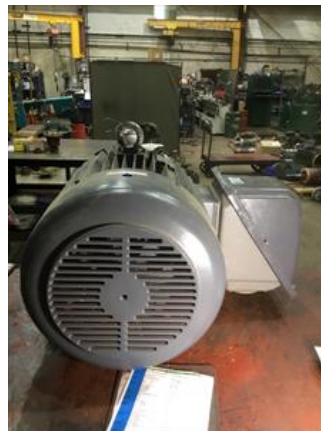
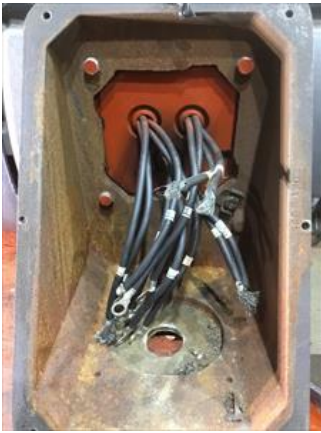
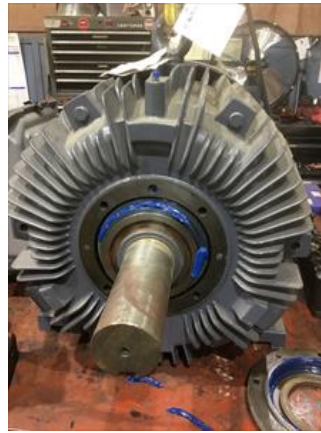
3. Photos of all six sides of the machine.

P46

4.	Describe the Overall Condition of the Equipment as Received	
	<i>Serviceable</i>	
5.	Is this a UL Listed Motor	(NO) NO
6.	Is the motor water cooled or can be pressure checked before teardown	(NO) NO
<b>Initial Mechanical/Electrical</b>		<input type="checkbox"/>
7.	Does Shaft Turn Freely?	(Y) Yes
8.	Does the shaft require T.I.R in Lathe to identify additional repairs?	(NO) NO
9.	Does Shaft Have Visible Damage?	(No) No
10.	Assembled Shaft Runout	0 Inches
11.	Assembled Shaft End Play	0 inches
12.	Air Gap Variation <10%

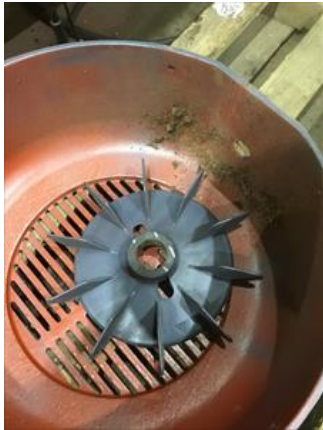
13.	Lead Condition	(P) Pass	
14.	Lead Length	10.5 Inches	
15.	Does it have Lugs?, If so what is the Stud Size?	(YES) YES	
16.	Lead Numbers	1-12	
17.	Are the Leads insulated with Chico or other material	(NO) NO	
18.	Frame Condition	pass	
19.	Fan Condition	(P) Pass	P121

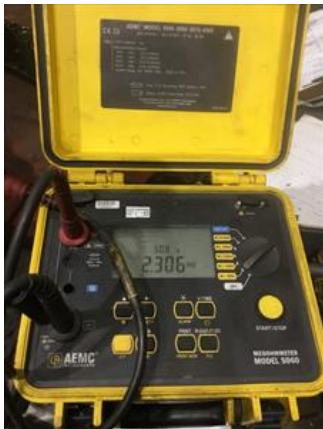
22.	Insulation Resistance/Megger	2.306 Megohms	P8
-----	------------------------------	---------------	----

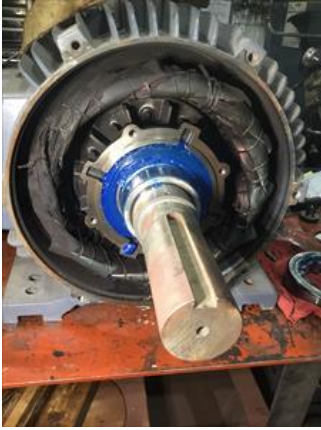
23.	Winding Resistance		
	1-2	1-3	2-3

*Coil to coil short.*

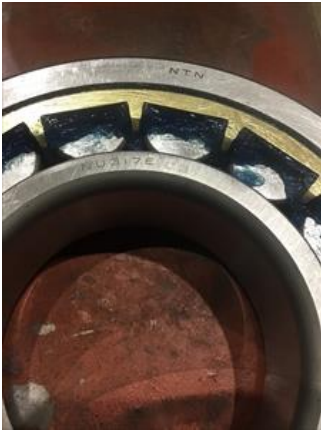
29. Drive End Bearing Brand	NTN	P12
-----------------------------	-----	-----

34.	Drive End Bearing Insulation or Grounding Device?		
35.	Drive End Wavy Washer/Snap-Ring Other Retention Device?	none	
36.	Drive End Bearing Condition	replace

48.	Growler Test	(Pass) Pass	
49.	Number of Rotor Bars	48	
50.	Rotor Condition	pass	
51.	List the Parts needed for the Repair Below		
	1) NU 317E		
	1) 6313 C3

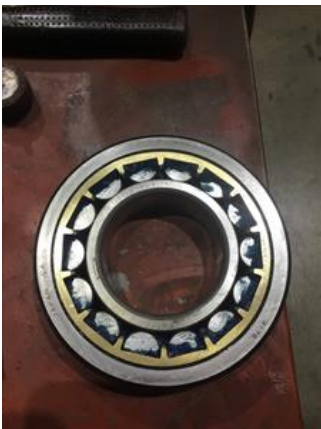
30.	Drive End Bearing Number-	NU 317 E	
31.	Drive End Bearing Qty.	1	
32.	Drive End Bearing Type	(Roller) Roller Bearing	P50

44.	Opposite Drive End Bearing Condition	replace	
45.	Drive End Seal		
46.	Opposite Drive End Seal		
<b>Rotor Inspection</b>			
47.	Rotor Type/Material	(Squirrel Aluminum) Squirrel Cage Aluminum Die Cast
