## AC Inspection as Found

**Scepter**  
1485 SCEPTER LN  
WAVERLY, TN 37185

### AC Inspection - Rev. 2

Location: Cast House

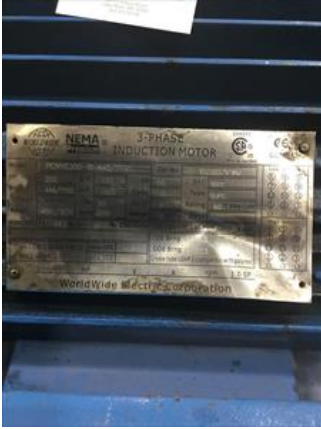
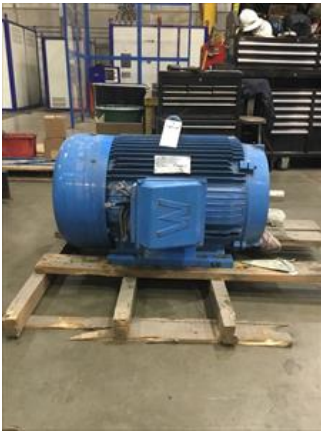
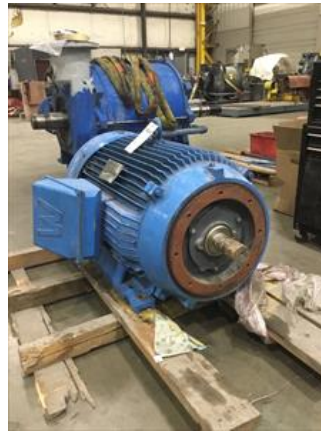
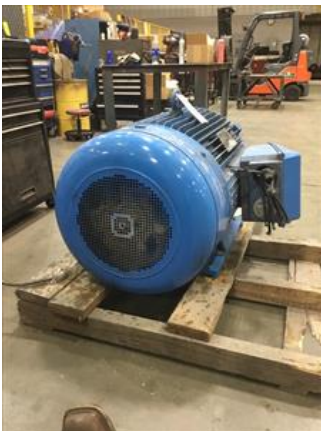
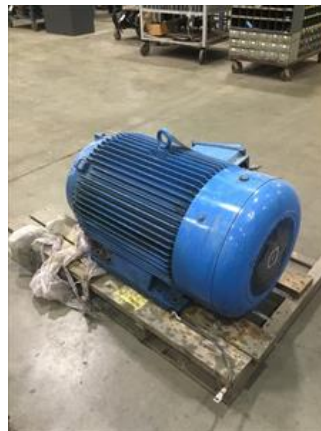
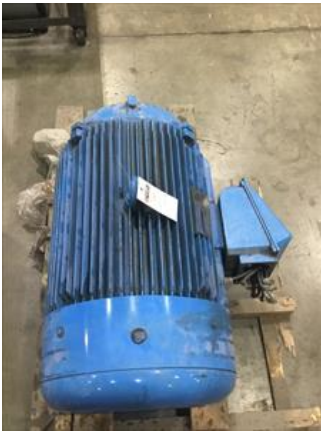
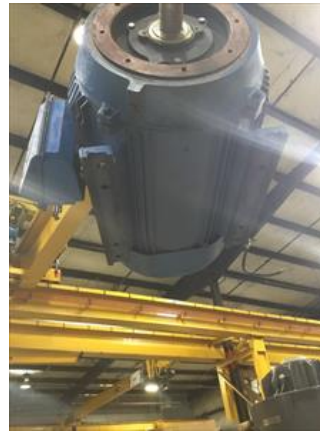
*Recon with 2 B&B*

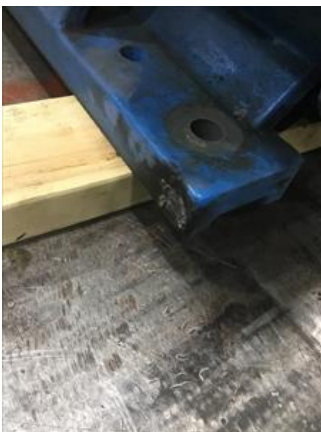
P18

5.	Does Shaft Turn Freely?	(Y) Yes
6.	Does the shaft require T.I.R in Lathe to identify additional repairs?	(No) No
7.	Does Shaft Have Visible Damage?	(No) No
8.	Assembled Shaft Runout	0.001 Inches
9.	Assembled Shaft End Play	0.002 inches
10.	Air Gap Variation <10%	no provision for measurement
11.	Lead Condition	(P) Pass
12.	Lead Length	18 Inches
13.	Does it have Lugs?, If so what is the Stud Size?	(No) No
14.	Lead Numbers	1-12
15.	Frame Condition	good
16.	Fan Condition	(P) Pass
17.	Does motor have internal fan?	(No) No
18.	Broken or Missing Components	grounding stud

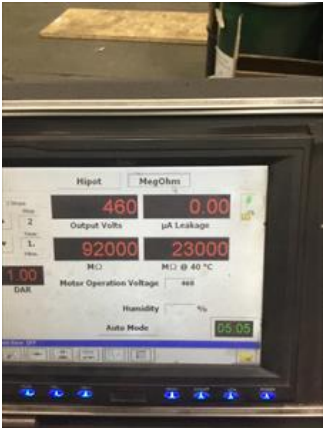
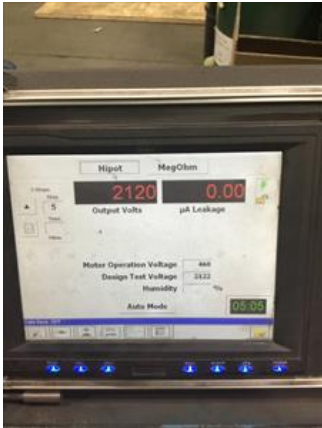
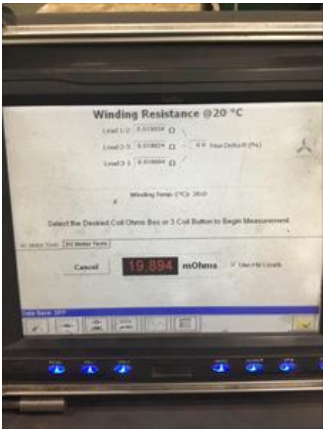
1-2	1-3	2-3
.019934	.019824	.019894

22. Number of Stator Slots	48
23. Stator Condition	good
24. Stator Thermistors/Ohms	N/A
25. Stator Overloads/Ohms	N/A

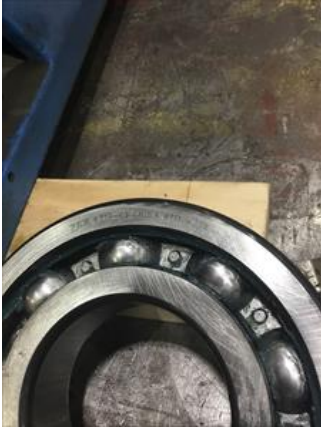
28. Drive End Bearing Qty.	1
29. Drive End Bearing Type	(Ball) Ball Bearing
30. Drive End Lubrication Type	(Grease) Grease Lubricated
31. Drive End Bearing Insulation or Grounding Device?	none present
32. Drive End Wavy Washer/Snap-Ring Other Retention Device?	none present
33. Drive End Bearing Condition	normal wear

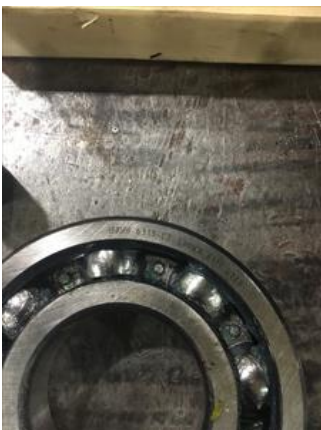
P35

34. Opposite Drive End Bearing Brand	FAG
35. Opposite Drive End Bearing Number-	6313 zz c3

44.	Rotor Type/Material	(Squirrel Aluminum) Squirrel Cage Aluminum Die Cast	
45.	Growler Test	(Pass) Pass	
46.	Number of Rotor Bars	44	
47.	Rotor Condition	good	
48.	List the Parts needed for the Repair Below 1- 6313 zz c3 bearing 1- RB 95-115-5.5 slinger with metal housing 1- 6319 zz c3 bearing		
49.	Signature of Technician that Disassembled Motor	Nigel Hill

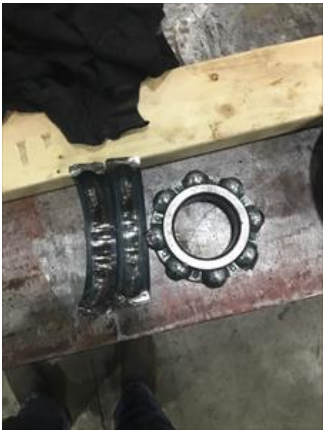
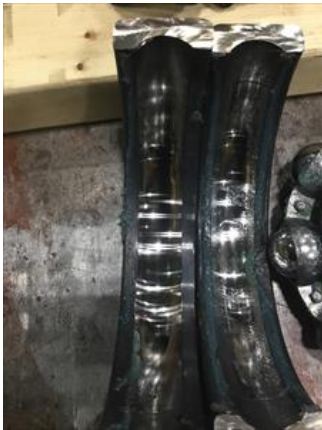
38.	Opposite Drive End Lubrication Type	(Grease) Grease Lubricated	
39.	Opposite Drive End Bearing Insulation or Grounding Device?	none present	
40.	Opposite Drive End Wavy Washer/Snap-Ring Other Retention Device?	Snap-ring outboard bearing	
41.	Opposite Drive End Bearing Condition	normal wear	P41

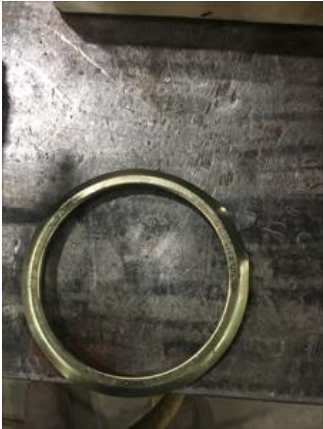
42.	Drive End Seal	RB 95-115-5.5	P42
-----	----------------	---------------	-----

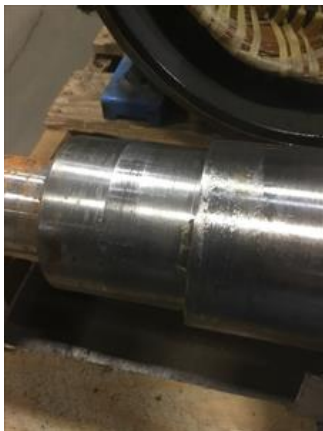
51.	Rotor Runout		
	Drive End Bearing Fit	Rotor Body	Opposite Drive End Bearing
52.	Coupling Fit Closest to Bearing Housing		
	0 Degrees	90 Degrees	120 Degrees
	2.375	2.375	2.375
53.	Coupling Fit Closest to the end of the Shaft		
	0 Degrees	60 Degrees	120 Degrees
	2.375	2.375	2.375
54.	Drive End Bearing Shaft Fit		
	0 Degrees	60 Degrees	120 Degrees
	3.7405	3.7405	3.7405
	Tolerance is 3.7403-3.7409

55.	Drive End Bearing Shaft Fit Condition		(P) Pass
56.	Opposite Drive End Bearing Shaft Fit		P56
	0 Degrees	60 Degrees	120 Degrees
	2.5595	2.5595	2.5595
	Tolerance is 2.5592-2.5597

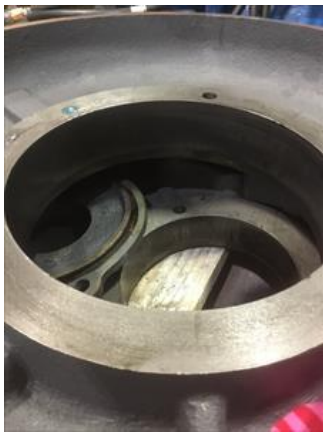
59.	Drive End - Endbell Bearing Fit			P59
	0 Degrees	60 Degrees	120 Degrees	
	7.8765	7.8765	7.8765	
	Tolerance is 7.8740-7.8751

60.	Drive End - Endbell Bearing Fit Condition			(F) Fail
61.	Opposite Drive End - Endbell Bearing Fit			P61
	0 Degrees	60 Degrees	120 Degrees	
	5.5138	5.5137	5.514	
	Tolerance is 5.5118-5.5128

62.	Opposite Drive End - Endbell Bearing Fit Condition			(F) Fail
63.	Bearing Cap Condition			
	Drive End Bearing Cap	Opposite Drive End Bearing Cap		
	Pass	Pass		
64.	End Bell Air Seal Fits			
	Drive End Air Seal	Opposite Drive End Air Seal		
	Pass	Pass		
65.	List Machine Work Needed Below			
	Bore and bush both end bells.			
66.	Technician			Brandon Woodard
