## AC Inspection as Found

MOTOR - KTG USA

### AC Inspection - Rev. 2

Description: 75 HP AC

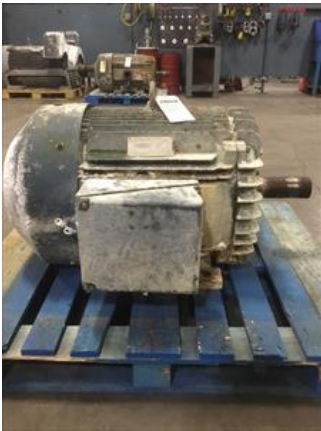
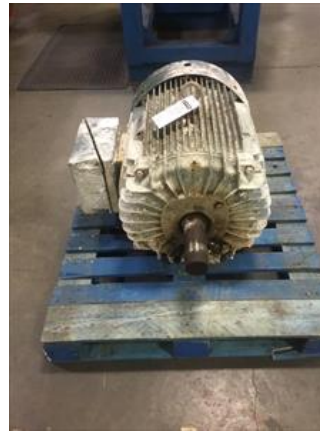
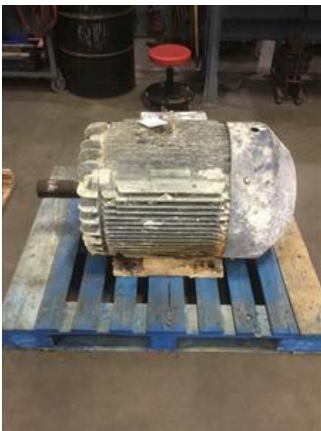
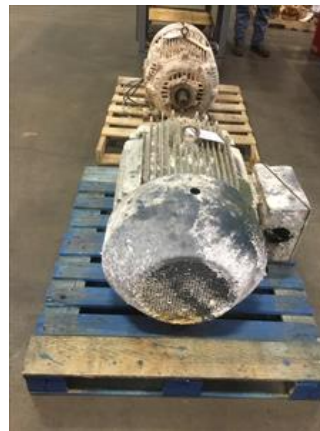
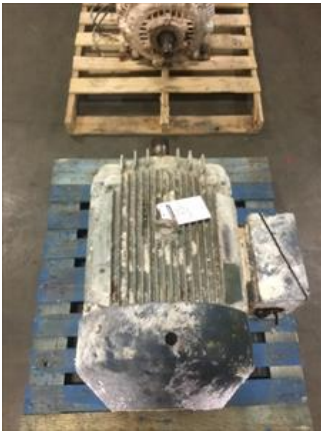
3. Photos of all six sides of the machine.

4. Describe the Overall Condition of the Equipment as Received  
*Passed all electrical tests. Requires machine work to all 4 bearing fits.*

64.	End Bell Air Seal Fits	
	Drive End Air Seal	Opposite Drive End Air Seal
	Pass	Pass
65.	List Machine Work Needed Below <i>Repair all 4 bearing fits. Double check bearing shoulder depths due to bearings spinning on the shaft.</i>	
66.	Technician	Brandon Woodard

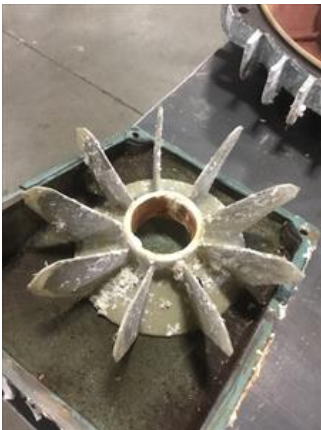
*Fan saw excessive heat from bearing failure and cracked.*

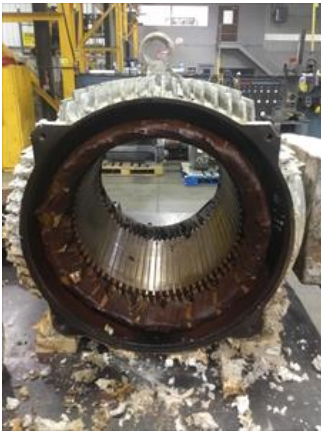
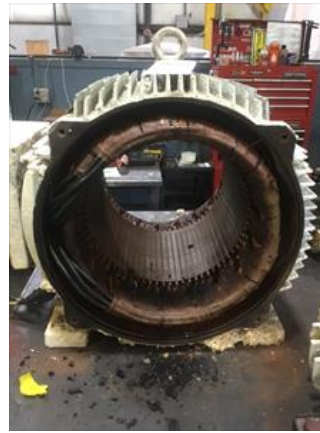
## 23. Stator Condition

Pass

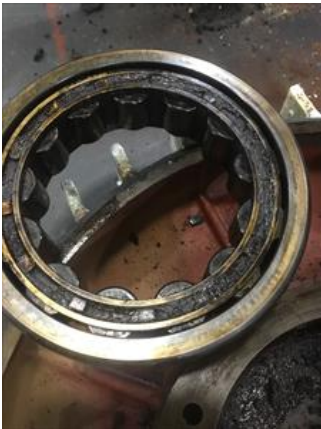
P26

26. Drive End Bearing Brand

C&U

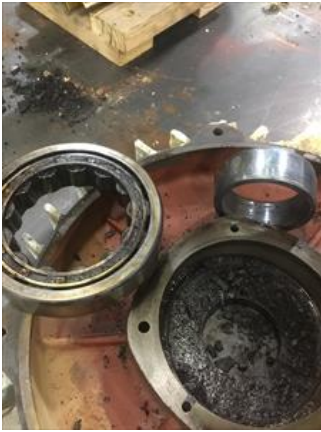
P33

33. Drive End Bearing Condition

Destroyed

Locked up from heat and old grease

47.	Rotor Condition	Pass
48.	List the Parts needed for the Repair Below NU318 6317 C3 VA85 VA90	
49.	Signature of Technician that Disassembled Motor	Brandon Woodard

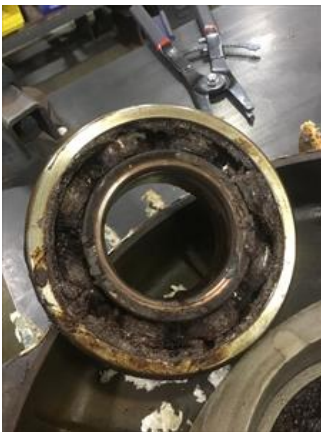
P34

34. Opposite Drive End Bearing Brand

ZEZ

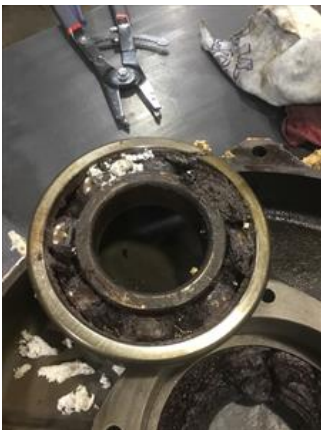
P41

41. Opposite Drive End Bearing Condition

destroyed

Locked up from heat and old grease. Spun on shaft

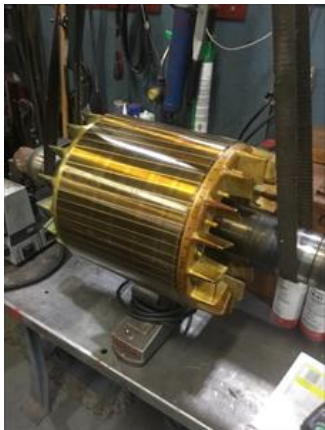
44.	Rotor Type/Material	(Squirrel Aluminum) Squirrel Cage Aluminum Die Cast
45.	Growler Test	(Pass) Pass
46.	Number of Rotor Bars	58 P46

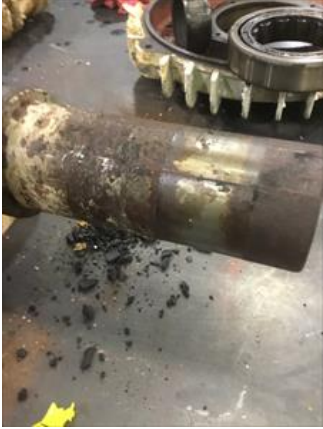
P52

## 52. Coupling Fit Closest to Bearing Housing

0 Degrees	90 Degrees	120 Degrees
2.875	2.875	2.875

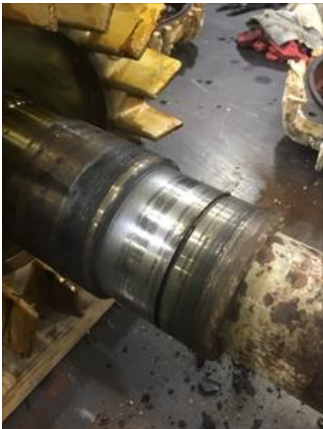
P54

## 54. Drive End Bearing Shaft Fit

0 Degrees	60 Degrees	120 Degrees
3.5402

🗨 Tolerance is 3.5442-3.5451

(F) Fail

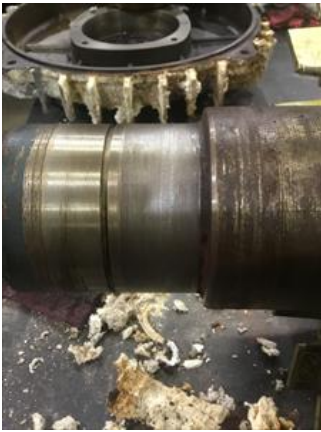
## 56. Opposite Drive End Bearing Shaft Fit

Tolerance is 3.3466-3.3472

57. Opposite Drive End Bearing Shaft Fit Condition **(F) Fail**

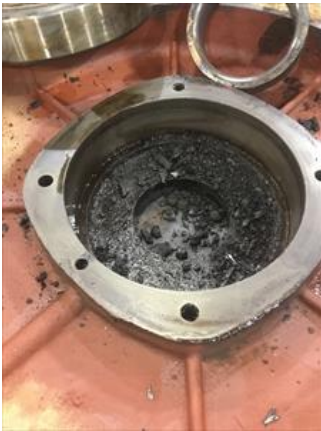
P59

## 59. Drive End - Endbell Bearing Fit

7.4825

7.4823

7.5827

Tolerance is 7.4803-7.4814

60. Drive End - Endbell Bearing Fit Condition **(F) Fail**
