AC Inspection as Found
GEORGIA PACIFIC GYPSUM
150 TEMPLE DR
CUMBERLAND, TN 37050

AC Inspection - Rev. 2

Location: Motor Shop
Serial Number: 1093144308
Description: 300 HP AC

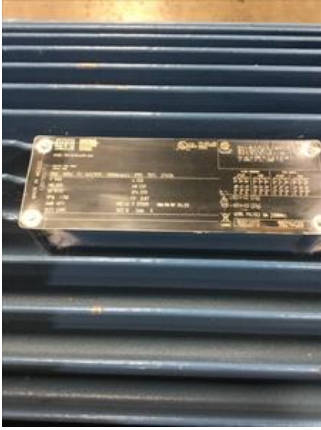
P2

2. Nameplate Picture

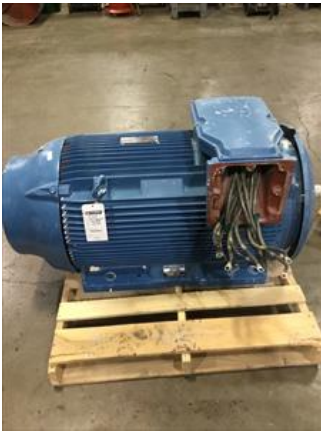
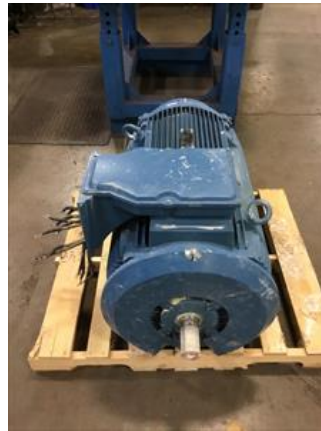
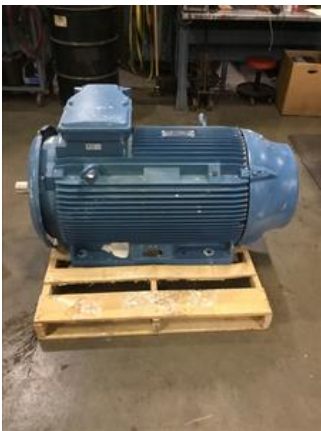
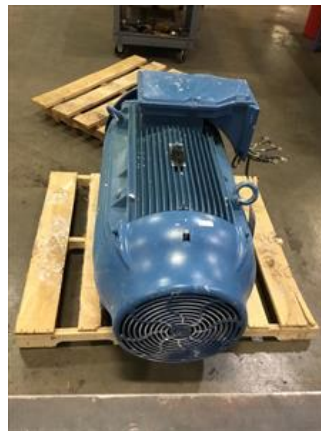
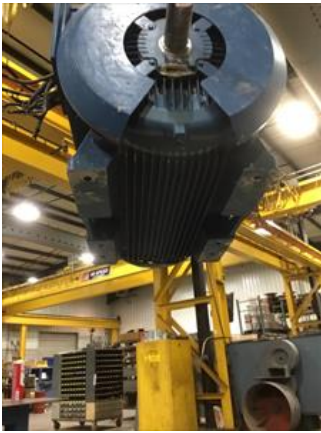
P3

3. Photos of all six sides of the machine.

4. Describe the Overall Condition of the Equipment as Received
Failed surge test and requires. Machine work required in both end bells. Sticker on side of motor says AEGIS ring is installed on motor but none is present.
5. Is this a UL Listed Motor (NO) NO
6. Is the motor water cooled or can be pressure checked before teardown (NO) NO

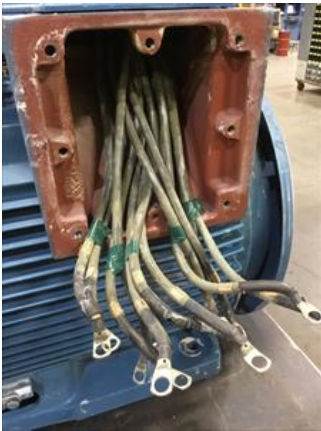
7. Does Shaft Turn Freely? (Y) Yes
8. Does the shaft require T.I.R in Lathe to identify additional repairs? (NO) NO
9. Does Shaft Have Visible Damage? (No) No
10. Assembled Shaft Runout 0.0005 Inches
11. Assembled Shaft End Play 0 inches
12. Air Gap Variation <10% No Provisions for measurement
13. Lead Condition (P) Pass
14. Lead Length 12 Inches P14

Measurement from outer edge of j box

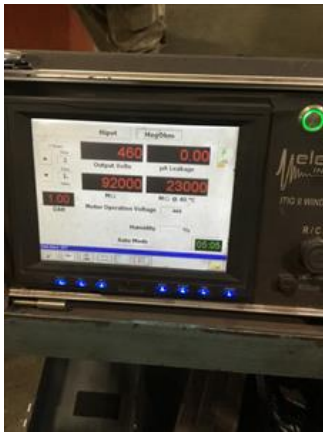
P22

22. Insulation Resistance/Megger

92000 Megohms

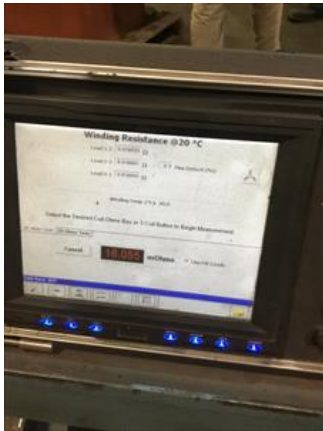
P23

23. Winding Resistance

1-2

1-3

2-3

.016033

.016001

.016055

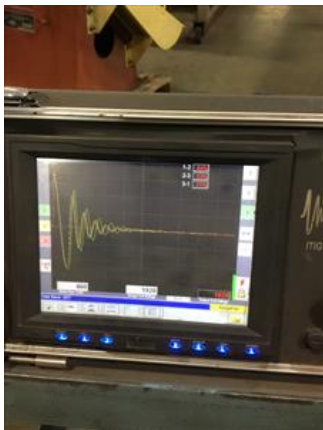
P24

24. Perform Surge Test

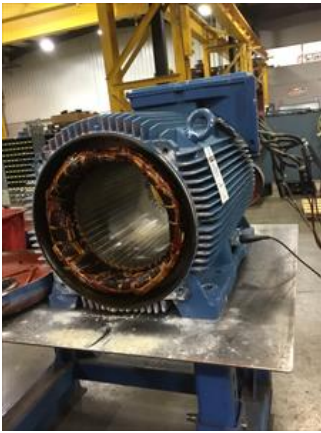
P26

26. Stator Condition

Requires rewind

*Rewind
Lugs 1/2" x wire size
6314 C3 insulated
6314 ZC3
Aegis ring SGR-82.1-3FH [Mfr# SGR-82.1-104.1-3FH]*

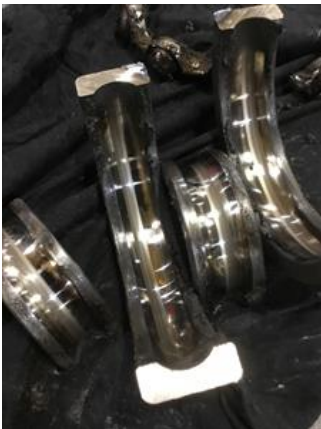
P36

29.	Drive End Bearing Brand	C&U
30.	Drive End Bearing Number-	6314 C3
31.	Drive End Bearing Qty.	1
32.	Drive End Bearing Type	(Ball) Ball Bearing
33.	Drive End Lubrication Type	(Grease) Grease Lubricated
34.	Drive End Bearing Insulation or Grounding Device?	None
35.	Drive End Wavy Washer/Snap-Ring Other Retention Device?	None
36.	Drive End Bearing Condition

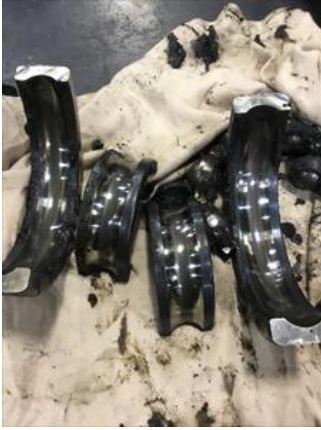
37.	Opposite Drive End Bearing Brand	C&U
38.	Opposite Drive End Bearing Number-	6314 C3
39.	Opposite Drive End Bearing Qty.	1
40.	Opposite Drive End Bearing Type	(Ball) Ball Bearing
41.	Opposite Drive End Lubrication Type	(Grease) Grease Lubricated
42.	Opposite Drive End Bearing Insulation or Grounding Device?	None
43.	Opposite Drive End Wavy Washer/Snap-Ring Other Retention Device?	Snap Ring and springs
