AC Recondition Repair Report

FolderID: 97868
FormID: 10005822

Phelps Fan Manufacturing Co.
10701 Interstate 30
Little Rock, AR 72209

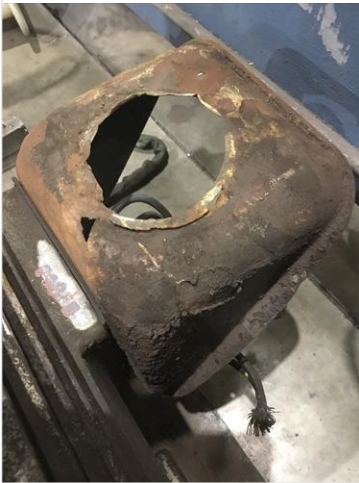
P113

34. Broken or missing components
Connection box rusted with holes on the surface.

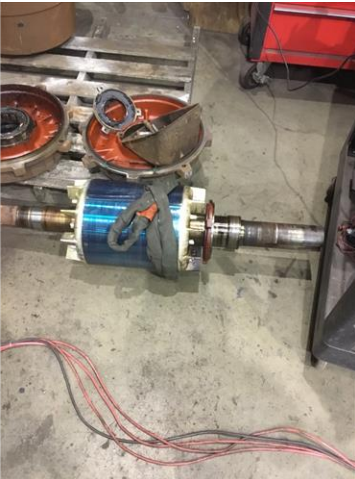
P4

44. Rotor Type

squirrel cage

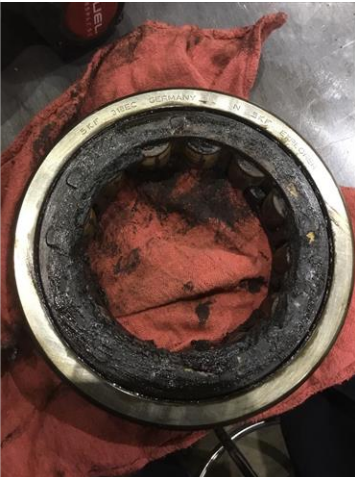
P1

50. Bearing Manufacture

Skf

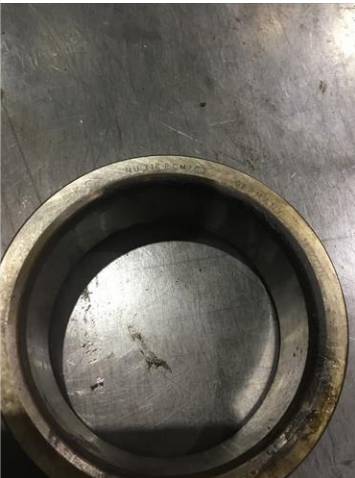
P15

51. Bearing DE Size

NU 318 ECM/C3

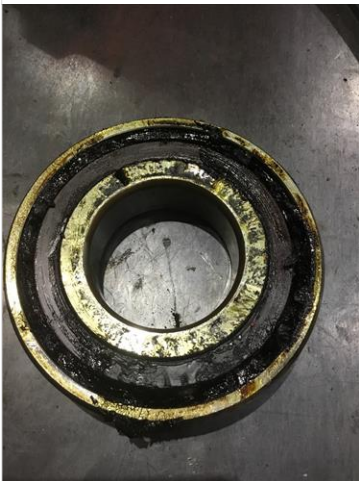
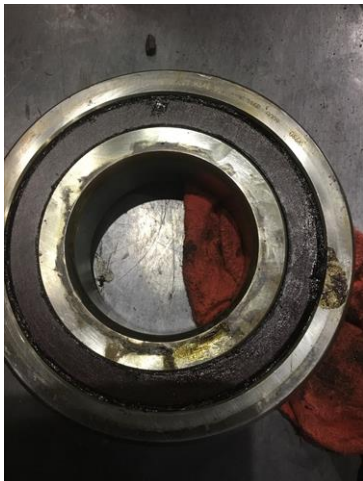
52.	Bearing DE Type	NU	
53.	DE Bearing Qty.	1	
54.	Bearing ODE Size	MRC 316R thrust	P43

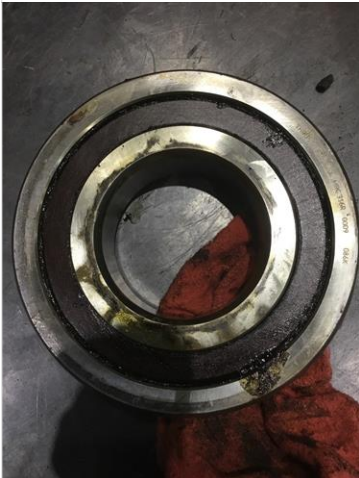
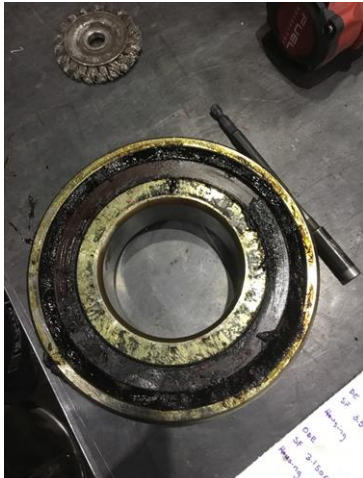
55.	Bearing ODE Type	thrust	P53

59. Grease Condition	(F) Fail

Dirty

Contaminated bearing grease

Bearings failed due to grease dirty/ contaminated

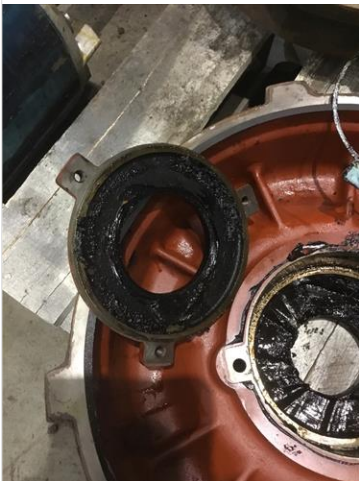
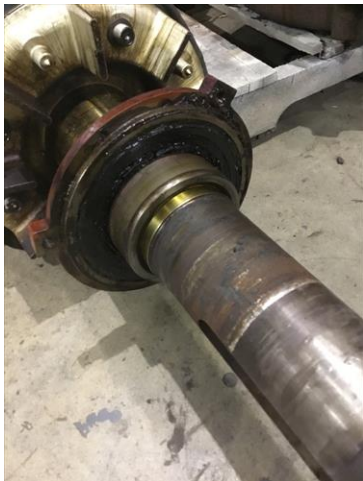
60. Bearing Retainers	(Y) Yes	P80
