AC Recondition Repair Report

FolderID: 97921
FormID: 10132499

1. Job Number	97921
2. Report Date	03/02/2021
3. Customer	ARKANSAS ELECTRIC SERVICES

4. Manufacturer	U.S. MOTORS	P5
-----------------	-------------	----

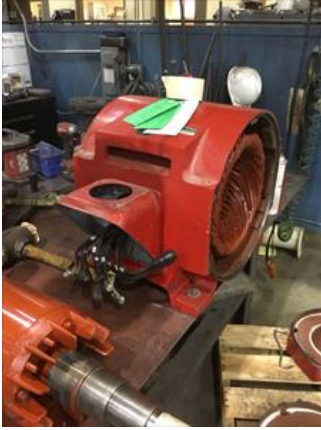
P65

41. Surge Test	(P) Pass

42. Stator Condition

good

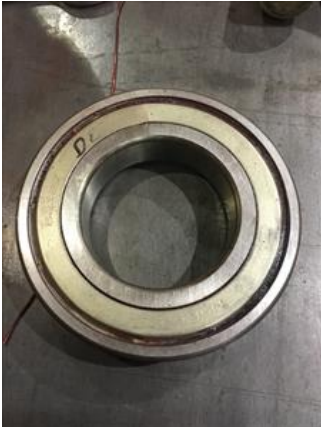
P23

50. Bearing Manufacture **NSK**

51. Bearing DE Size **6212 2Z/C3**

52. Bearing DE Type **regular ball bearing**

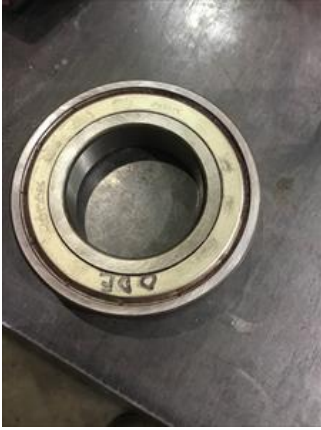
54. Bearing ODE Size **6212 2Z/C3**

56. ODE Bearing Qty.	1
57. Insulated Bearing	no
58. Lubrication Type	grease
59. Grease Condition	(F) Fail
Contaminated grease	
60. Bearing Retainers	(NA) Not Applicable
61. Shaft Grounding Device	(NA) Not Applicable
62. DE Seal	(NA) Not Applicable
63. DE Seal Type/Size	
64. ODE Seal	
65. ODE Seal Type/Size

66. Component Failure	bearings
67. Cause of Failure	Grease contaminated
68. Comments	Customer request windings tested for electrical integrity. Windings check good. Both bearings failed due to contaminated grease.
69. Service Technician	Terrence Holland

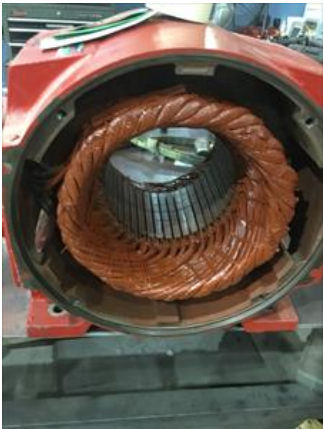
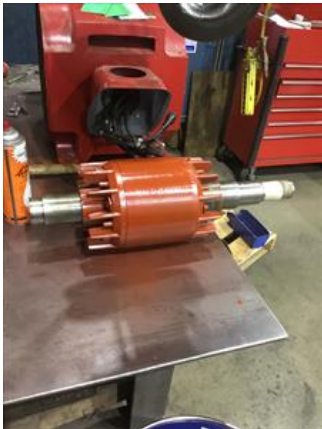
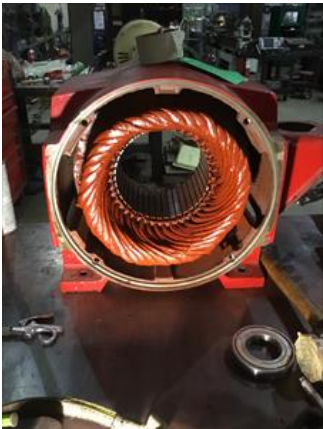
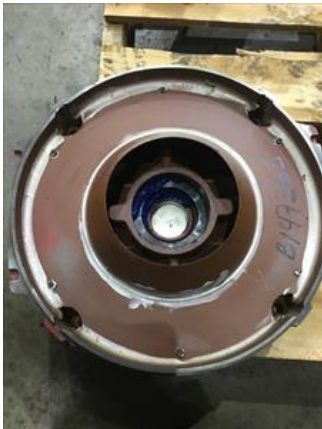
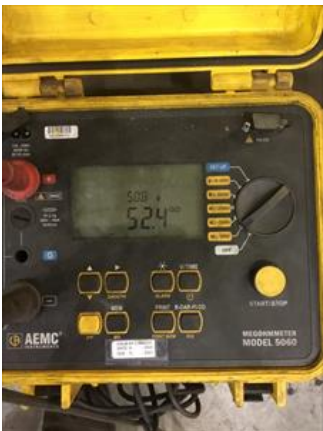
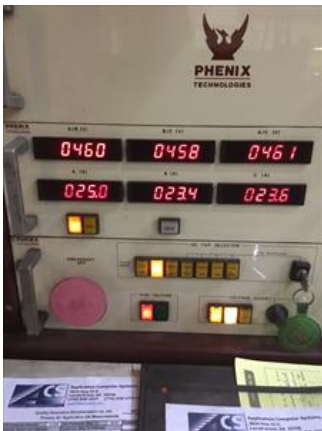
154. Temp at 45 minutes		
155. Temp at 50 minutes		
156. Temp at 55 minutes		
157. Temp at 60 minutes		
● 158. Motor Paint	(P) Pass	P136
