Hi-Speed Industrial Service
7030 Ryburn Dr
Millington, Tn 38053
901-873-5300

AC Recondition Repair Report

FolderID: 97936
FormID: 10154219

Peco Foods
Hwy 67
Pocahontas, AR 72455

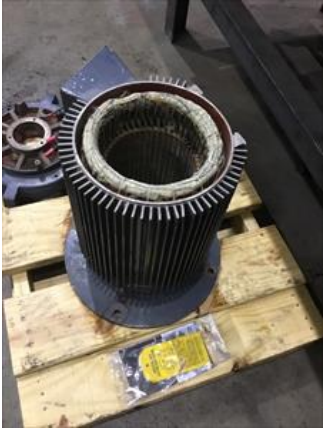
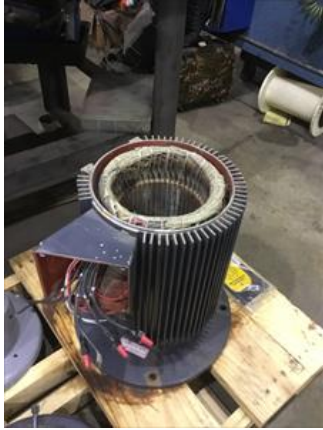
27.	Does Shaft Turn Freely		
28.	Does Shaft Have Visible Damage		
29.	Bearing Rtd's		
30.	Bearing Rtd's Condition		
31.	Contamination Yes		
32.	Frame Condition	(P) Pass	P106
<div style="display: flex; justify-content: space-around;">

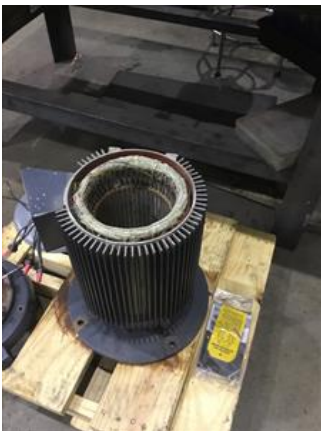
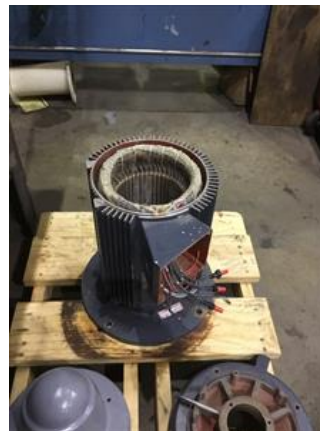
42. Stator Condition

good

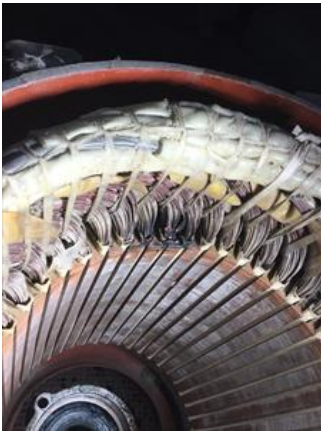
43. Failure Location

66. Component Failure windings

Coil to coil short

Windings tested bad. Coil to coil short. Bearing grease contaminated with water and dirt.

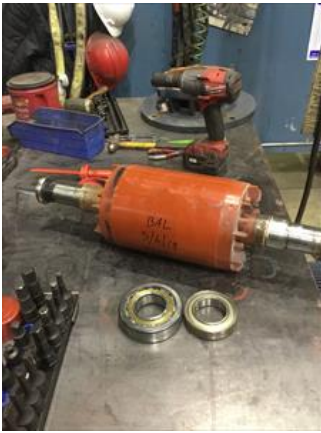
● 49. Rotor Condition

(P) Pass

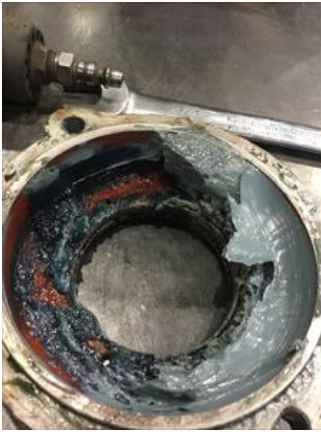
Watery/dirty
