## AC Recondition Repair Report

Union Pacific-Vine St 10945  
1020 N. Vine Street  
North Little Rock, AR

1. Job Number	97951
2. Report Date	03/09/2021
3. Customer	UNION PACIFIC

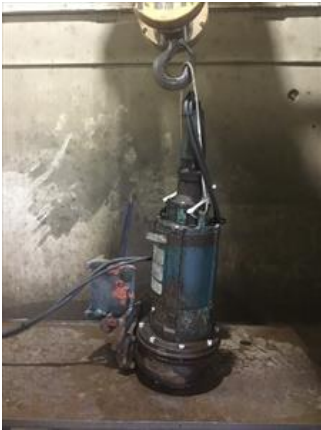
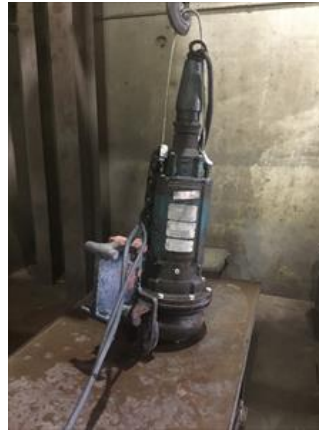
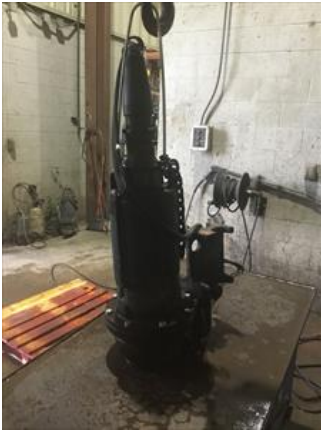
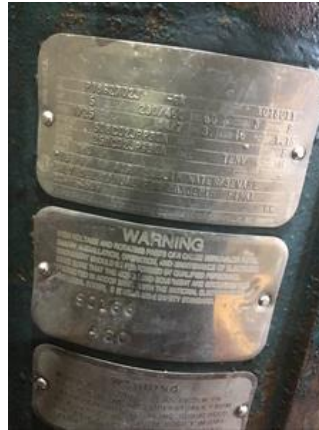
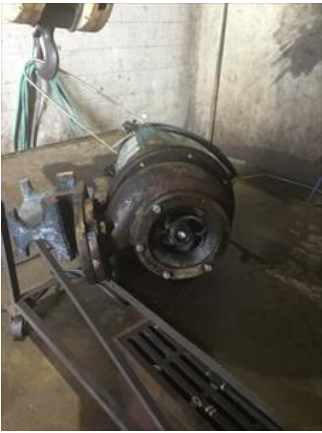
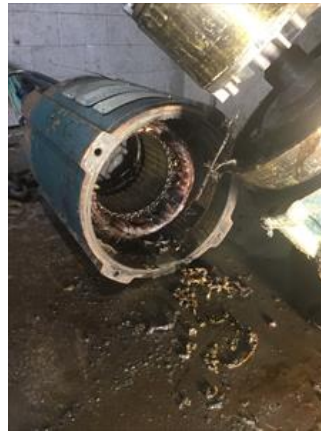
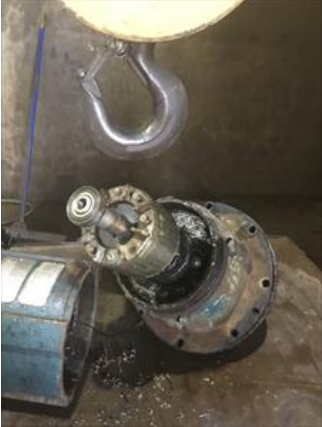
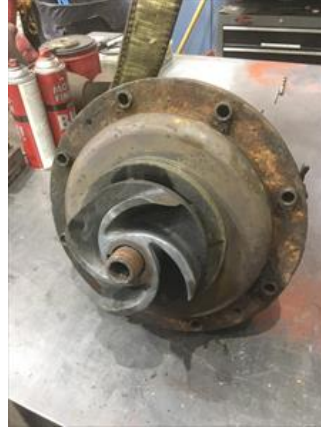
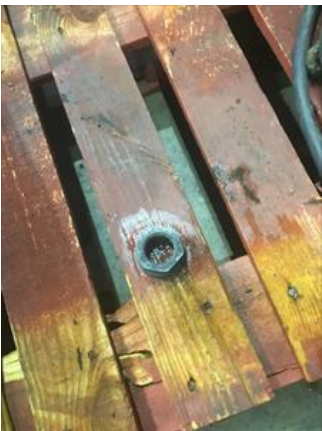
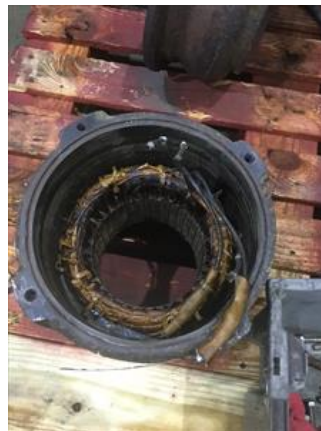
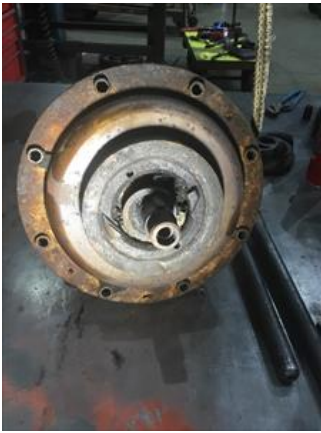
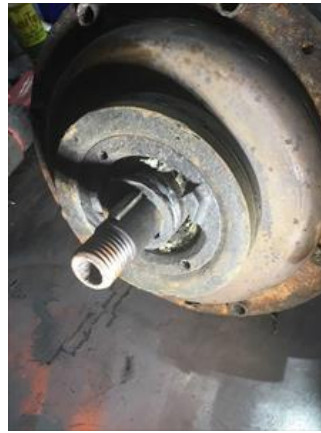
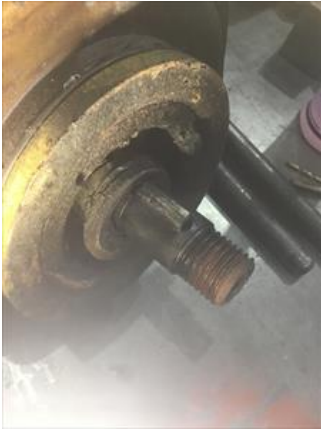
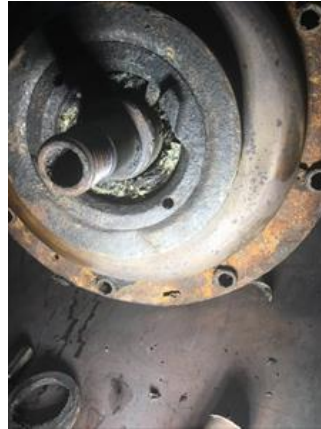
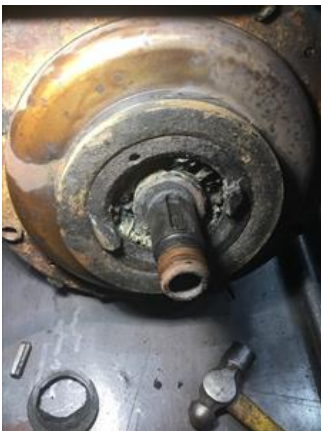
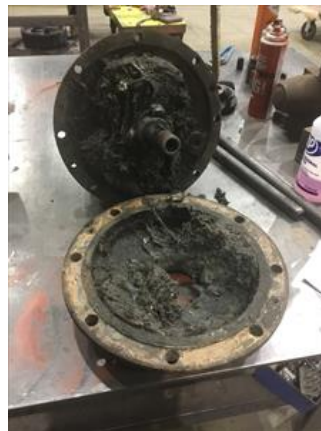
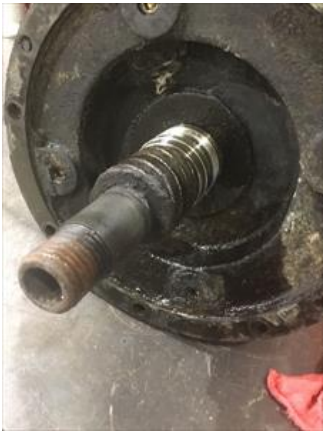
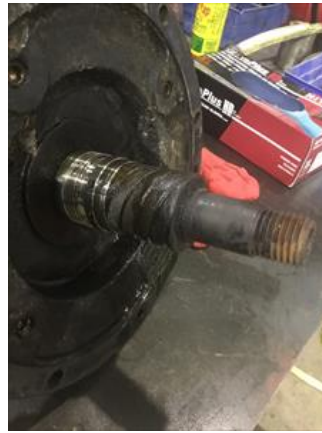
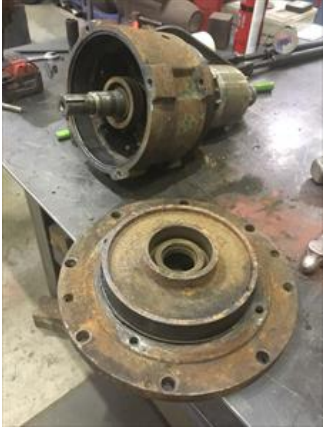
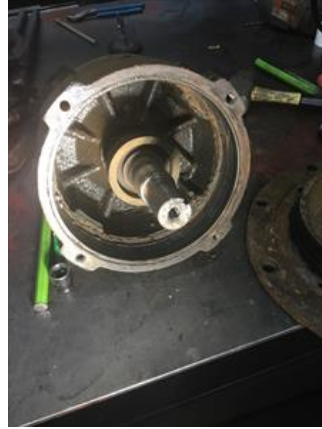
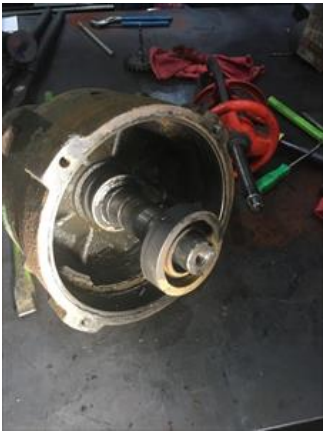
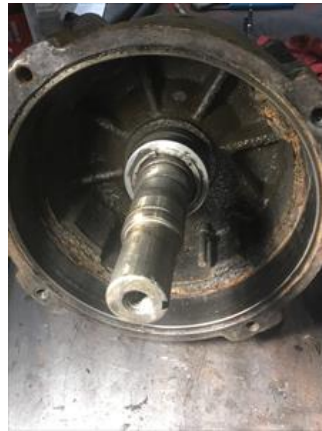
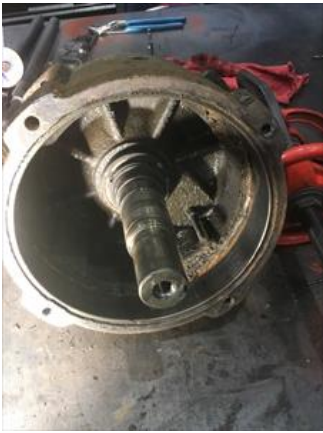
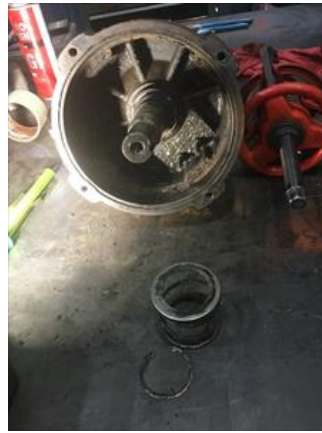
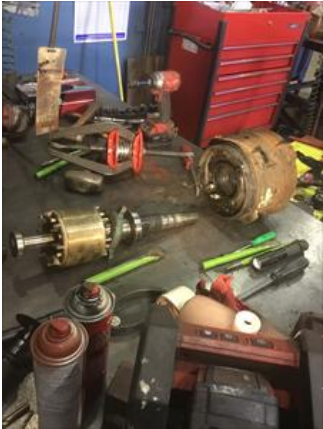
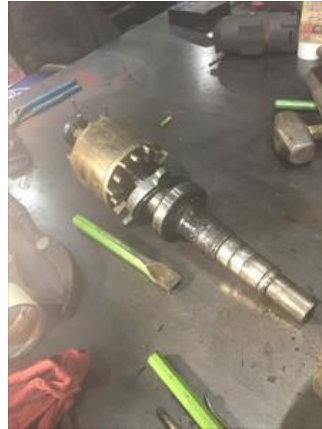
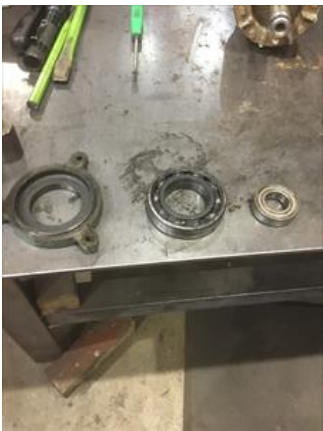
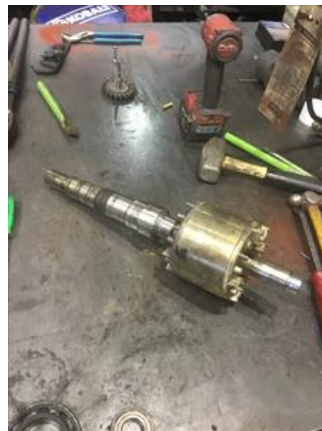
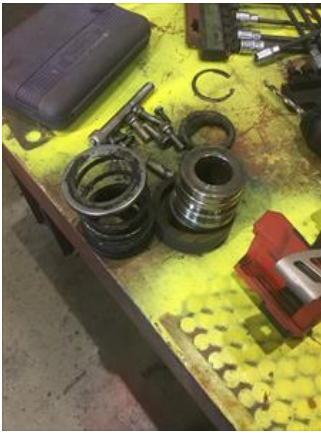
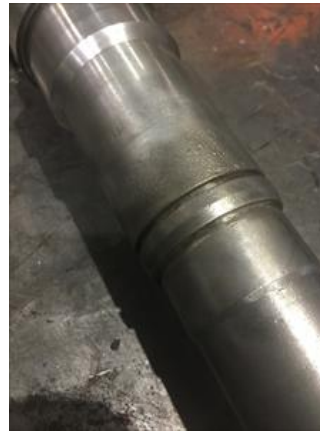
43.	Failure Location	windings blown from excessive moisture
<b>Initial Rotor Inspection</b>		
44.	Rotor Type	squirrel cage
45.	Air Gap <10% Variation	
46.	Number of Rotor Bars

57.	Insulated Bearing	no
58.	Lubrication Type	grease
59.	Grease Condition	(F) Fail
	Contaminated with water	
60.	Bearing Retainers	(Y) Yes
61.	Shaft Grounding Device	(NA) Not Applicable

62.	DE Seal	
63.	DE Seal Type/Size	
64.	ODE Seal	
65.	ODE Seal Type/Size	
<b>Root Cause of Failure</b>		
66.	Component Failure	seals failed.
67.	Cause of Failure	Excessive debris entangled around the impeller caused the seals to fail, allowing water to permeate the stator windings.

68.	Comments	Rewind stator. Repair seal surfaces and D.E. shaft bearing journal. Replace both power and sensor cords @ 27' long. Sensor cord: 5c/18 AWG Power cord: 4c/12 AWG Replace broken snap ring and missing bolts.
