AC Recondition Repair Report

Malvern, AR 72104

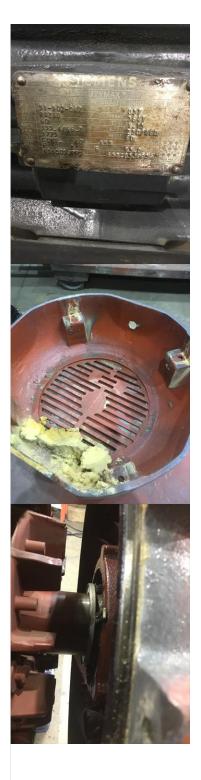
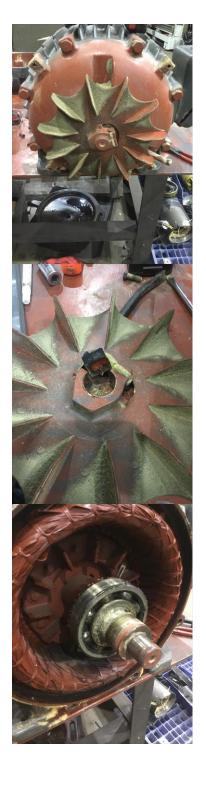
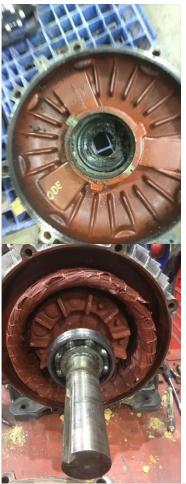
32.	Frame Condition	(P) Pass	
33.	Fan Condition	(F) Fail	
34.	Broken or missing components		
	Fan	-	
	Electric Test	0	
35.	Resistance to Ground	0 Mohm	
36.	Winding Resistance 1-2

37.	Winding Resistance 2-3		
38.	Winding Resistance 1-3		
39.	Resistive Imbalance		
40.	Hi-Pot	Ua	
41.	Surge Test	(F) Fail	
42.	Stator Condition	burned	
43.	Failure Location For Inspection	ODE bottom	P6

63.	DE Seal Type/Size	<i></i>	
	64.	ODE Seal	(NA) Not Applicable	
	65.			
Ro		ause of Failure		
	66.	Component Failure	stator	
	67.			
		Unknown		
	68.			
		Rewind. Replace Fan. Sleeve DE end bell
