AC Recondition Repair Report

DELTA PLASTICS OF THE SOUTH
3104 SOUTH MAIN STREET
STUTT GART, AR 72160

1. Job Number	97985
2. Report Date	03/16/2021
3. Customer	DELTA PLASTICS SOUTH

5. Model	13218ET3Y315S/M-W22
6. Serial Number	04MA112 1015868298
7. Horsepower	175 HP
8. KW	
9. Volts	460
10. Amps	203
11. RPM	1790
12. Frame	315S/M
13. Enclosure	TEFC
14. Cycles	60 HZ
15. Phase	3
16. Service Factor	1.25
17. Motor Mount Position	
Initial Inspection	
18. Number of Leads	6
19. Lead Length	
20. Lead Size	
21. Lead Condition	
22. Lead Markings	T1-T6
23. Lug Size, Condition, and Type	
24. Winding RTD's	
25. Winding Rtd's Condition	
26. Shaft Run Out	
27. Does Shaft Turn Freely	yes
28. Does Shaft Have Visible Damage	no
29. Bearing Rtd's	
30. Bearing Rtd's Condition	
31. Contamination

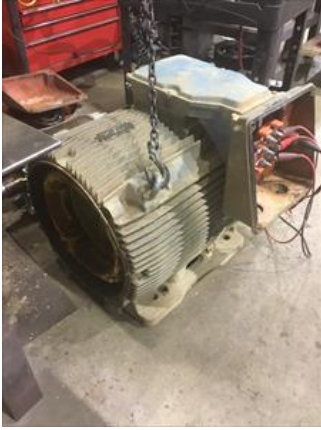
Has crack and needs to be Replaced. WEG fan# 11026502

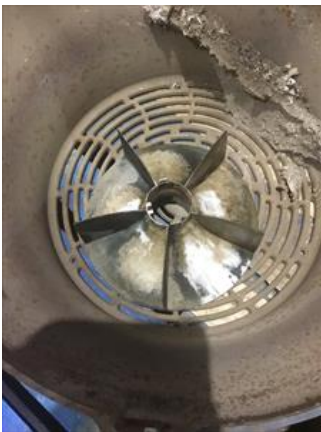
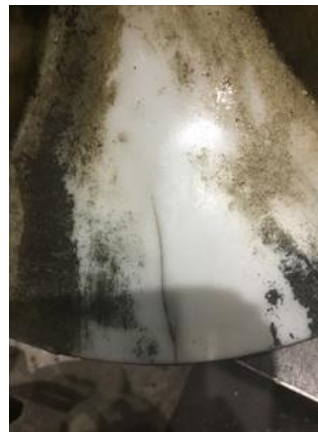
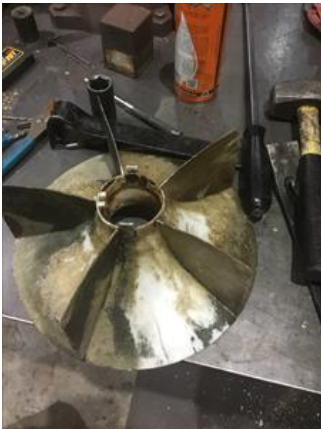
Fan blade has crack.

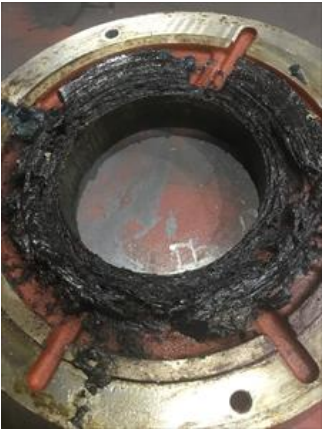
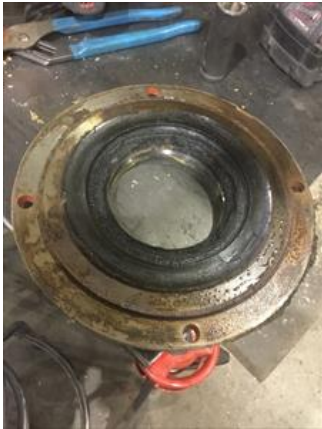
59. Grease Condition	(F) Fail	P74

| 67. Cause of Failure | <i>Bearing grease contaminated. Both housing fits require machine work.</i> |

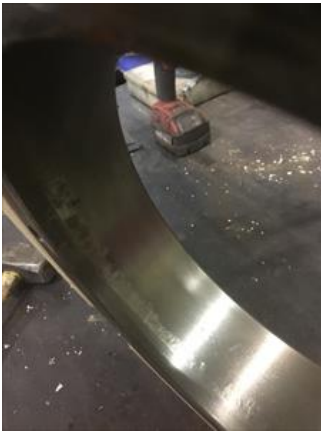
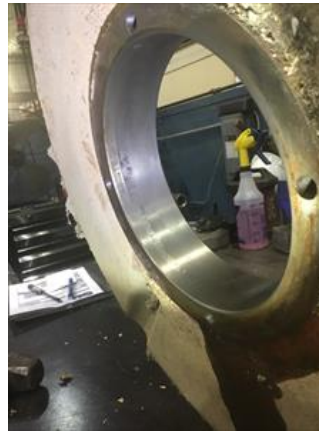
88.	DE Initial Air Seal Shaft Size		
89.	DE Final Air Seal Shaft Size		
90.	ODE Air Seal Shaft Fit		
91.	ODE Initial Air Seal Shaft Size		
92.	ODE Final Air Seal Shaft Size		
● 93.	DE Endbell Fit	(F) Fail	P129

94.	DE Initial Endbell Fit Size 1	7.8746 "	
95.	DE Initial Endbell Fit Size 2	7.875 "	
96.	DE Initial Endbell Fit Size 3	7.8742 "	
97.	DE Final Endbell Fit Size 1		
98.	DE Final Endbell Fit Size 2		
99.	DE Final Endbell Fit Size 3		
100.	DE Endbell Fit Insulated		
101.	DE Endbell Air Seal Fit		
102.	Initial Endbell Air Seal Fit Size		
103.	Final Endbell Air Seal Fit Size		
● 104.	ODE Endbell Fit	(F) Fail	P145
