AC Recondition Repair Report

CoorsTek Inc.
 3315 Boone Road
 Benton, AR 72015

1. Job Number	98027
2. Report Date	03/30/2021
3. Customer	COORS TEK

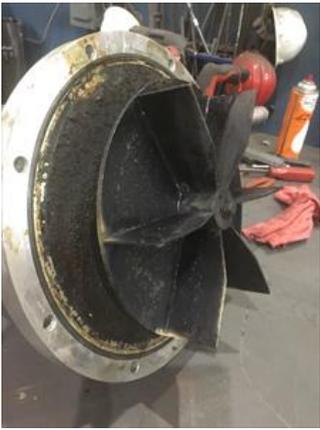
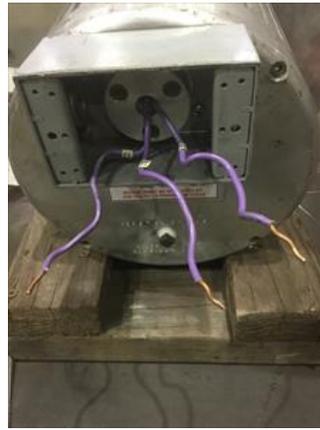
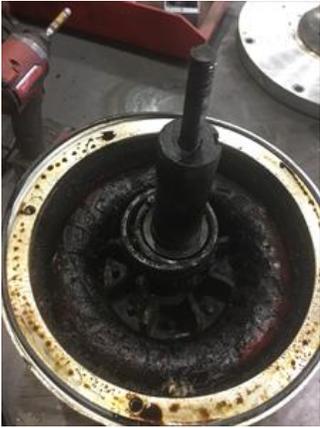
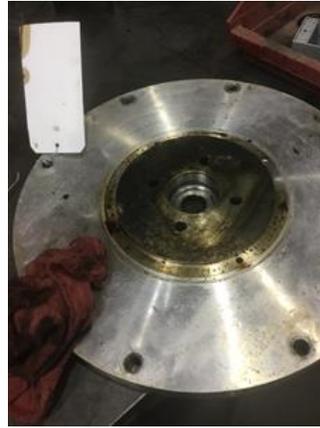
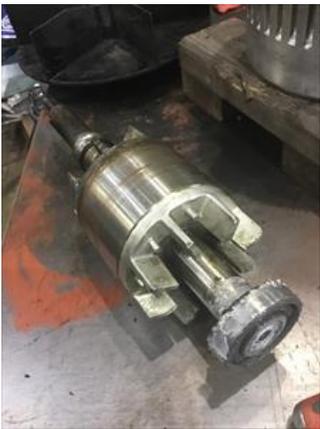
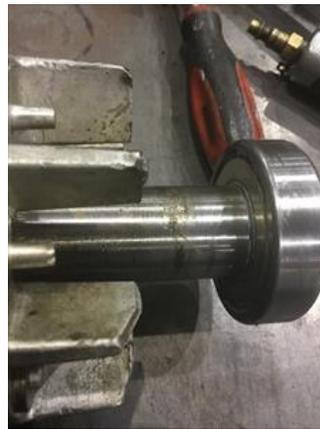
39.	Resistive Imbalance		
40.	Hi-Pot		
● 41.	Surge Test		(F) Fail
42.	Stator Condition		pass
43.	Failure Location		windings shorted by impact with bearing fragments
Initial Rotor Inspection

66.	Component Failure	D.E. bearing suffered catastrophic cage failure
67.	Cause of Failure	<i>Insufficient amount of grease in D.E. housing contributed to bearing cage failure. This caused pieces of it to impact with the stator windings.</i>
68.	Comments	
69.	Service Technician	Terrence Holland

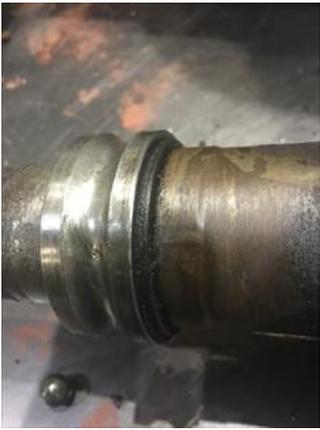
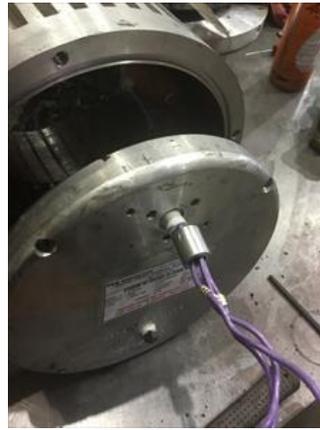
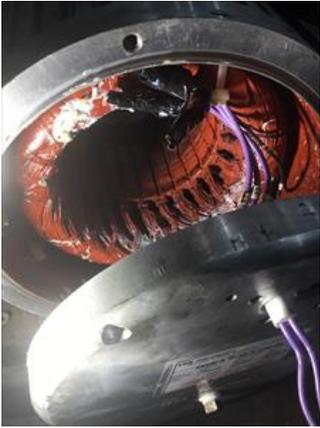
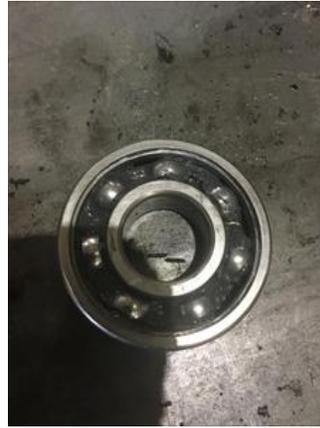
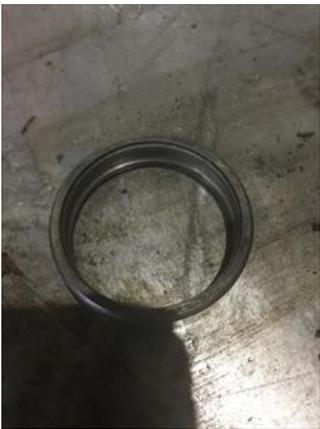
58.	Lubrication Type	grease
● 59.	Grease Condition	(F) Fail
60.	Bearing Retainers	(NA) Not Applicable
61.	Shaft Grounding Device	(NA) Not Applicable
62.	DE Seal	
63.	DE Seal Type/Size	
64.	ODE Seal	
65.	ODE Seal Type/Size
