Hi-Speed Industrial Service
7030 Ryburn Dr
Millington, Tn 38053
901-873-5300

AC Recondition Repair Report

APPLIED INDUSTRIAL
TECHNOLOGIES
1620 SIDNEY SRTEET
BATESVILLE, AR 72501

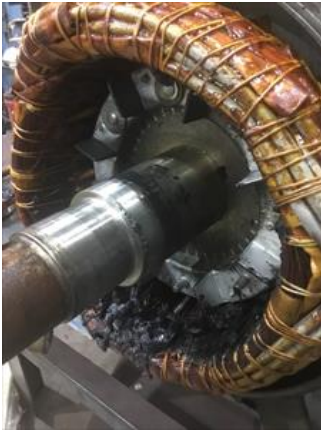
P104

31. Contamination

Yes

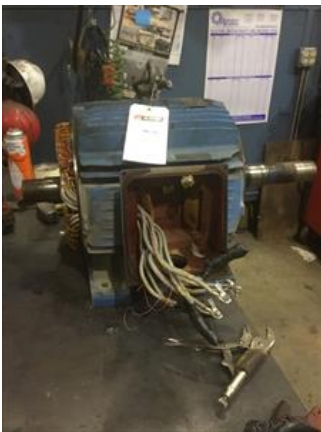
P106

32. Frame Condition

(P) Pass

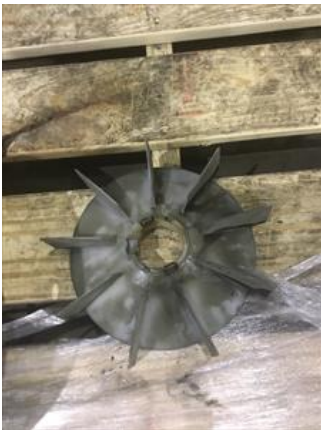
P109

33. Fan Condition

(P) Pass

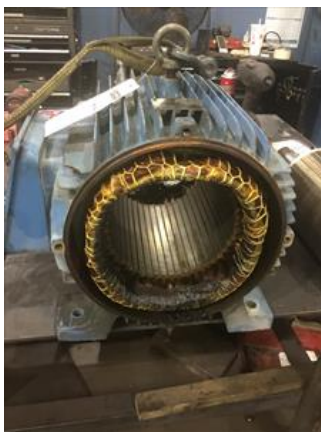
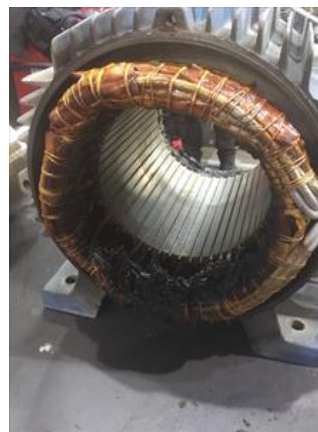
P65

42. Stator Condition

good

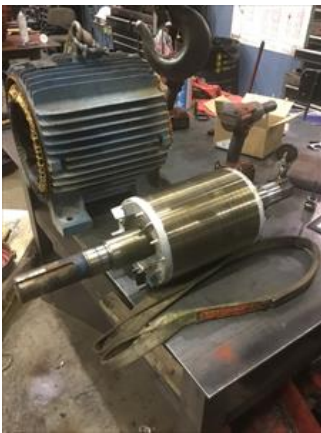
P4

44. Rotor Type

squirrel cage

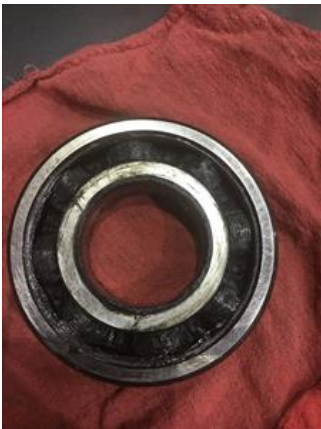
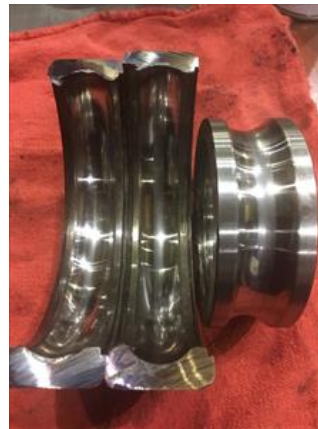
P15

51. Bearing DE Size

6312 C3

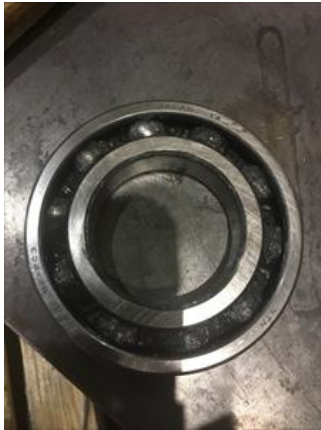
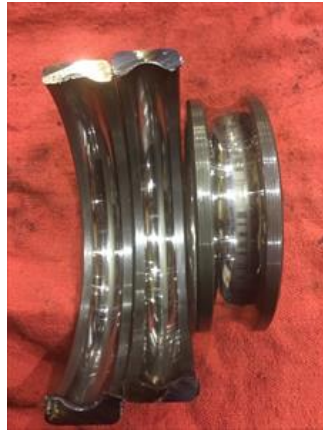
52.	Bearing DE Type	regular ball bearing		
53.	DE Bearing Qty.	1		
54.	Bearing ODE Size	6212 C3		P43
<div><div>

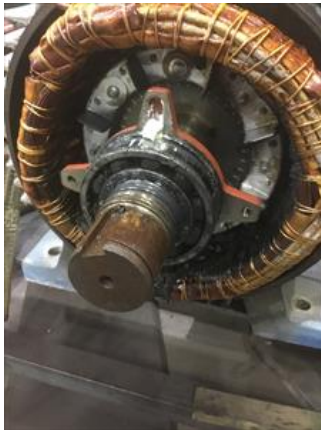
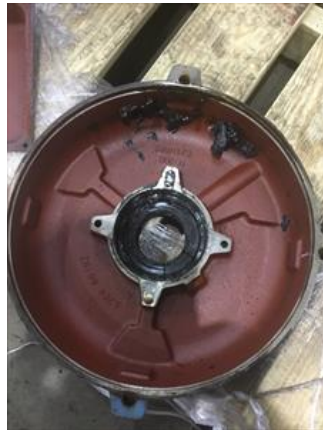
</div></div>				
55.	Bearing ODE Type	regular ball bearing		
56.	ODE Bearing Qty.	1		
57.	Insulated Bearing	no		
58.	Lubrication Type	grease		
<div></div> 59.	Grease Condition	(F) Fail		P74
<div><div>

Bearings over greased/grease contaminated/dirty.

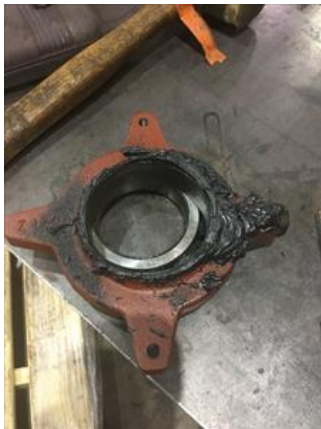
</div></div>				
<div></div> 60.	Bearing Retainers	(Y) Yes		P80
<div><div>

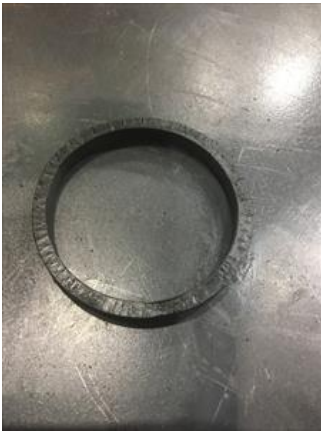
P95

64. ODE Seal

(Y) Yes

dust shield
