Hi-Speed Industrial Service
7030 Ryburn Dr
Millington, Tn 38053
901-873-5300

AC Recondition Repair Report

FolderID: 98063
FormID: 10378263

**ARKANSAS INDUSTRIAL
MACHINERY**
3804 N. NONA ST
NORTH LITTLE ROCK, AR 72118

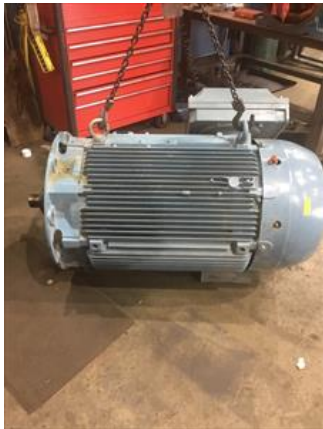
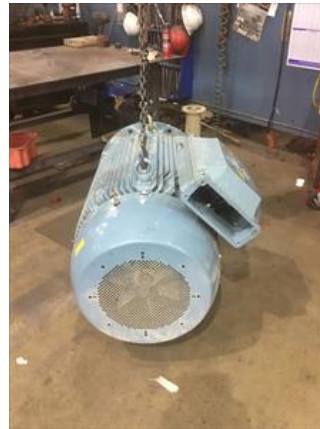
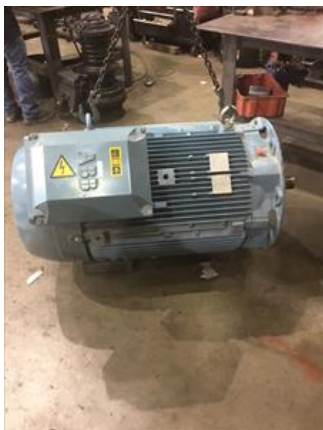
36.	Winding Resistance 1-2		
37.	Winding Resistance 2-3		
38.	Winding Resistance 1-3		
39.	Resistive Imbalance		
40.	Hi-Pot		
41.	Surge Test	(F) Fail	
42.	Stator Condition	good	
43.	Failure Location	windings on the drive end.	
Initial Rotor Inspection

66.	Component Failure	D.E bearing caused rotor to drop.
67.	Cause of Failure	D.E.bearing failed.
68.	Comments	D.E. bearing suffered catastrophic cage failure causing the rotor, to drop onto the stator iron core. This caused the destruction of the motor windings, the bearing cap, both housing fits and the drive end shaft. The excessive damage caused by this incident makes it impossible to determine exact root cause of failure.

Replace broken d.e. bearing cap. Rewind stator and minor core repair. Repair d.e. shaft bearing journal and shoulder.

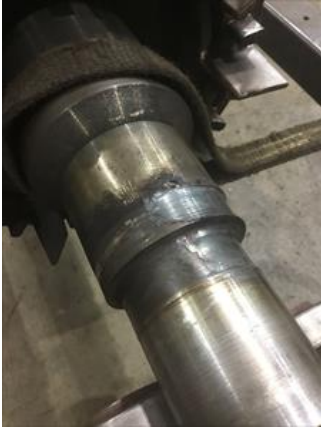
P94

28. Does Shaft Have Visible Damage

yes

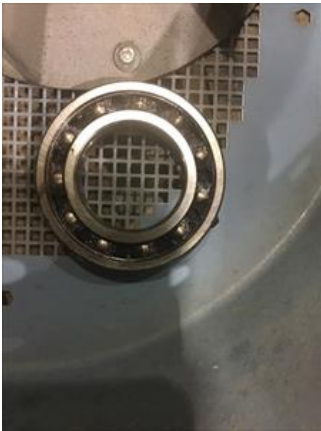
P104

31. Contamination

Grease contaminated.

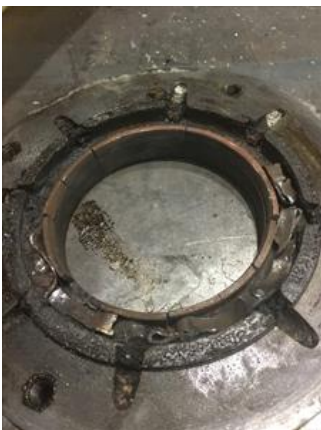
P113

34. Broken or missing components

D.E. Bearing cap

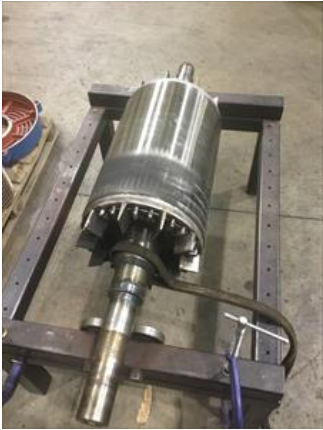
44.	Rotor Type	squirrel cage	P4

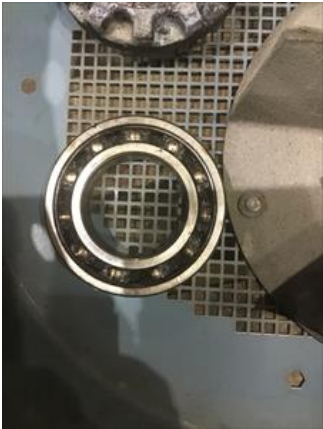
50.	Bearing Manufacture	SKF	
51.	Bearing DE Size	6214 2Z	
52.	Bearing DE Type	regular ball bearing	
53.	DE Bearing Qty.	1	
54.	Bearing ODE Size	6214 2Z	P43
