## AC Recondition Repair Report

1. Job Number	98068
2. Report Date	04/07/2021
3. Customer	SAGE FOODS

4. Manufacturer	BALDOR	P5
-----------------	--------	----

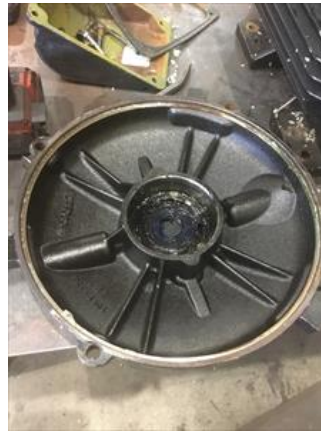
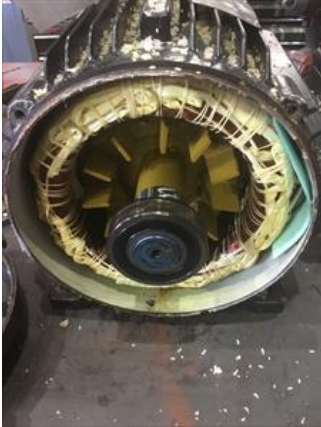
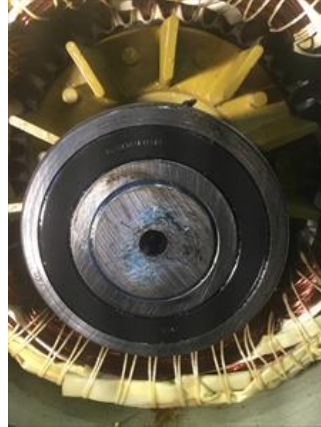
5.	Model	
6.	Serial Number	C 1703270 142
7.	Horsepower	25
8.	KW	
9.	Volts	460
10.	Amps	30
11.	RPM	1770
12.	Frame	284T
13.	Enclosure	TEAO
14.	Cycles	60
15.	Phase	3
16.	Service Factor	1.15
17.	Motor Mount Position	
<b>Initial Inspection</b>

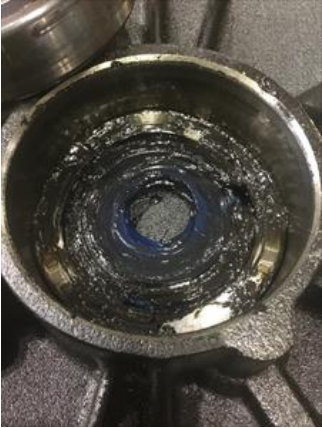
27.	Does Shaft Turn Freely	yes	
28.	Does Shaft Have Visible Damage	no	
29.	Bearing Rtd's		
30.	Bearing Rtd's Condition		
31.	Contamination <i>Grease dirty</i>		P104

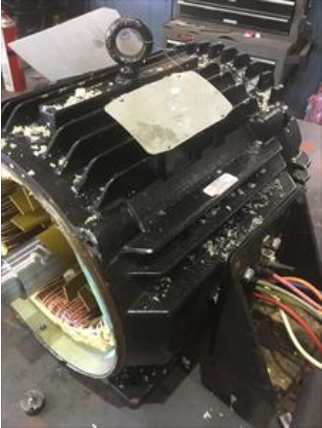
32.	Frame Condition	(P) Pass	P106

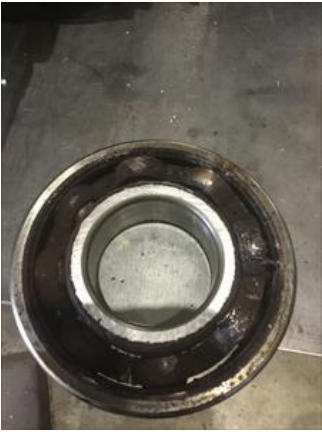
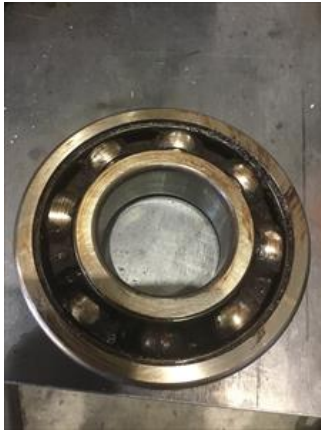
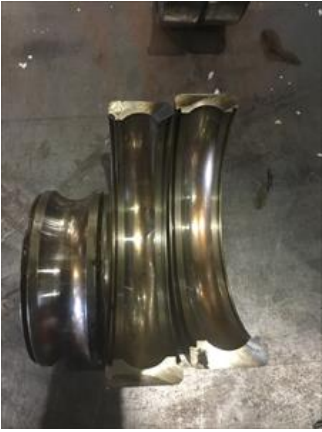
50. Bearing Manufacture	FAG	
51. Bearing DE Size	6311 RSR	P15
<div>

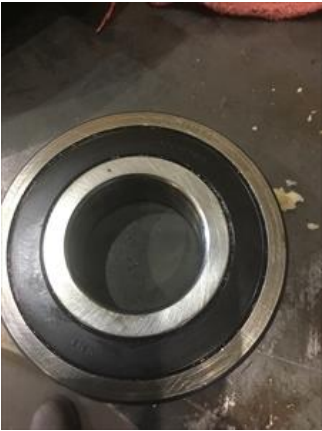
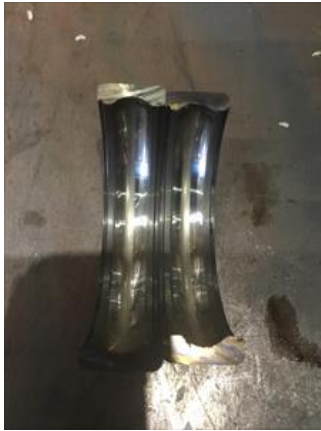
</div>		
52. Bearing DE Type	regular sealed ball bearing	
53. DE Bearing Qty.	1	
54. Bearing ODE Size	6309 RSR	P43
<div>

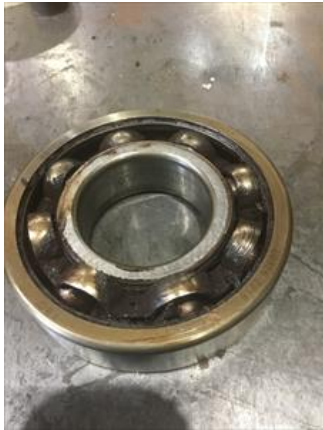
P2

66. Component Failure

D.E. Bearing cage.

67. Cause of Failure

*Contaminated grease.*

*Recondition stator windings and replace bearings. In pro seal o-rings need replaced.*
