AC Recondition Repair Report

SAGE
5901 SLOAN DRIVE
LITTLE ROCK, AR 72206

| 1. Job Number | 98069 |

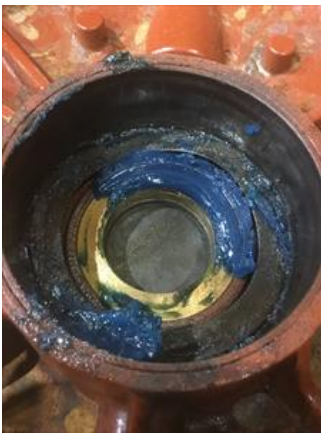
P104

31. Contamination

Grease dirty

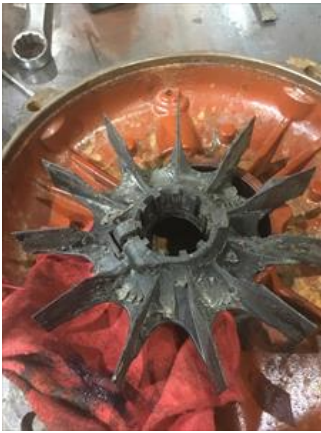
P109

33. Fan Condition

(F) Fail

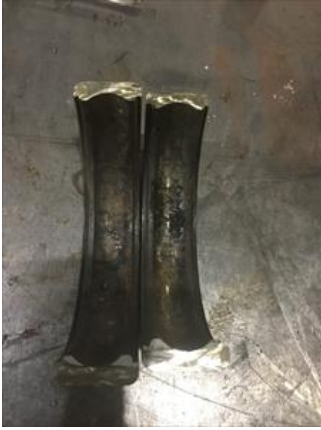
P15

51. Bearing DE Size

6312 RSR

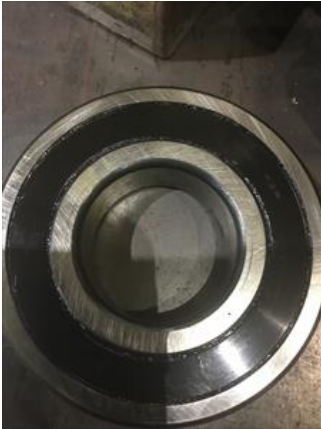
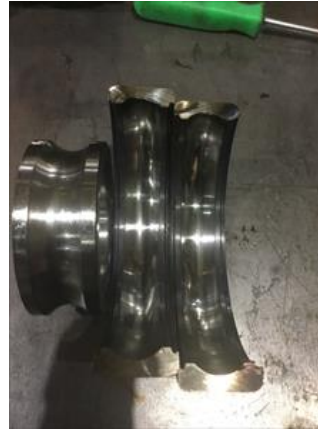
P53

54. Bearing ODE Size

6311 RSR

55. Bearing ODE Type

sealed

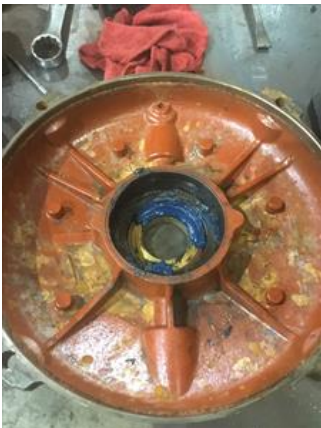
P74

☒ 59. Grease Condition

(F) Fail

67.	Cause of Failure	<i>D.E. Bearing failed due to contaminated grease. Also excessive amounts of rust was found inside the stator and end bell housings indicating moisture.</i>
