AC Recondition Repair Report

Arauco-Malvern MDF (10298)
1275 Willamette Rd
Malvern, AR 72104

1. Job Number	98077
2. Report Date	04/08/2021
3. Customer	ARAUCO

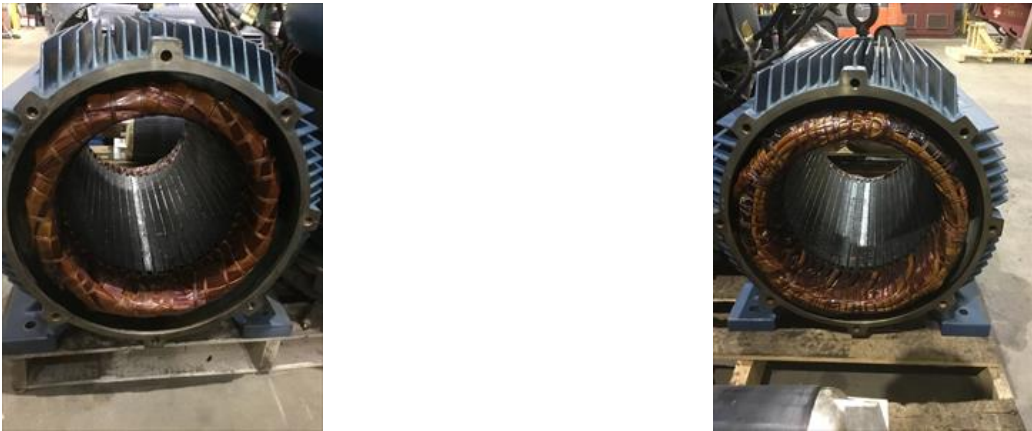
34.	Broken or missing components	NA	
Initial Electric Test			
35.	Resistance to Ground	0 Mohm	P7

38.	Winding Resistance 1-3		
39.	Resistive Imbalance		
40.	Hi-Pot		
● 41.	Surge Test	(F) Fail	
42.	Stator Condition	clean	
43.	Failure Location	unknown	
Initial Rotor Inspection

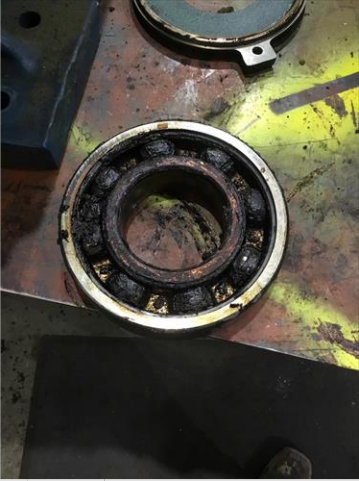
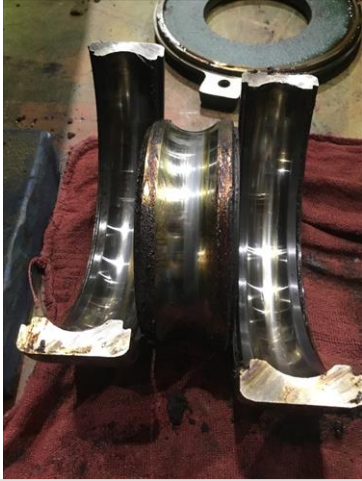
50.	Bearing Manufacture	ORS	
51.	Bearing DE Size	6316	
52.	Bearing DE Type	ball	P23

66. Component Failure	bearings
67. Cause of Failure	<i>Bearings show signs of frosting and brenalling</i>
68. Comments	<i>Rewind, 2x 6316, 3 5/8 Aegis ring</i>
69. Service Technician

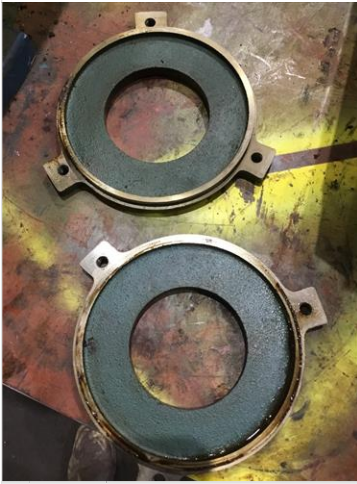
56.	ODE Bearing Qty.	1	
57.	Insulated Bearing	no	
58.	Lubrication Type	grease	
59.	Grease Condition	(F) Fail
