AC Recondition Repair Report

ALCOA REMEDIATION
1401 BAUXITE CUTOFF
BAUXITE, AR 72011

1. Job Number	98080
2. Report Date	04/08/2021
3. Customer	ALCOA REMEDIATION

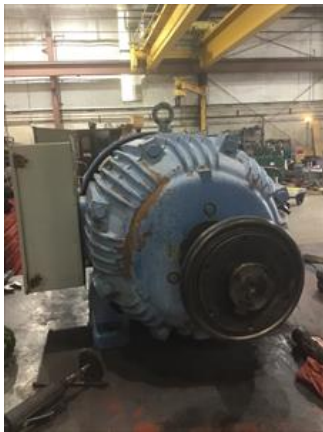
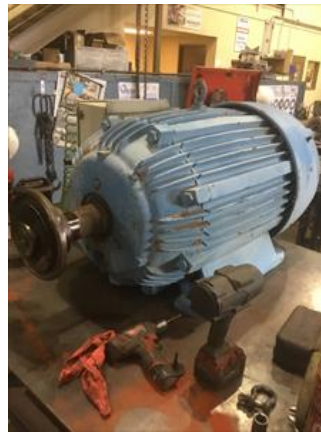
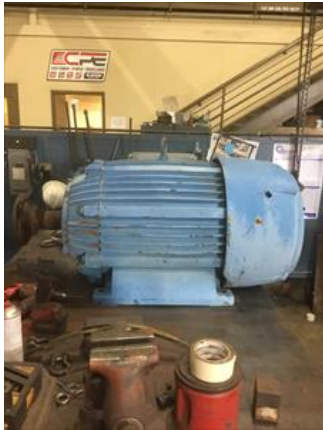
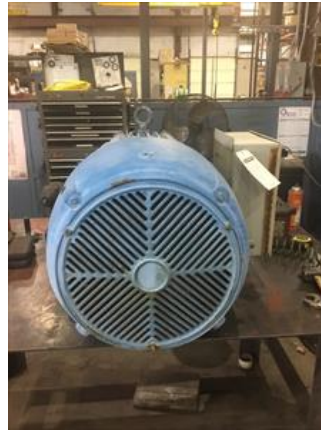
P5

4. Manufacturer	U.S. MOTORS
-----------------	-------------

5. Model	TYPE: TC
6. Serial Number	
7. Horsepower	200
8. KW	
9. Volts	460
10. Amps	228
11. RPM	1780
12. Frame	447T
13. Enclosure	TEFC
14. Cycles	60
15. Phase	3

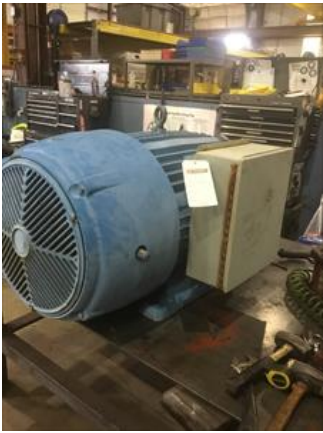
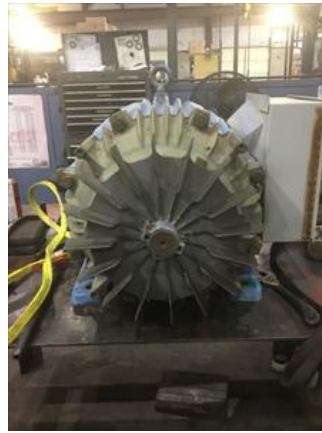
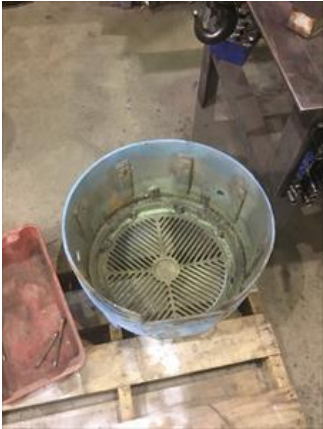
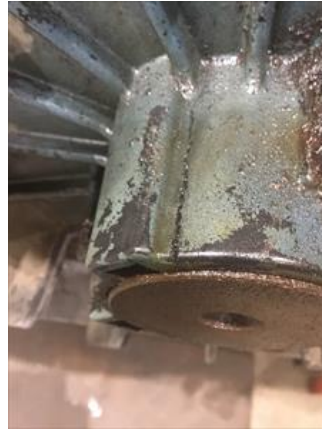
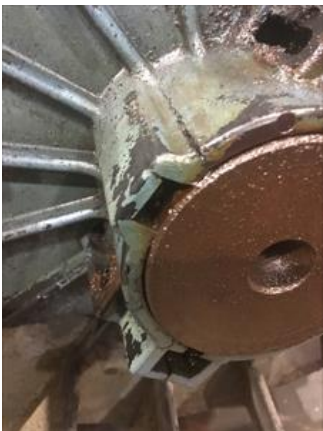
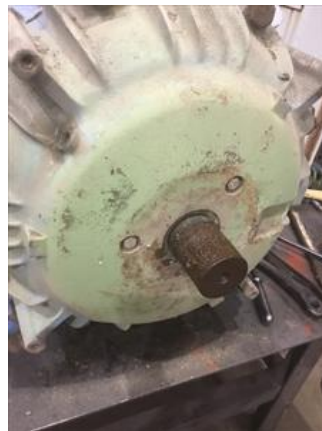
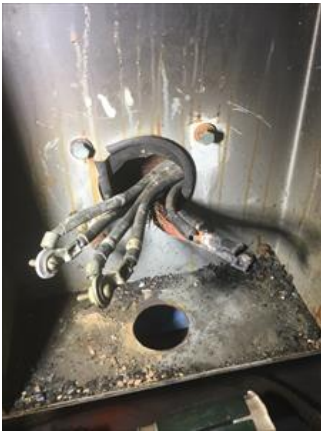
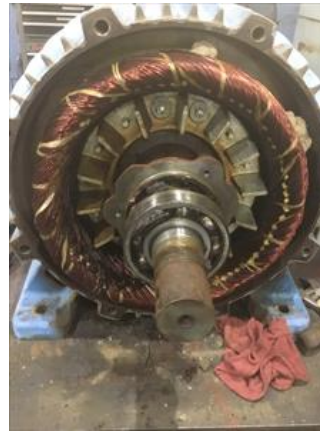
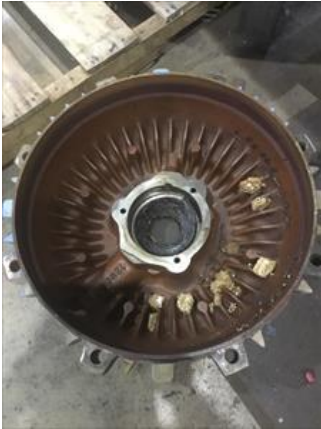
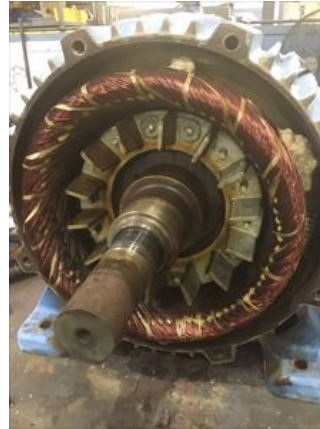
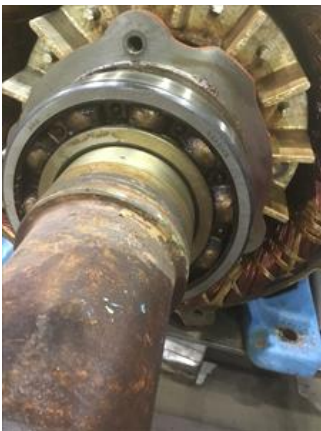
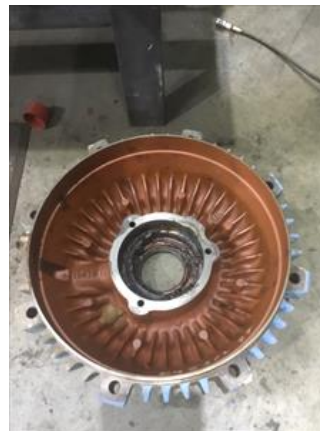
21. Lead Condition	(F) Fail

<i>Leads #2&8 need to be re-leaded.</i>		
22.	Lead Markings	1,2,3. 7,8,9.	
23.	Lug Size, Condition, and Type		
24.	Winding RTD's		
25.	Winding Rtd's Condition		
26.	Shaft Run Out		
27.	Does Shaft Turn Freely	yes	
28.	Does Shaft Have Visible Damage	no	
29.	Bearing Rtd's		
30.	Bearing Rtd's Condition		
31.	Contamination		
	<i>Yes. Grease contaminated.</i>

<i>Dirty and contaminated</i>		
60. Bearing Retainers	(Y) Yes	
61. Shaft Grounding Device	(N) No	
62. DE Seal		
63. DE Seal Type/Size		
64. ODE Seal		
65. ODE Seal Type/Size		
Root Cause of Failure		
66. Component Failure	leads	
67. Cause of Failure	<i>Most probable cause of failure is a loose connection between leads 2&8. Also the fan assembly was cracked and needs to be Replaced.</i>	
68. Comments	<i>Stator windings surge tested good. Machine fits check good.</i>

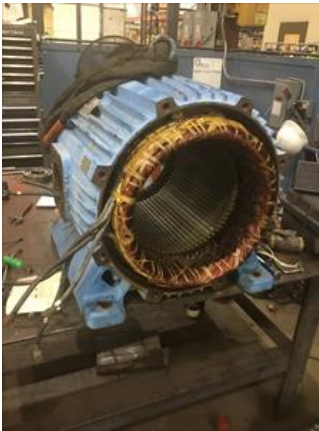
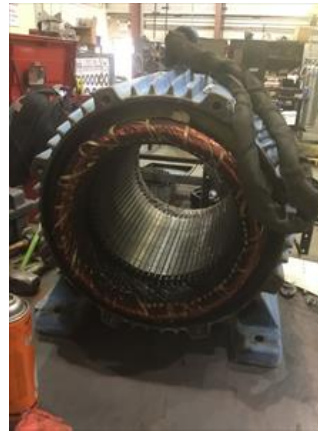
P65

42. Stator Condition

good

43. Failure Location

leads 2&8

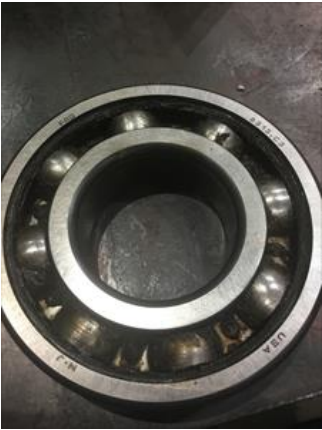
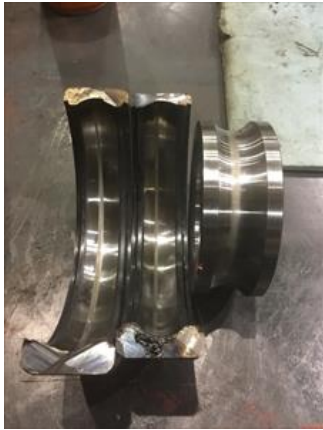
52. Bearing DE Type	regular ball bearing	
53. DE Bearing Qty.	1	
54. Bearing ODE Size	6313 C3	P43

55. Bearing ODE Type	regular ball bearing	
56. ODE Bearing Qty.	1	
57. Insulated Bearing	no	
58. Lubrication Type	grease	
59. Grease Condition	(F) Fail
