Hi-Speed Industrial Service
7030 Ryburn Dr
Millington, Tn 38053
901-873-5300

AC Recondition Repair Report

Arauco-Malvern MDF (10298)
1275 Willamette Rd
Malvern, AR 72104

1. Job Number	98099
2. Report Date	04/14/2021
3. Customer	ARAUCO

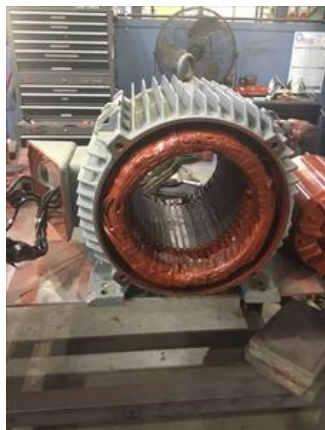
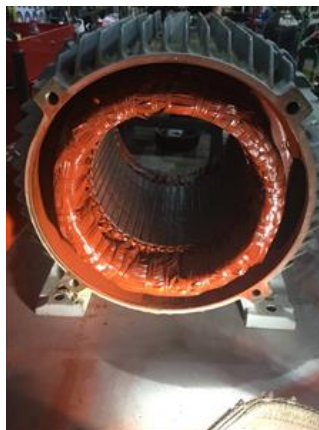
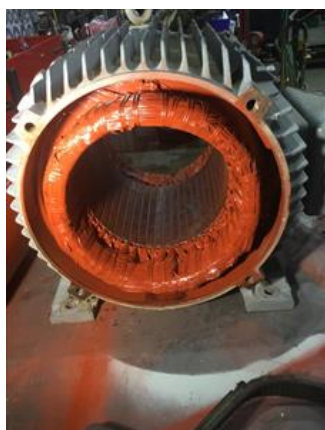
P65

42. Stator Condition

good

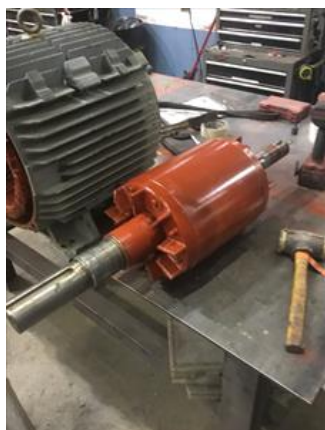
P50

● 49. Rotor Condition

(P) Pass

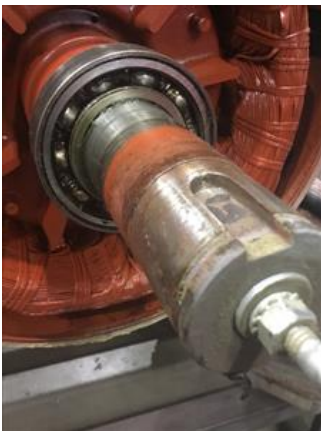
P43

51. Bearing DE Size

6314 ZE C3

54. Bearing ODE Size

6210 ZE C3

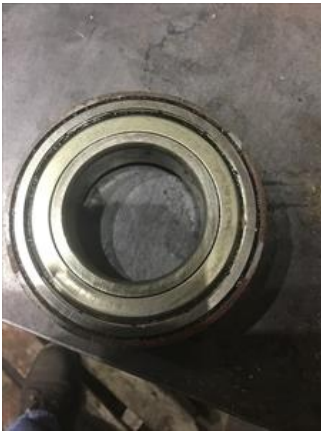
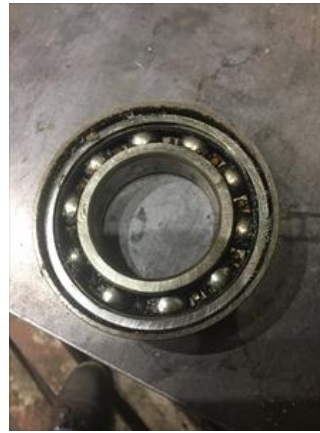
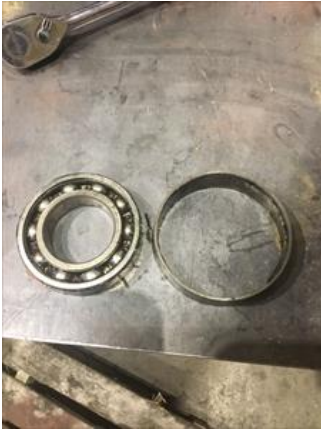
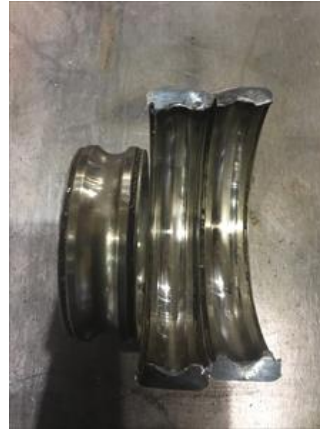
P53

55. Bearing ODE Type

regular ball bearing

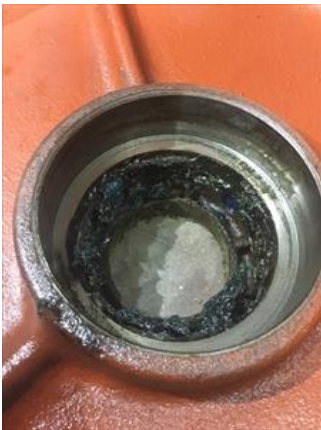
56. ODE Bearing Qty.	1	
57. Insulated Bearing	no	
58. Lubrication Type	grease	
59. Grease Condition	(F) Fail	P74

66. Component Failure	ODE housing sleeve.
67. Cause of Failure	<i>Grease contaminated and ode sleeve loose in housing. Both bearings have frosting and the ode bearing shows signs of fluting. The drive end bearing housing measures too tight.</i>
68. Comments	
69. Service Technician	Terrence. Holland

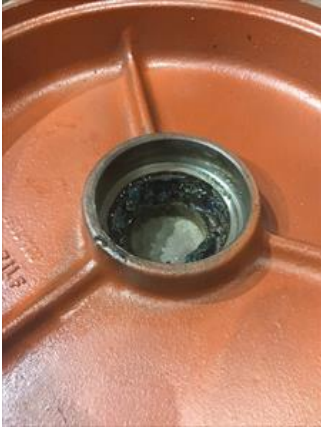
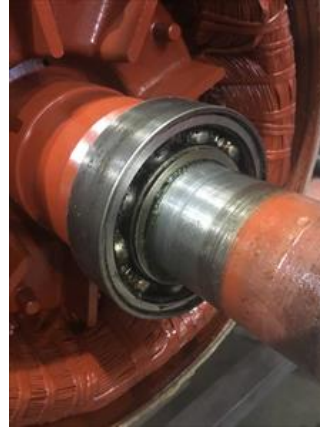
92. ODE Final Air Seal Shaft Size	
93. DE Endbell Fit	(F) Fail
94. DE Initial Endbell Fit Size 1	5.9043 "
95. DE Initial Endbell Fit Size 2	5.9042 "
96. DE Initial Endbell Fit Size 3	5.9043 "
