Hi-Speed Industrial Service
7030 Ryburn Dr
Millington, Tn 38053
901-873-5300

AC Recondition Repair Report

Riviana Foods
28 W. White Oak st
Brinkley, AR 72021

1. Job Number	98111
2. Report Date	04/16/2021
3. Customer	RIVIANA FOODS

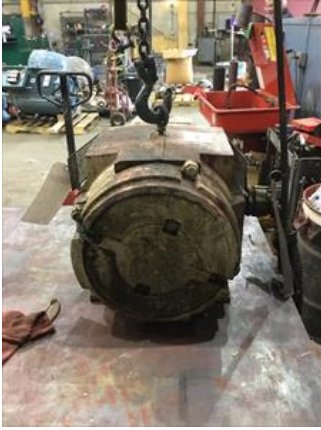
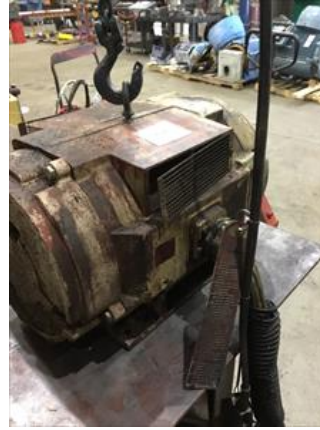
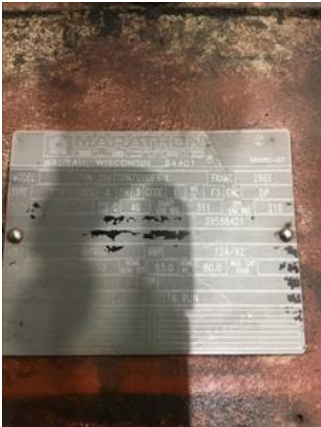
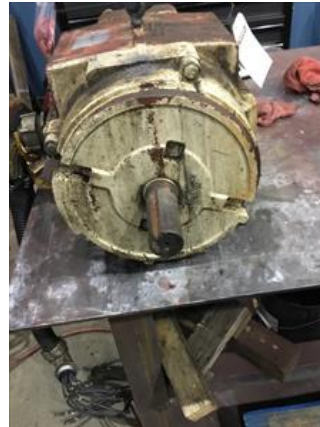
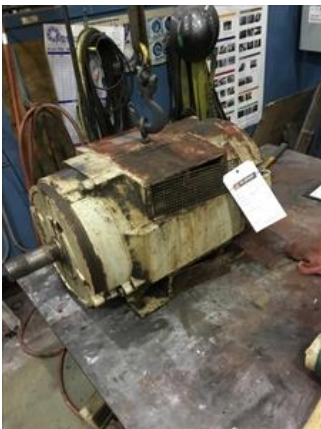
Name Plate Information

5. Model	7VN 286TTDN7010BA L
6. Serial Number	39588421
7. Horsepower	50
8. KW	
9. Volts	460
10. Amps	62
11. RPM	3570
12. Frame	286T
13. Enclosure	DP
14. Cycles	60

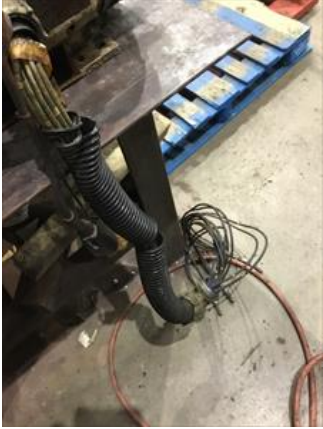
21. Lead Condition	(P) Pass	P42

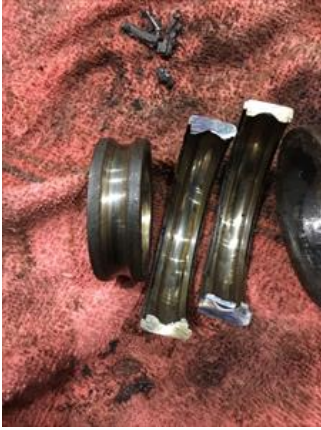
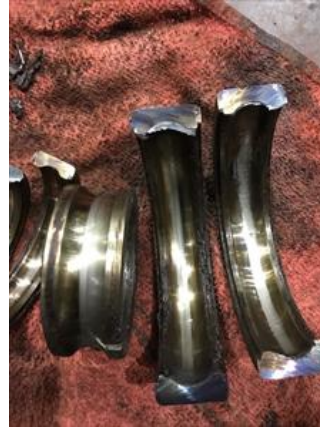
Start of fluting

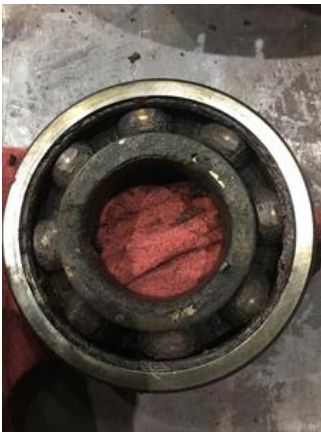
51. Bearing DE Size

6311 2Z

52. Bearing DE Type

ball

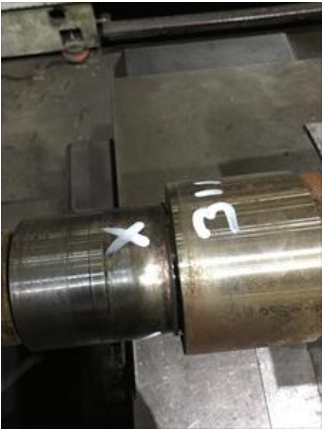
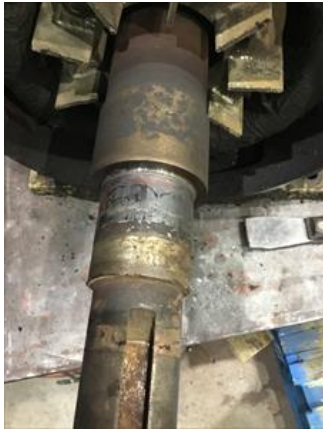
73. DE Bearing Shaft Fit	(F) Fail	P39
<div style="display: flex; justify-content: space-around;">

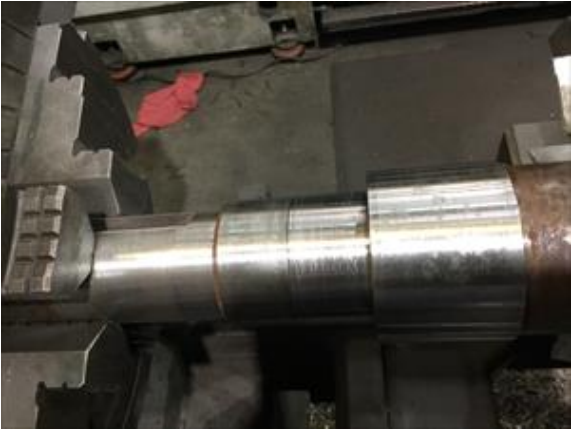
</div>			
74.	DE Initial Shaft Bearing Fit Size 1	2.1645 "	
75.	DE Initial Shaft Bearing Fit Size 2	2.1645 "	
76.	DE Initial Shaft Bearing Fit Size 3	2.1645 "	
77.	DE Final Shaft Bearing Fit Size 1	2.166 "	P71

78.	DE Final Shaft Bearing Fit Size 2	2.166 "	
79.	DE Final Shaft Bearing Fit Size 3	2.1659 "

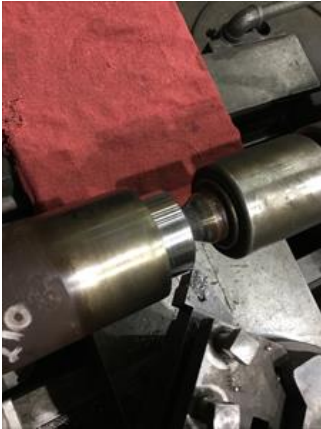
81. ODE Initial Shaft Bearing Fit Size 1

1.9499 "

84. ODE Finial Shaft Bearing Fit Size 1

1.969 "

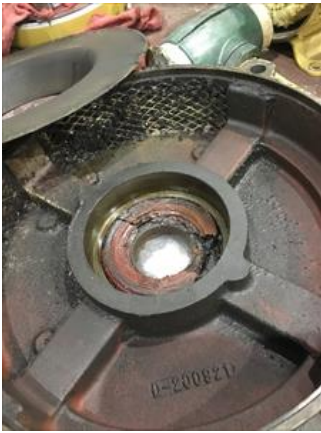
93. DE Endbell Fit

(P) Pass

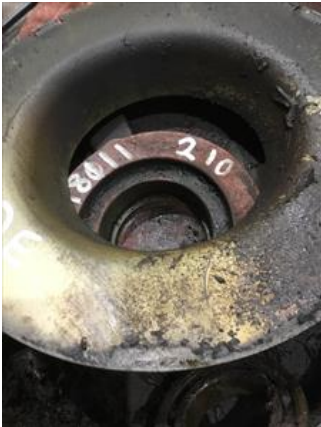
94.	DE Initial Endbell Fit Size 1	4.7254 "
95.	DE Initial Endbell Fit Size 2	4.7254 "
96.	DE Initial Endbell Fit Size 3	4.7254 "
97.	DE Final Endbell Fit Size 1	
98.	DE Final Endbell Fit Size 2	
99.	DE Final Endbell Fit Size 3	
100.	DE Endbell Fit Insulated	(NA) Not Applicable
101.	DE Endbell Air Seal Fit	
102.	Initial Endbell Air Seal Fit Size	
103.	Final Endbell Air Seal Fit Size	
104.	ODE Endbell Fit	(F) Fail
