AC Recondition Repair Report

Saint Jean Industries, Inc. (11653)
424 Industrial Park Road
Heber Springs, AR 72543

1. Job Number	98121
2. Report Date	04/19/2021
3. Customer	SAINT JEAN INDUSTRIES

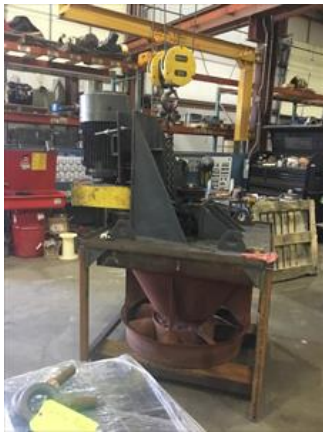
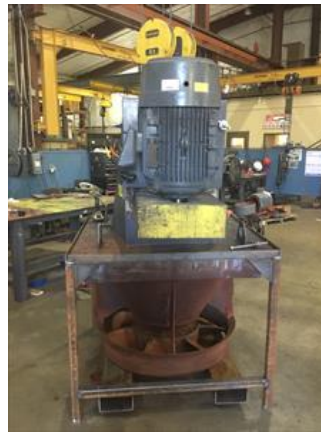
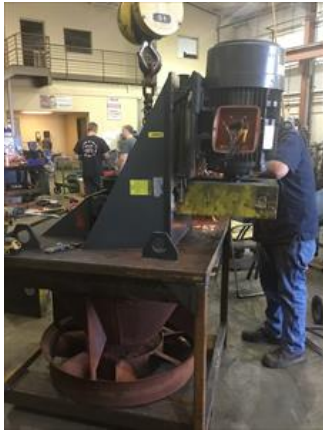
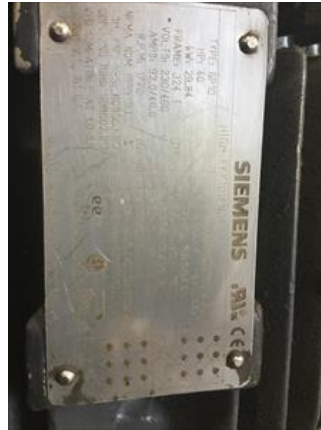
4. Manufacturer	SIEMENS	P5
-----------------	---------	----

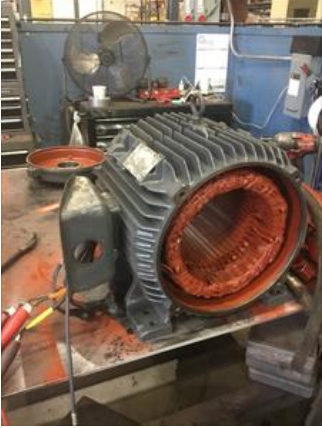
27.	Does Shaft Turn Freely	yes	
28.	Does Shaft Have Visible Damage	yes	
	<i>Slight wear.</i>		
29.	Bearing Rtd's		
30.	Bearing Rtd's Condition		
31.	Contamination		
32.	Frame Condition	(P) Pass	P106

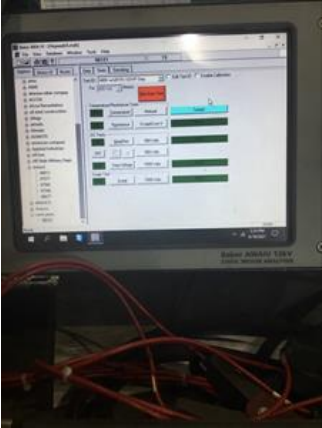
35.	Resistance to Ground		
36.	Winding Resistance 1-2		
37.	Winding Resistance 2-3		
38.	Winding Resistance 1-3		
39.	Resistive Imbalance		
40.	Hi-Pot		
41.	Surge Test	(P) Pass	P58

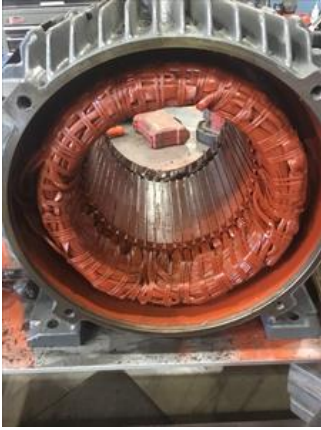
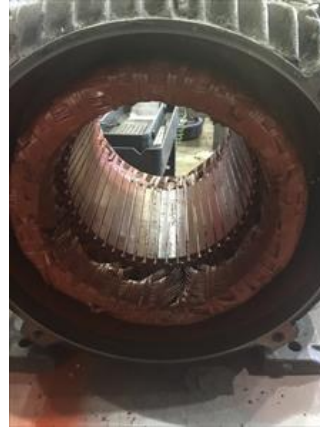
P65

42. Stator Condition

good

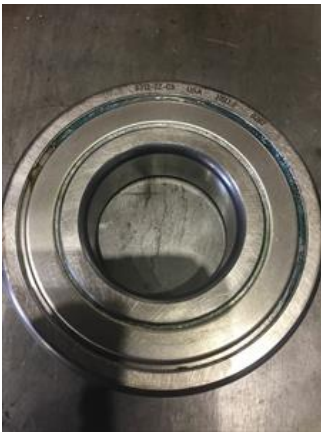
P15

50. Bearing Manufacture **FAG**51. Bearing DE Size **6312 2Z-C3**

52. Bearing DE Type **regular ball bearing**53. DE Bearing Qty. **1**54. Bearing ODE Size **6210 2Z-C3**55. Bearing ODE Type **regular ball bearing**56. ODE Bearing Qty. **1**57. Insulated Bearing **no**58. Lubrication Type **grease**● 59. Grease Condition **(F) Fail**
Dirty
60. Bearing Retainers **(NA) Not Applicable**61. Shaft Grounding Device **(NA) Not Applicable**

| 66. Component Failure | grease dirty/contaminated |
