AC Recondition Repair Report

Almatis Inc/RCP Bauxite (10014)
4701 Alcoa Road
Bauxite, AR 72011

1. Job Number	98122
2. Report Date	04/20/2021
3. Customer	ALMATIS

4. Manufacturer	BALDOR
-----------------	--------

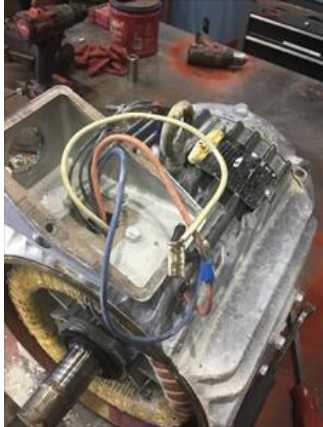
18. Number of Leads	3	
19. Lead Length		
20. Lead Size		
● 21. Lead Condition	(P) Pass	P42

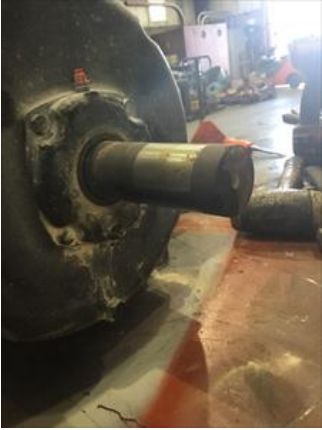
27. Does Shaft Turn Freely	yes	
28. Does Shaft Have Visible Damage	no	P94

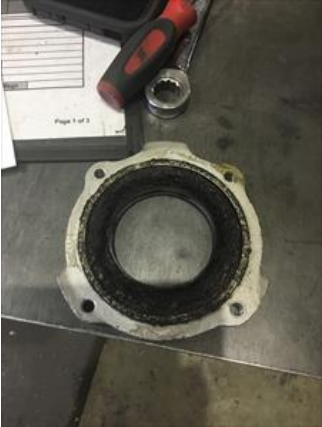
29. Bearing Rtd's		
30. Bearing Rtd's Condition		
31. Contamination <i>Grease dirty</i>		P104

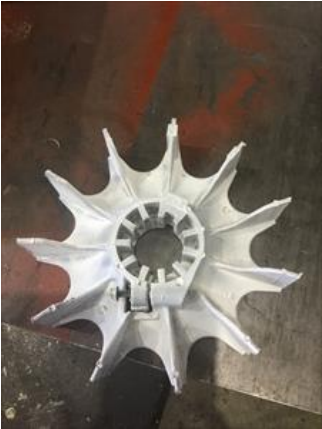
32. Frame Condition	(P) Pass	
33. Fan Condition	(P) Pass	P109

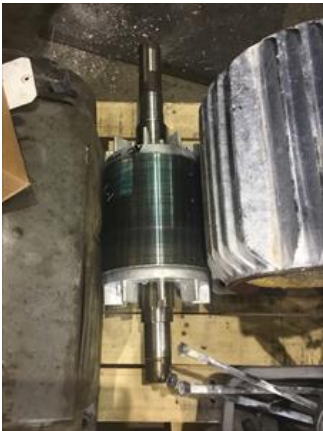
36.	Winding Resistance 1-2		
37.	Winding Resistance 2-3		
38.	Winding Resistance 1-3		
39.	Resistive Imbalance		
40.	Hi-Pot		
●	41. Surge Test	(F) Fail	
	42. Stator Condition	pass	
	43. Failure Location		
Initial Rotor Inspection			
	44. Rotor Type	squirrel cage laminate	
	45. Air Gap <10% Variation		
	46. Number of Rotor Bars		
	47. Number of Broken Rotor Bars		
●	48. Growler Test	(P) Pass	
●	49. Rotor Condition	(P) Pass	P50

65.	ODE Seal Type/Size	
Root Cause of Failure		
66.	Component Failure	windings tested bad
67.	Cause of Failure	<i>Windings shorted on legs 2&3 and 1&3. Tested bad on both machines.</i>
68.	Comments	<i>Re-sleeve O.D.E housing. Rewind stator.</i>
69.	Service Technician	Terrence. Holland

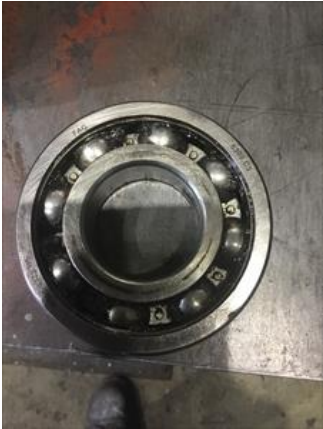
Mechanical Inspection			
	50. Bearing Manufacture	FAG	
	51. Bearing DE Size	6309	P15

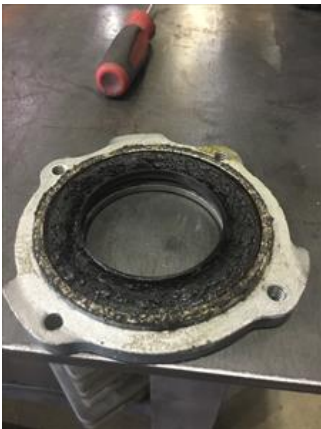
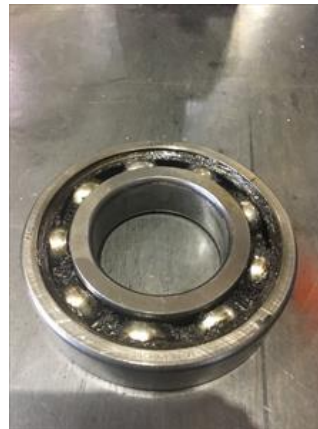
☒ 59. Grease Condition

(F) Fail

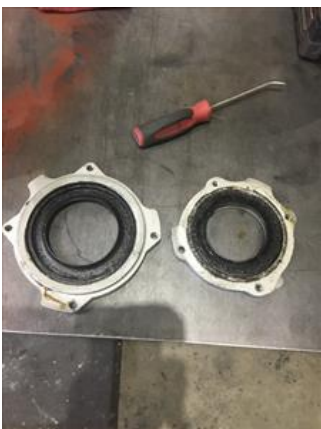
☒ 60. Bearing Retainers

(Y) Yes

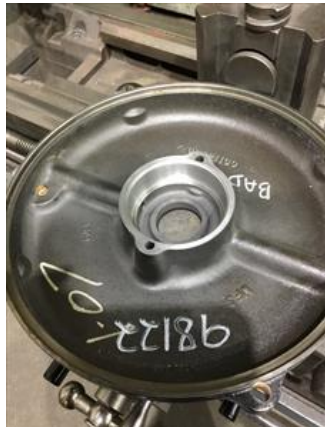
104. ODE Endbell Fit	(F) Fail	
105. ODE Initial Endbell Fit Size 1	3.1505 "	
106. ODE Initial Endbell Fit Size 2	3.1507 "	
107. ODE Initial Endbell Fit Size 3	3.1508 "	
108. ODE Final Endbell Fit Size 1	3.1497 "	P149

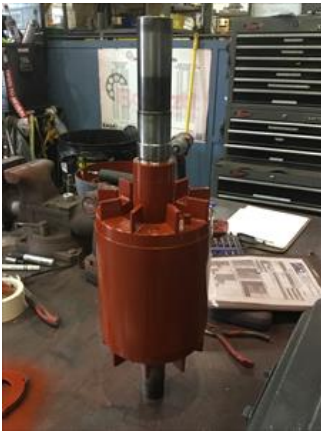
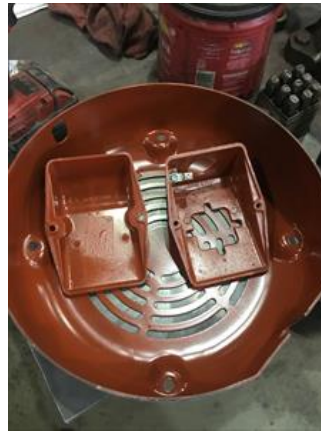
132.	Winding Resistance 1-3		
133.	Test Run Voltage Phase A		
134.	Test Run Amps A		
135.	Test Run Voltage Phase B		
136.	Test Run Amps B		
137.	Test Run Voltage Phase C		
138.	Test Run Amps C		
139.	DE Horizontal Vibration Reading		
140.	DE Vertical Vibration Reading		
141.	DE Axial Vibration Reading		
142.	ODE Horizontal Vibration Reading		
143.	ODE Vertical Vibration Reading		
144.	ODE Axial Vibration Reading		
145.	Ambient Temp at start of Test Run		
146.	Temp at 5 minutes		
147.	Temp at 10 minutes		
148.	Temp at 15 minutes		
149.	Temp at 20 minutes		
150.	Temp at 25 minutes		
151.	Temp at 30 minutes		
152.	Temp at 35 minutes		
153.	Temp at 40 minutes		
154.	Temp at 45 minutes		
155.	Temp at 50 minutes		
156.	Temp at 55 minutes		
157.	Temp at 60 minutes		
● 158.	Motor Paint	(P) Pass	P136
